# BUILDING CONDITION ASSESSMENT

WORKS GARAGE & SHOP

191274 13<sup>TH</sup> LINE  
EAST GARAFRAXA, ONTARIO

December 15, 2023

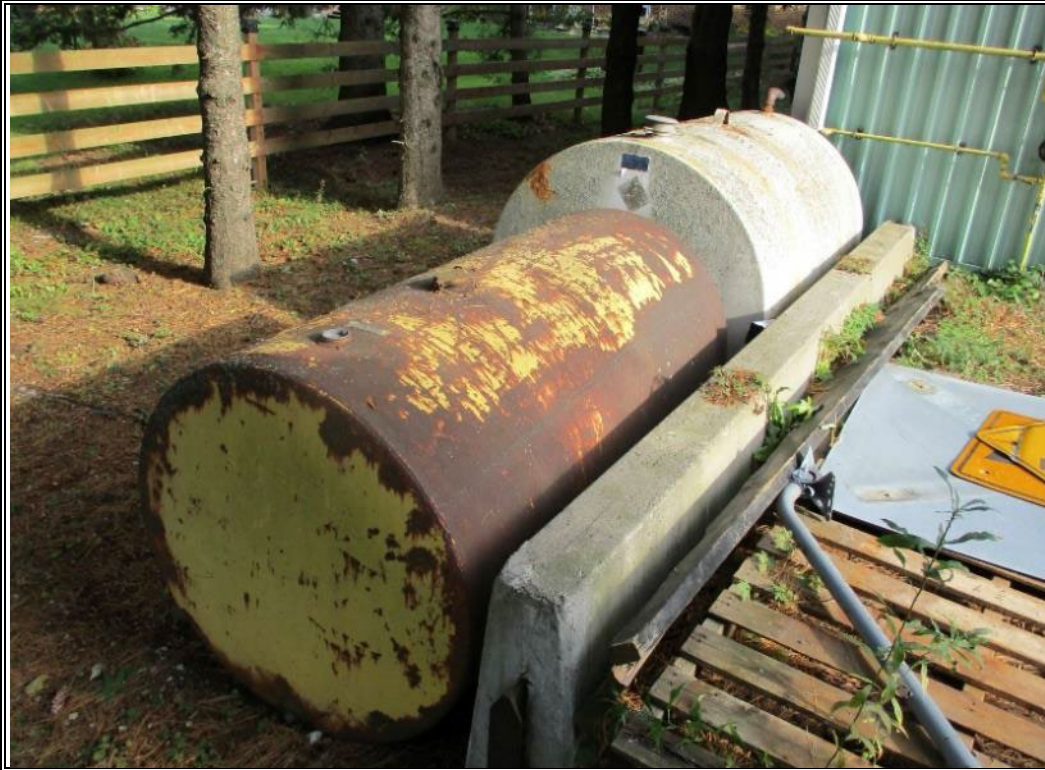
The yellow propane tank is abandoned/not in use and is disconnected. It is recommended that the tank be removed from the site. Costs associated with removal of the tank are expected to be below the Capital Threshold and are not included.

The yellow tank is corroded and is not in use/abandoned.

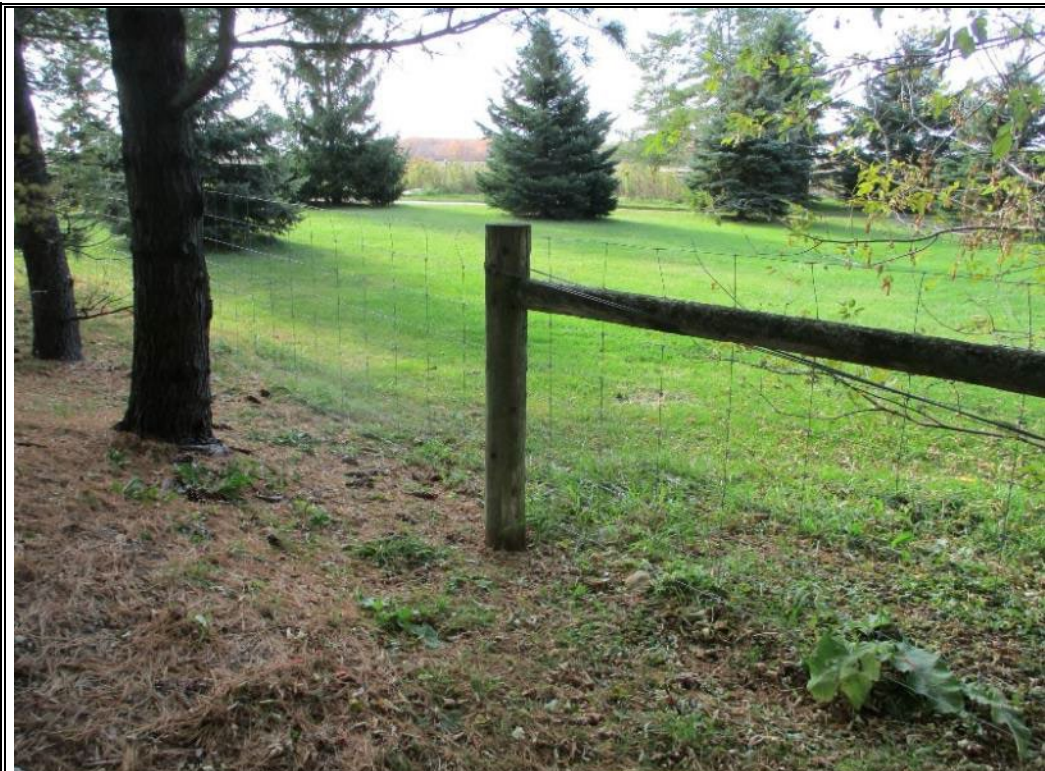
7

The low wood post and wire fence at the west side of the property appears to be in fair to poor condition. A budget for future fence repairs has been allowed for during the time-period of this study.

The fence on the property line is wood posts and wire fencing.

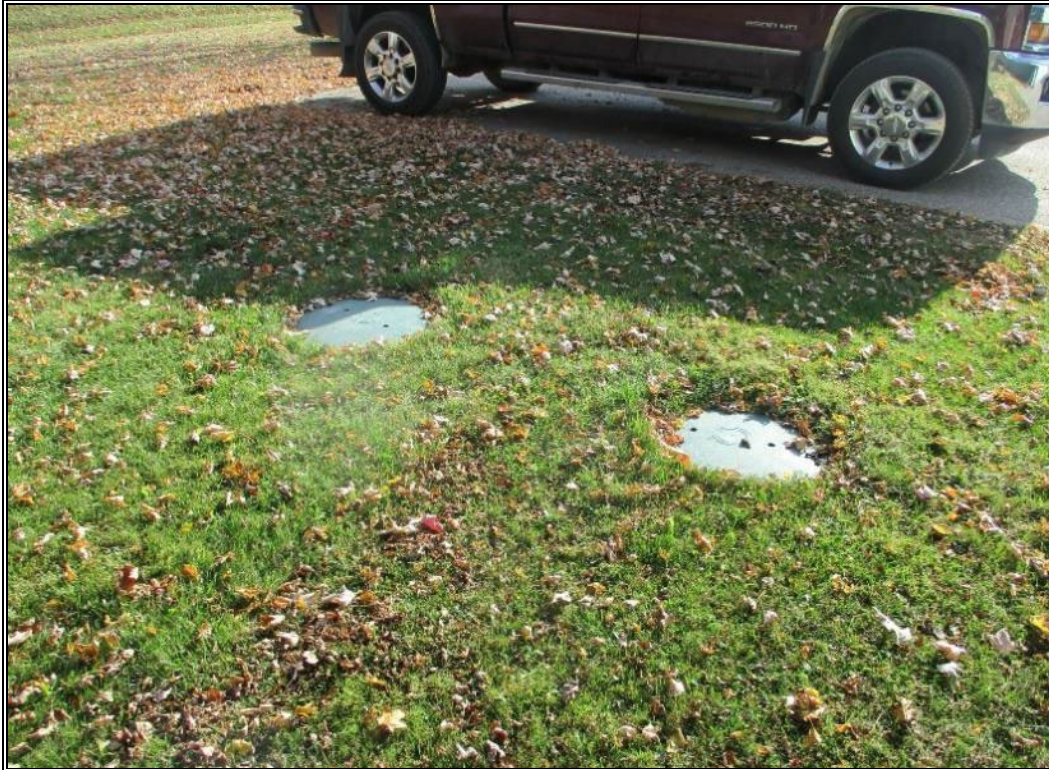
The septic system is operational and was serviced recently. The system may be original and is approaching the end of its service life. A budget for future replacement has been allowed for during the time-period of this study.

The septic system is possibly original to the building.

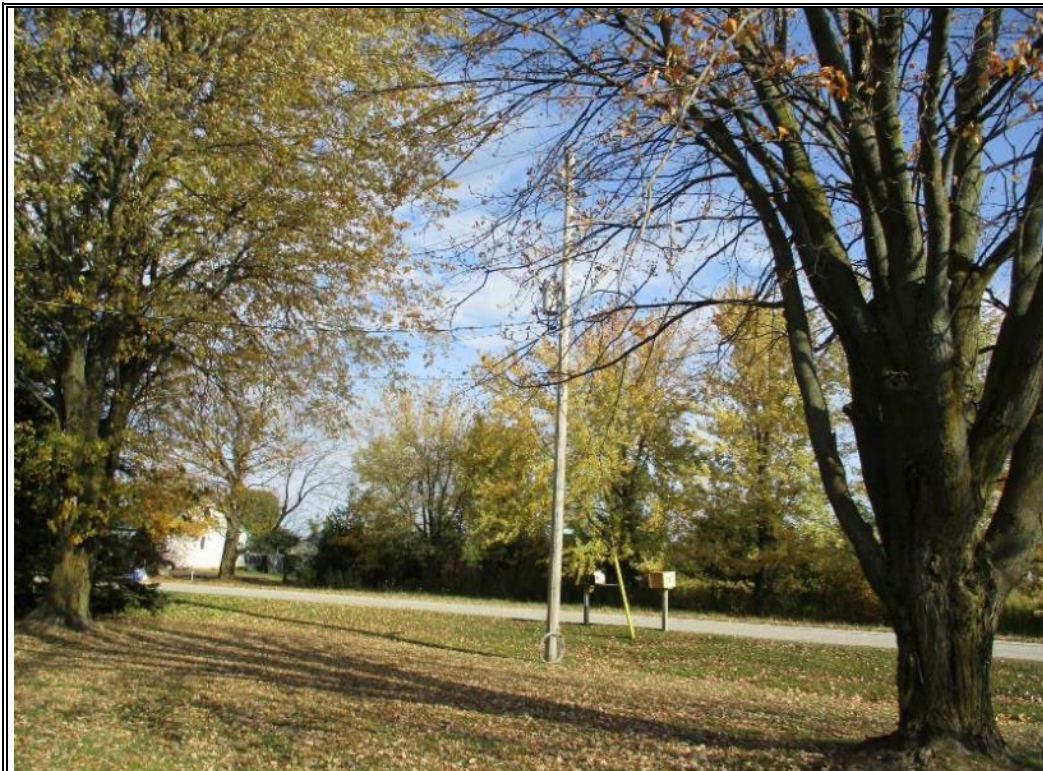
**13**

Landscaping and appurtenances are in fair to poor condition with plant overgrowth in the gravel sections and tree foliage overgrowth over electrical wires and the roof of the building. A budget for plant and trees overgrowth trimming and removals has been allowed for during the time-period of this study.

The tree branches are close to the overhead power lines.

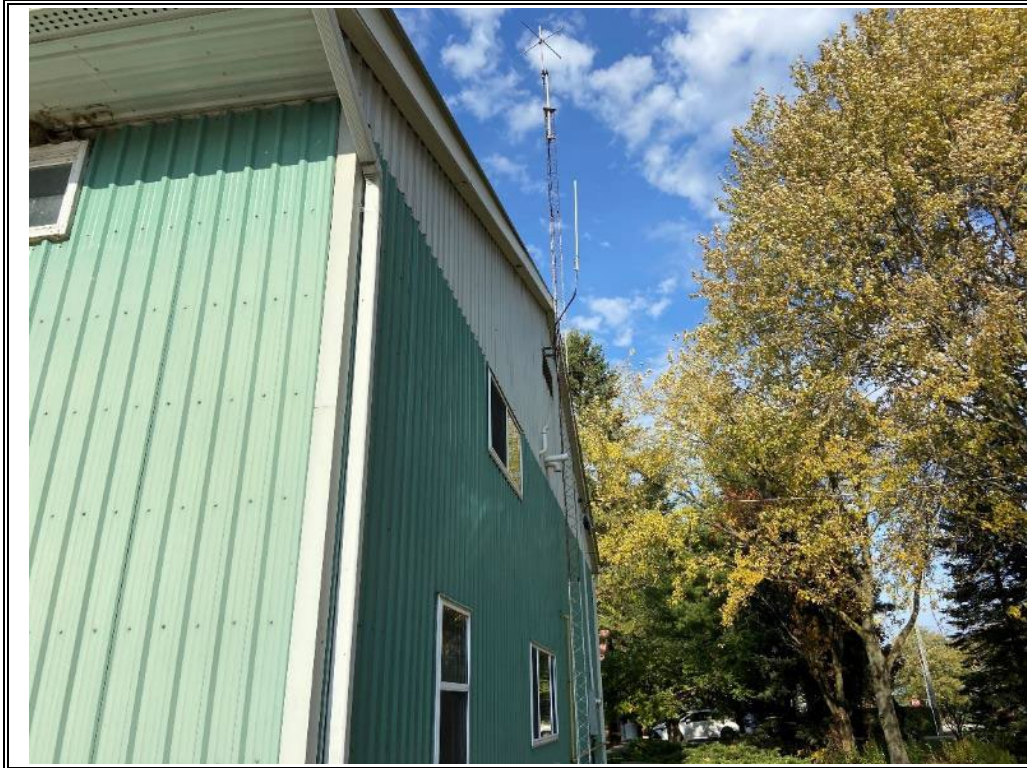
An antenna is provided at the east side of the building.

The antenna is in fair condition.

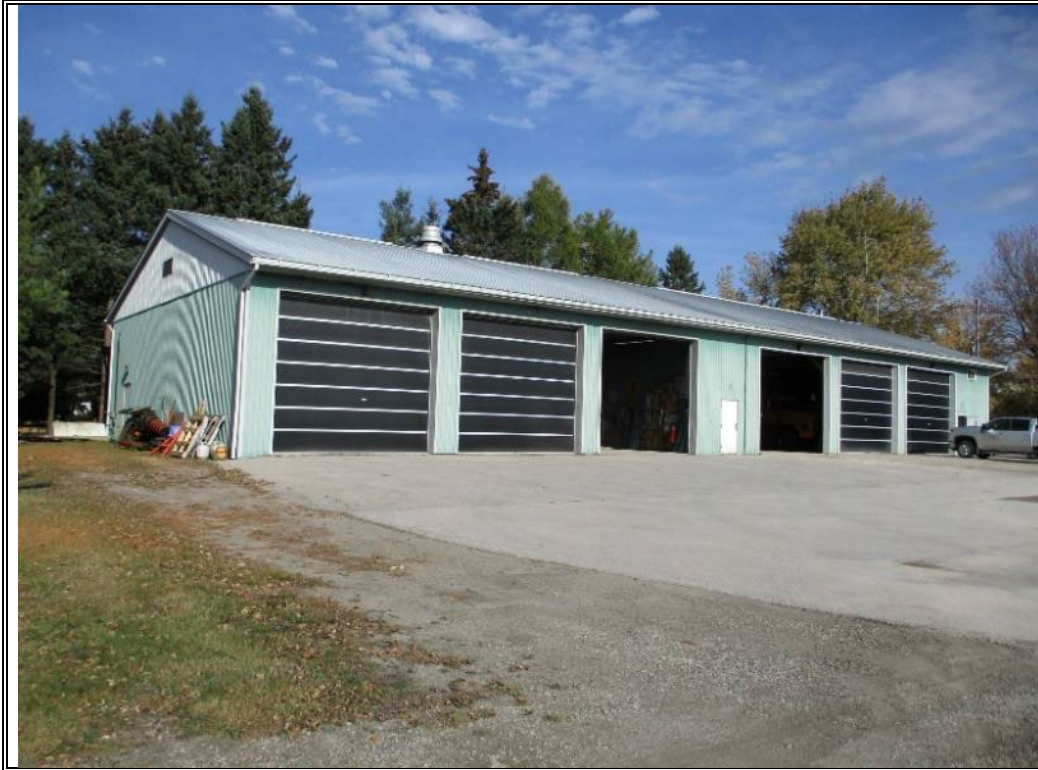
Asphalt pavement related to the works garage is in fair condition.

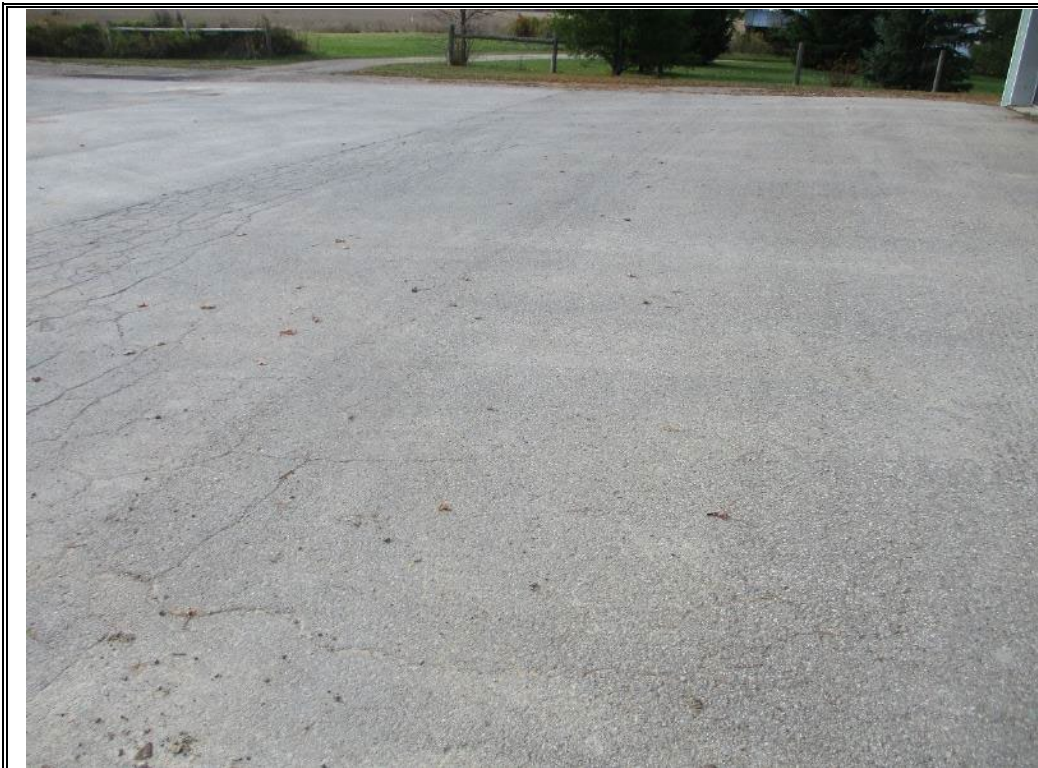
**17**

The asphalt pavement of the main lot and parking is in fair condition. There have been recent asphalt pavement repairs. Replacement is not anticipated during the timeline of this report. A budget for repairs has been allowed for during the time-period of this study.

Asphalt pavement related to the works garage is in fair condition with localized cracks.

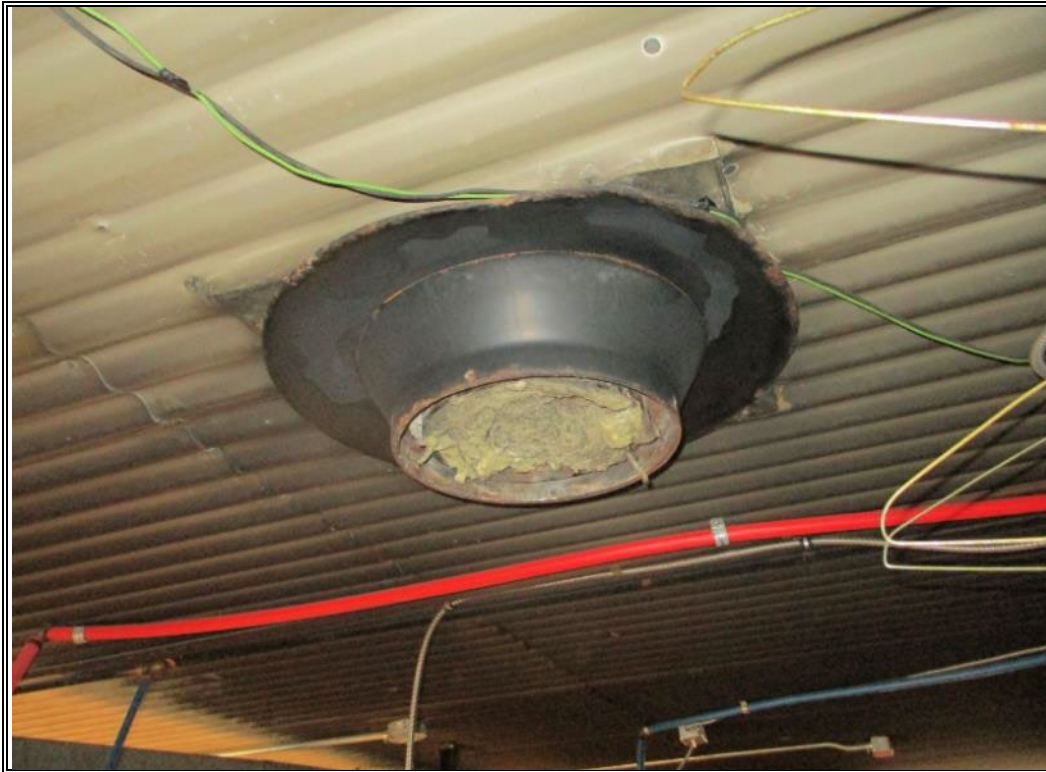
An abandoned chimney opening in the mezzanine ceiling from a past oil furnace is closed with insulation. The abandoned chimney and interior opening should be removed/closed correctly. Cost of repairs is below capital threshold and not included.

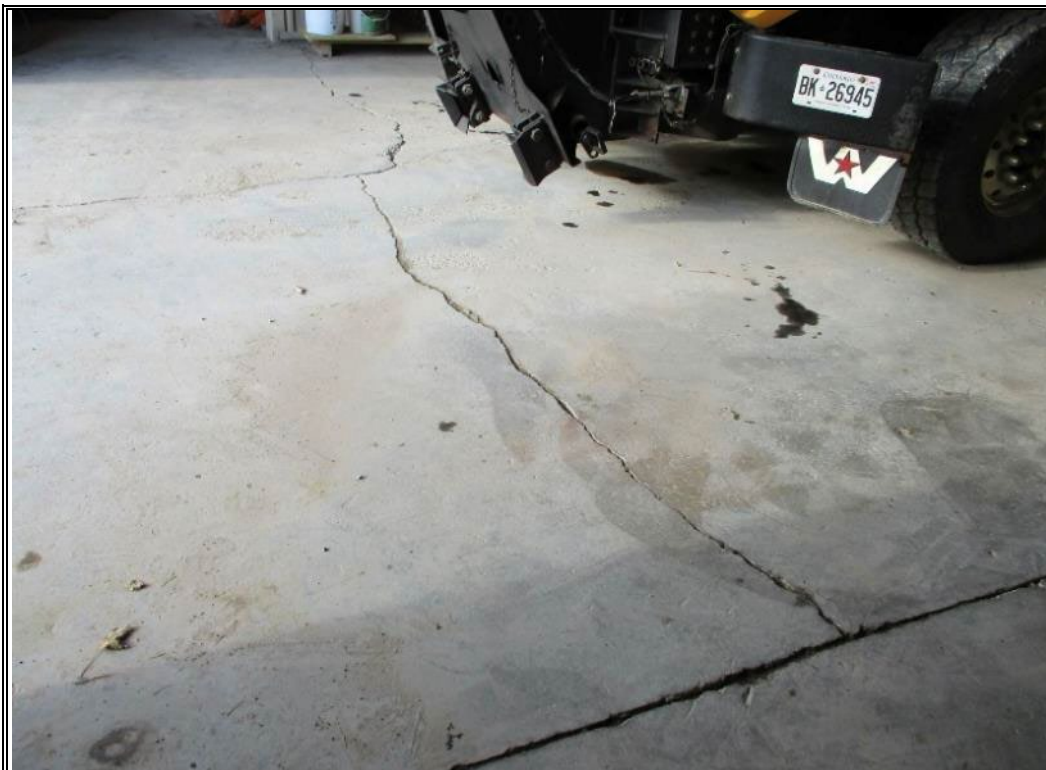
**37**

The slab-on-grade and substructure is in fair condition with localized cracks/fractures. Replacement is not anticipated during the timeline of this report. A budget for localized slab repairs has been allowed for during the time-period of this study.

In any building, slight settlement will occur over time. This was evident from localized cracks in the slab-on-grade.

The concrete slab is cracked.

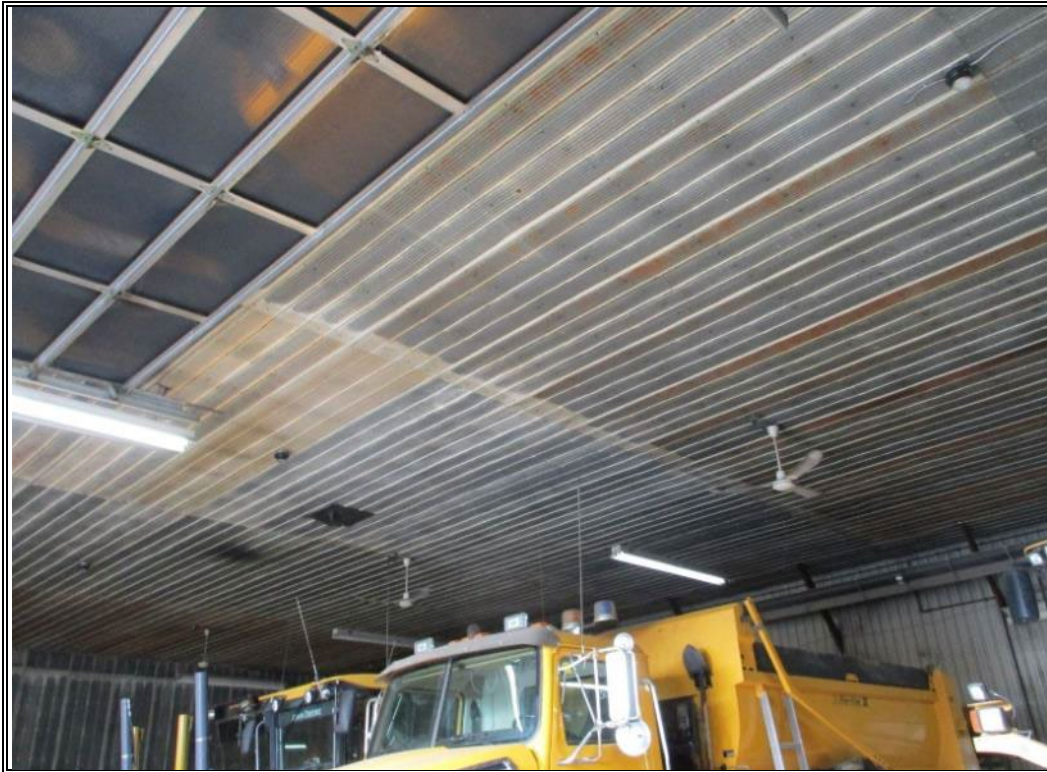
The metal corrugated soffit of the garage is rusted and stained.

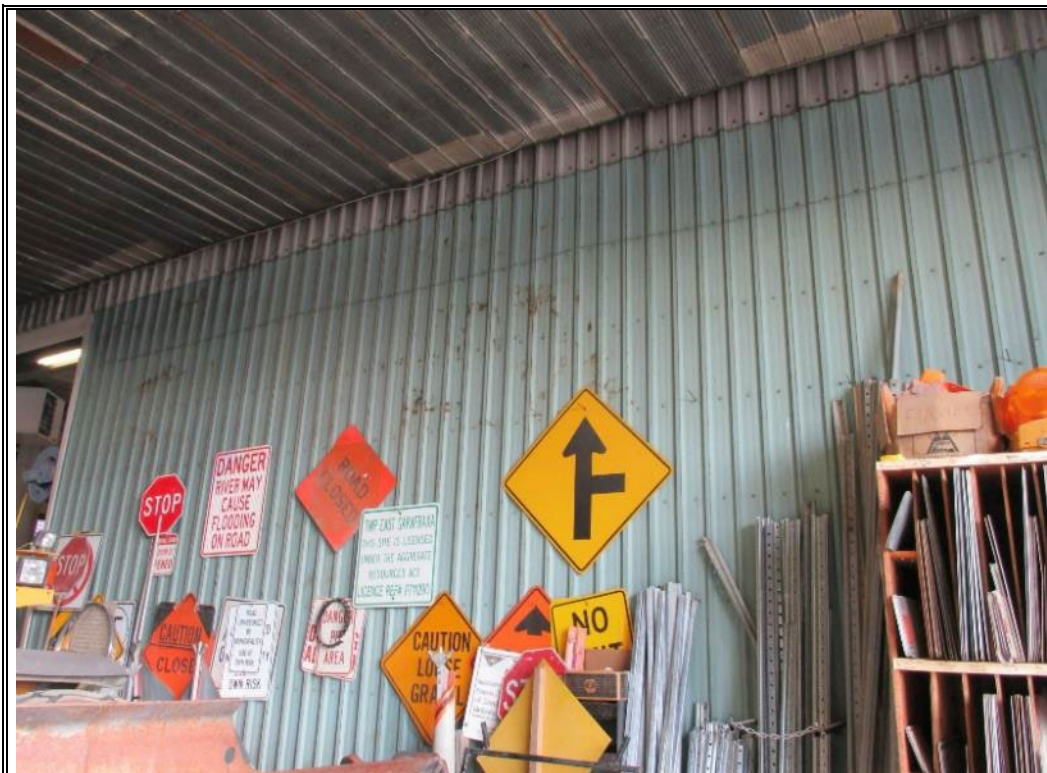
**39**

The exterior cladding system is original and is in fair to poor condition with faded paint coatings. Replacement is not anticipated during the timeline of this report. A budget for future metal siding paint coatings replacement has been allowed for during the time-period of this report.

The metal corrugated walls of the garage are rusted, faded and stained.

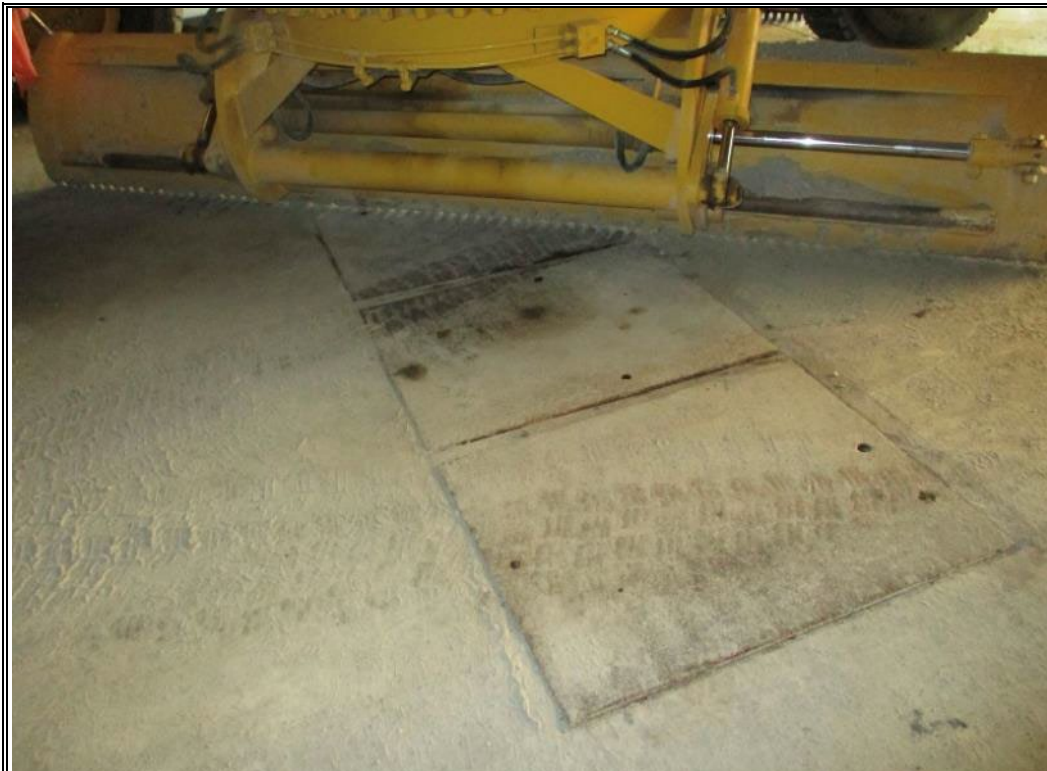
The oil-water interceptor is in working order and will reach the end of its service life within the time-period of this report. A budget for future replacement has been allowed for during the time-period of this report.

**Description:**  
There is an oil-water interceptor that collects water from the trench drain.

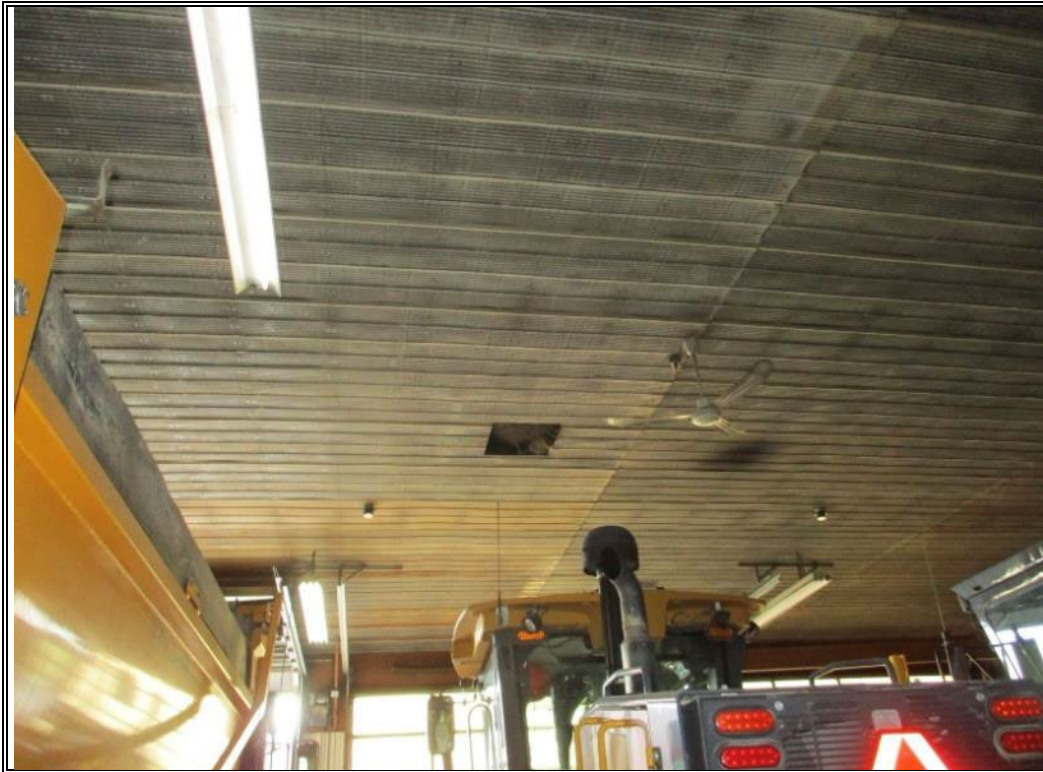
The roof top exhaust fan and venting for the garage is functional and is operated manually from a switch. It is recommended that the fan be operated automatically when specific interior ambient conditions occur. A budget for replacement with a system that has automatic systems and sensors has been allowed for during the time-period of this study.

Garage. The ceiling hole is for venting to the roof top exhaust fan.

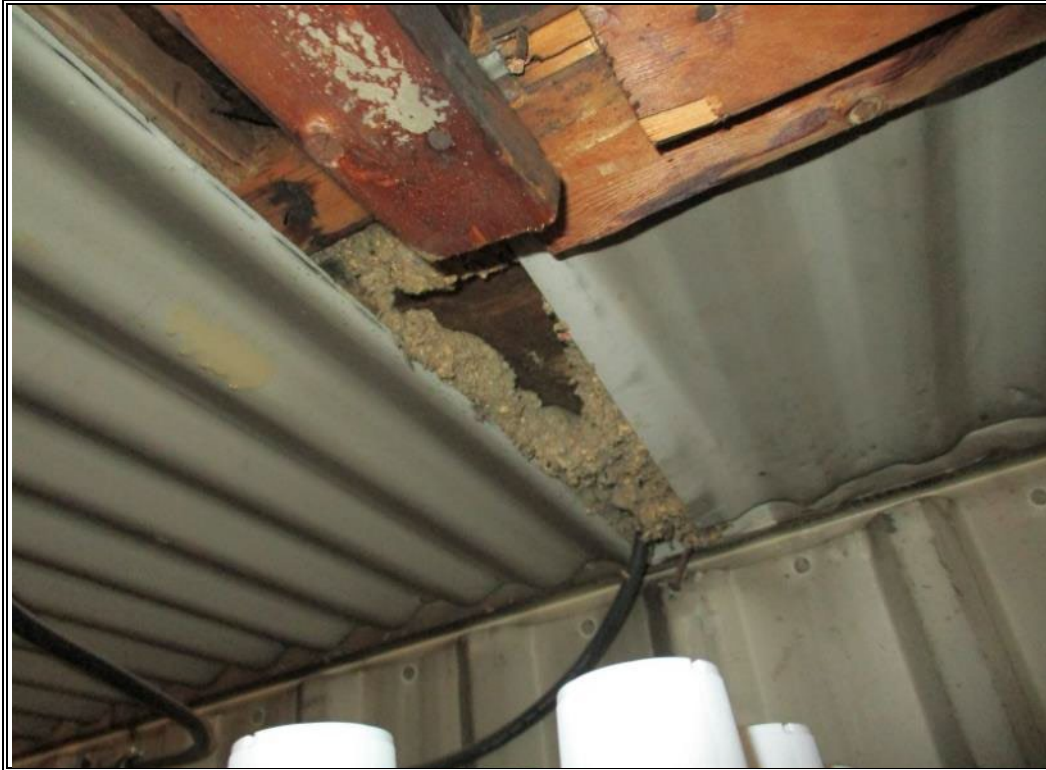
The insulation and attic space are exposed near the attic.
