BUILDING CONDITION ASSESSMENT

MEETING HALL & COMMUNITY CENTRE

191282 13TH LINE
EAST GARAFRAXA, ONTARIO

December 15, 2023

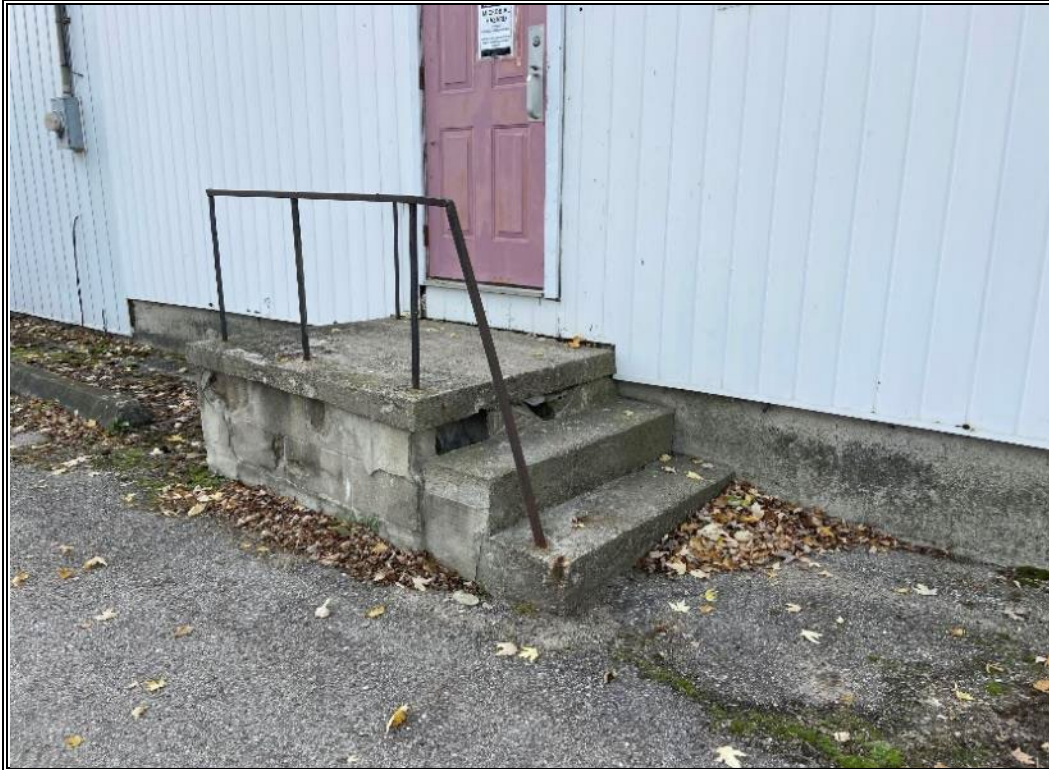
The concrete stairs are damaged, deteriorated, broken, and pieces of concrete are missing.

The concrete landing, steps and metal guard/railings are in poor condition with localized and cracked concrete/blocks, aged concrete surfaces and staining. The metal guard/railing is not to code is rusted with deteriorated paint and deformations. The deteriorated nature of the landing could be a safety hazard. A budget for urgent replacement of the concrete landing, steps and railing/guard has been allowed for during the time-period of this report.

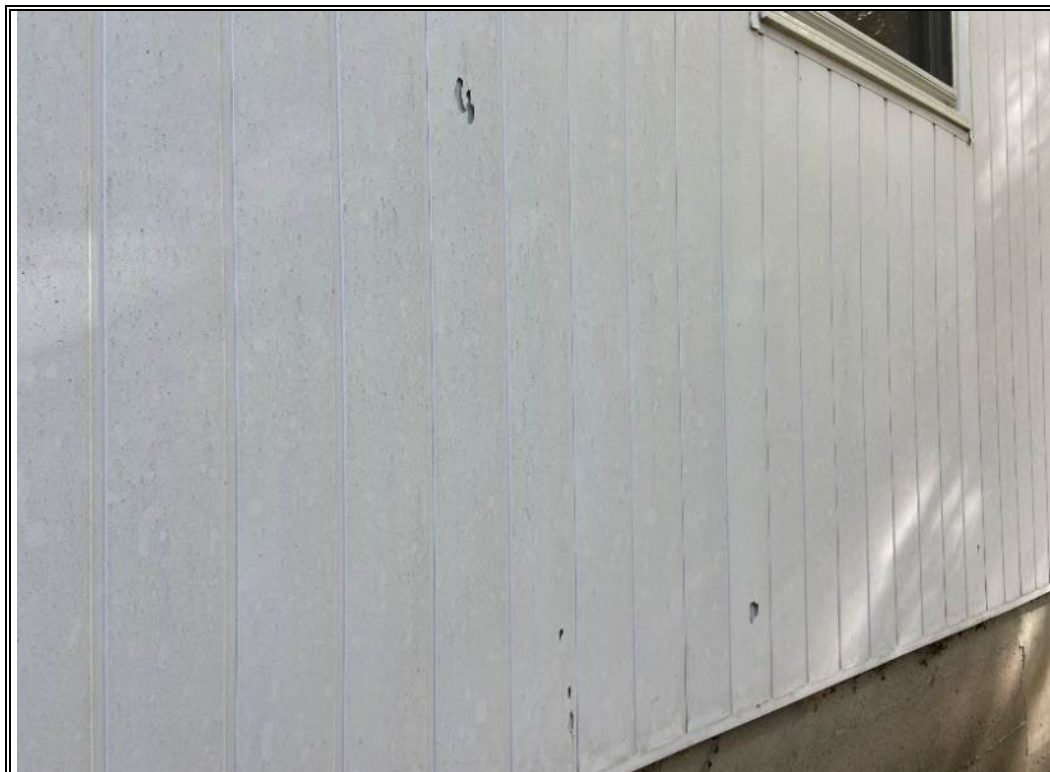
The vinyl siding is aged and has holes.

The siding is in poor condition with faded and brittle surfaces and damage in the form of dents and holes. A budget for replacement has been allowed for during the time-period of this report.

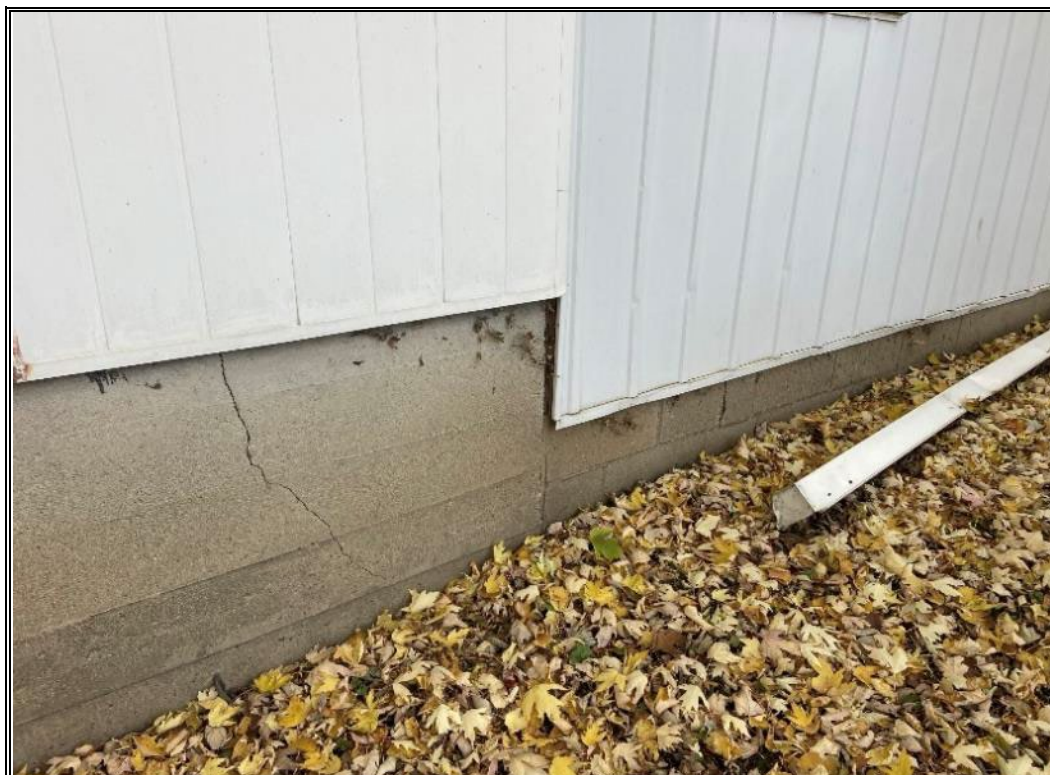
There are localized cracks in the foundation walls.

The exposed foundations walls have localized cracks, staining and surface deterioration/delaminated parging. A budget for repairs has been allowed during the time-period of this study.

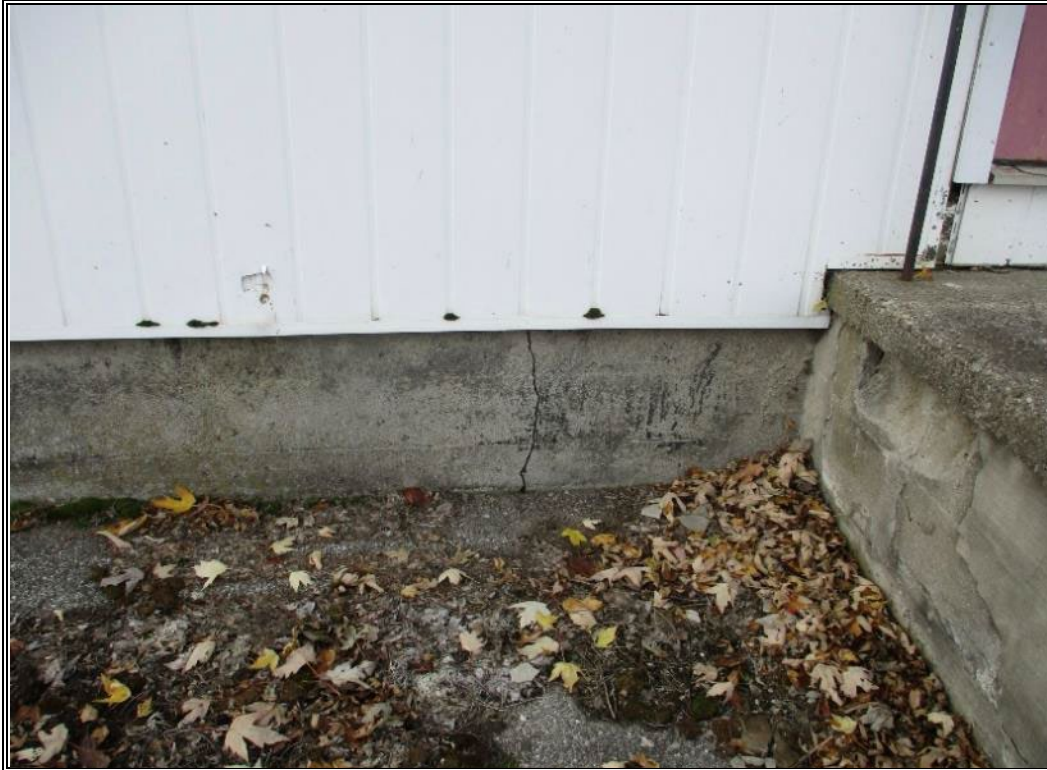
The foundation wall is cracked.

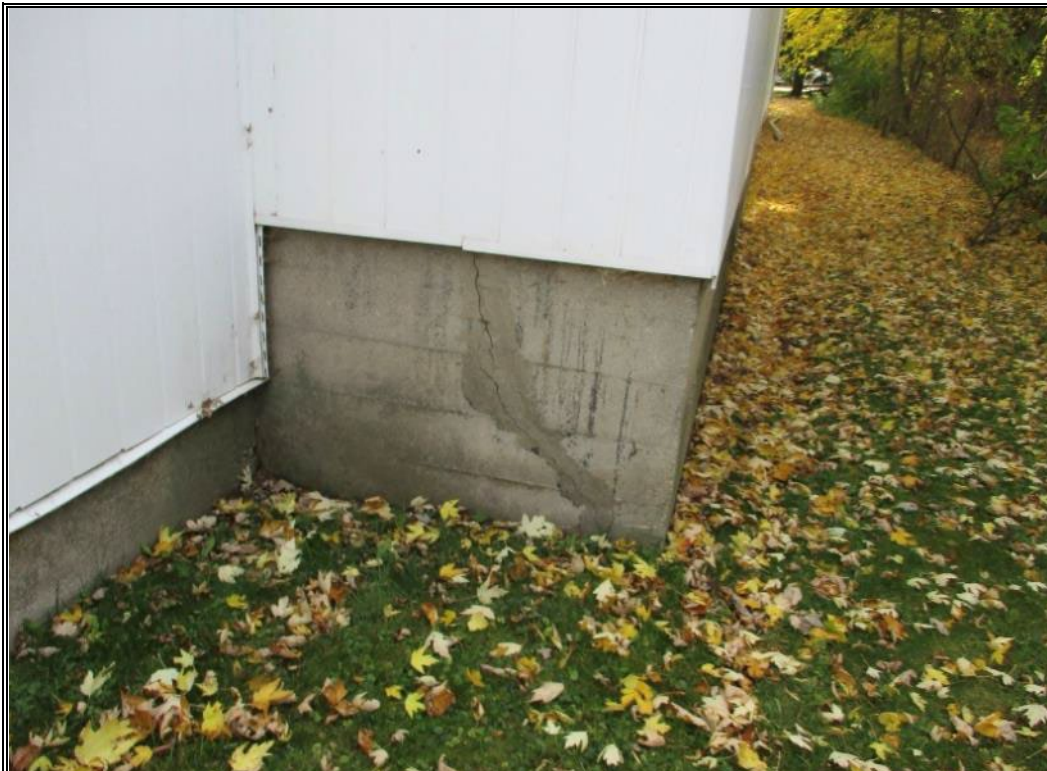
There are localized cracks in the foundation walls.

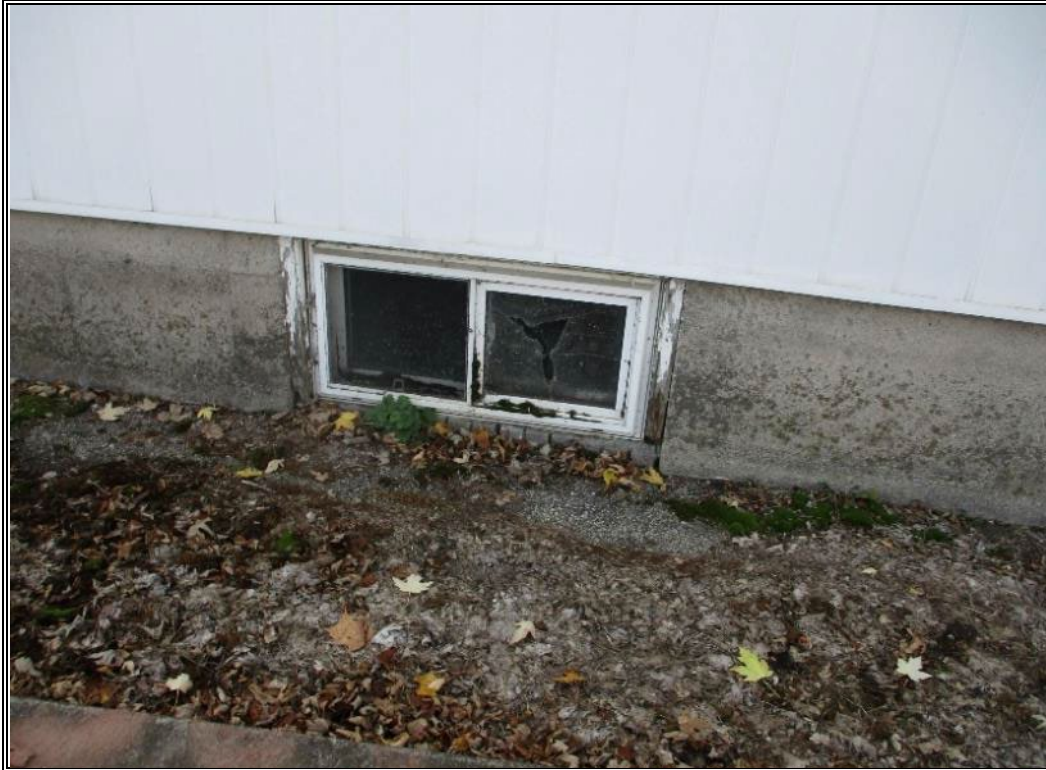
The basement IGU is broken.

The condition of the windows varies from poor to fair and are of different vintages. Windows will reach the end of their expected service life within the timeframe of this report. A budget for replacement of windows, frames and glazing has been allowed for during the time-period of this report. The service life of windows can be extended with moderate repairs that are anticipated to be below the capital threshold. It is reasonable to assume that the failure rate for these units may increase as they approach the end of their expected service life.

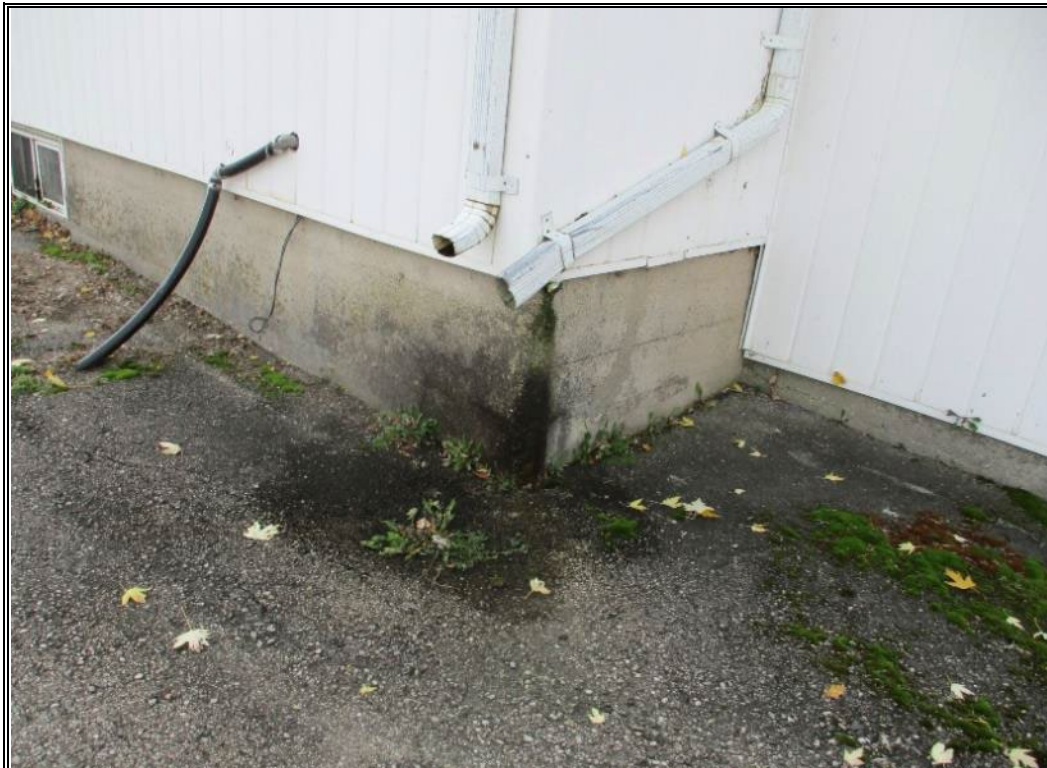
The asphalt driveway and parking area is aged and in poor condition with deterioration in the form of cracking, alligating, raveling and moss/grass growing at some locations. A budget for replacement has been allowed for during the time-period of this report.

There are weeds and moss growing on the asphalt pavement.

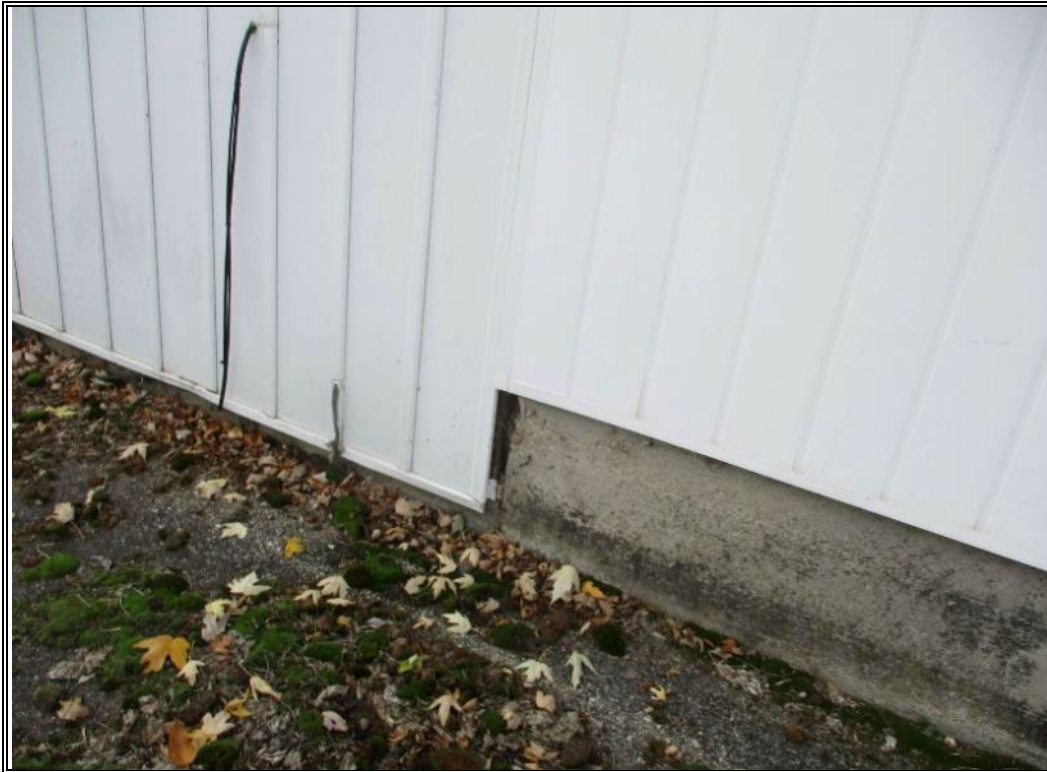
Description:
Abandoned wires
are exiting the
walls.

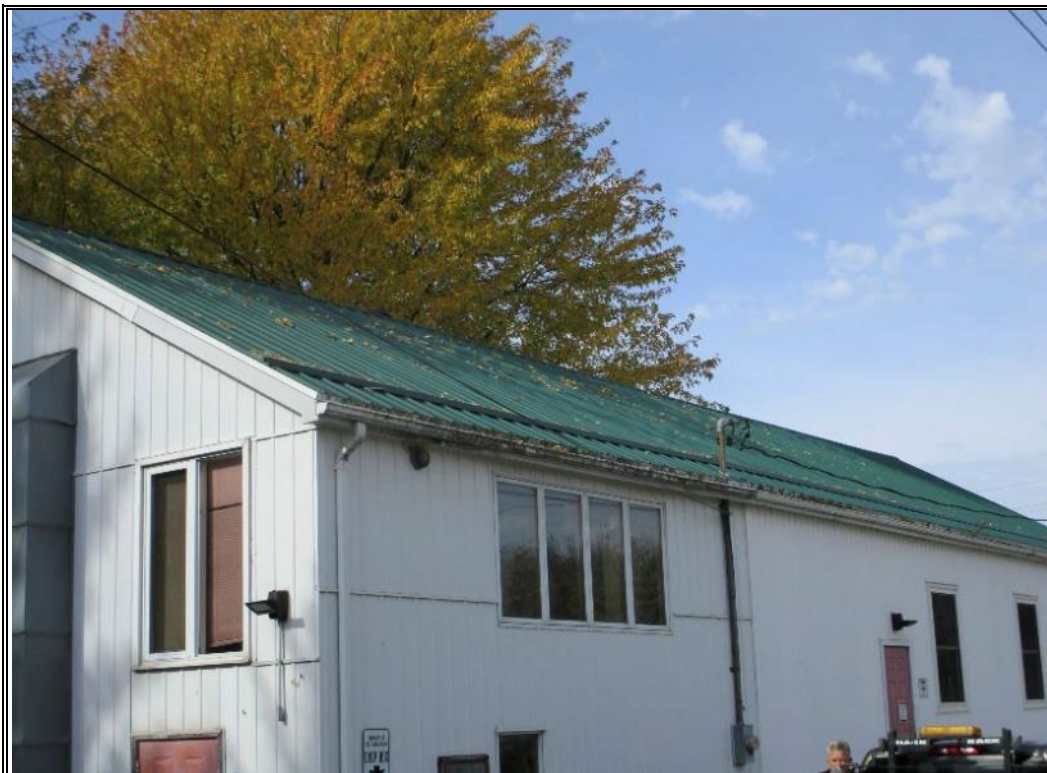
Description:
The building has a
metal corrugated
roofing with
snow/ice guards.

The roof is in fair
condition.

The paint/coatings of the metal roof are in fair condition; however, they will reach the end of their service life within the timeframe of this report. A budget for replacement has been allowed for during the time-period of this study.

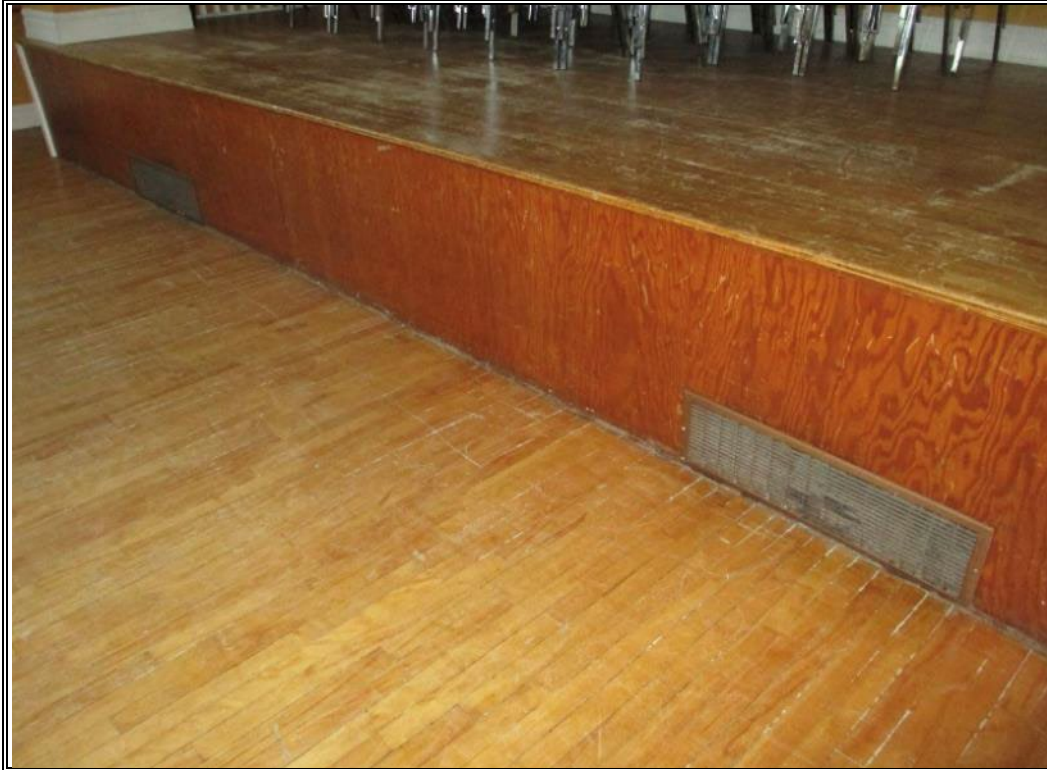
The stage is made of wood and wood flooring is in poor condition.

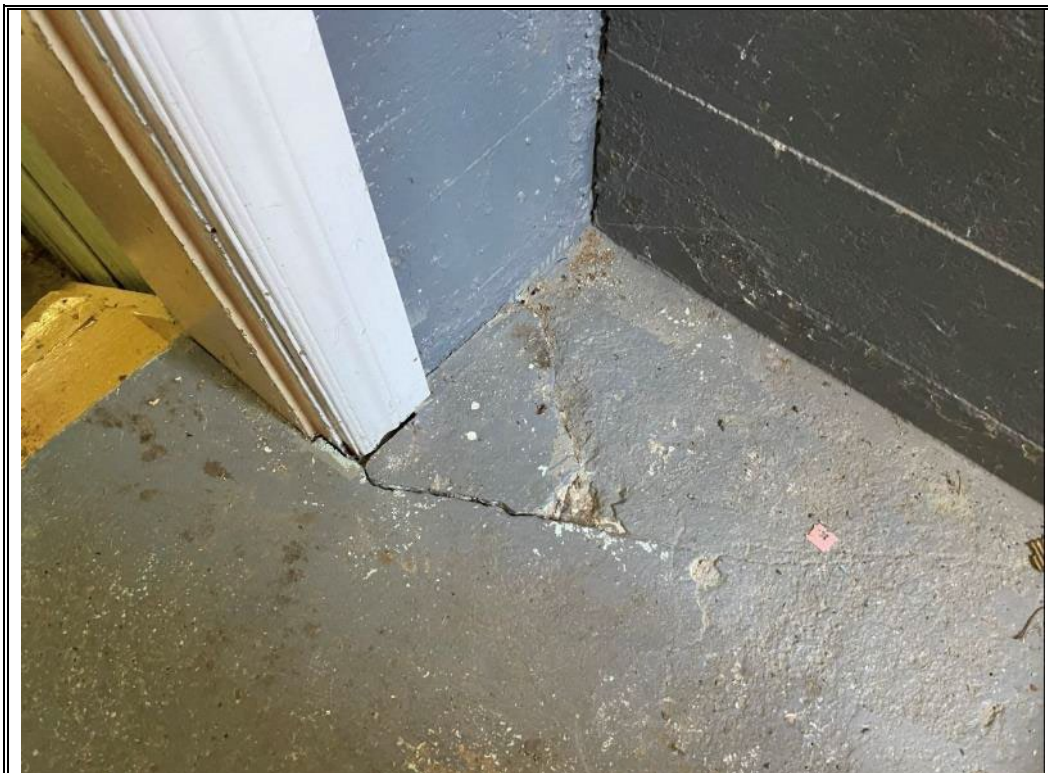
The concrete slabs of the main entrance vestibule, rear entrance and washrooms are on grade level and are in fair condition with deteriorated paint coatings, and localized cracks. A budget for repairs has been allowed during the time-period of this study.

Description:
The concrete slab at the main entrance vestibule is cracked.

Paint coatings are deteriorated.

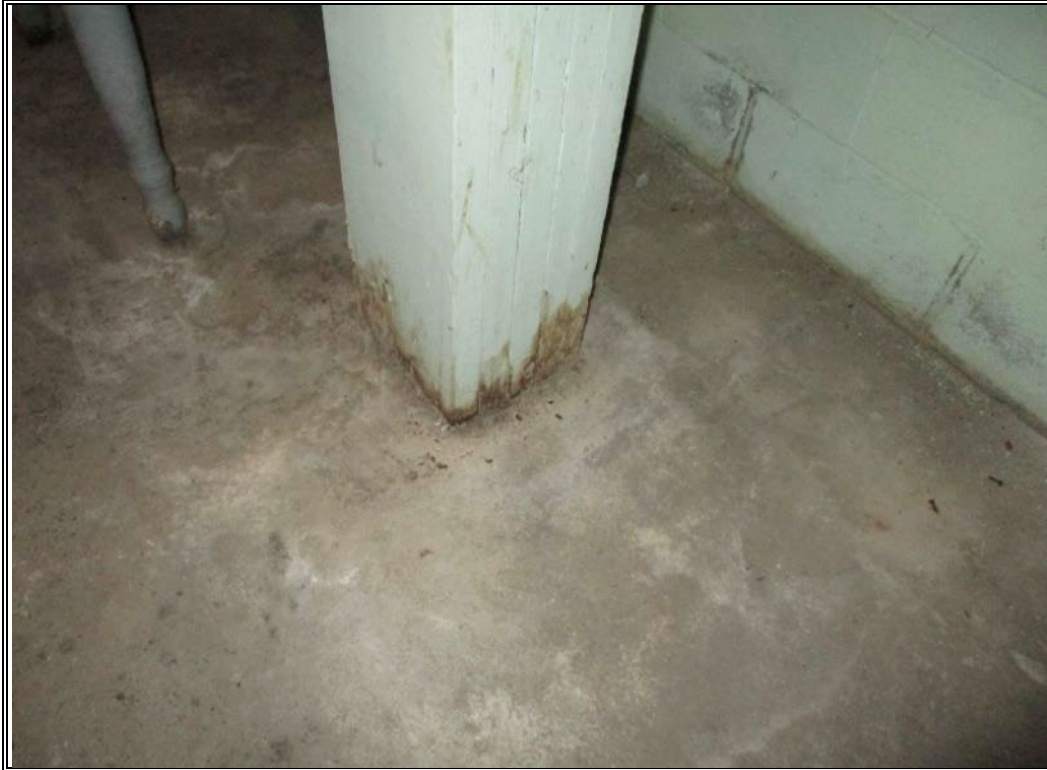
The concrete slab and substructure in the basement are in poor condition with localized cracks/fractures, staining, and evidence of flooding/water penetration. A budget for repairs has been allowed during the time-period of this study.

The concrete slab and substructure in the basement are in poor condition with localized cracks/fractures, staining, and evidence of flooding/water penetration.

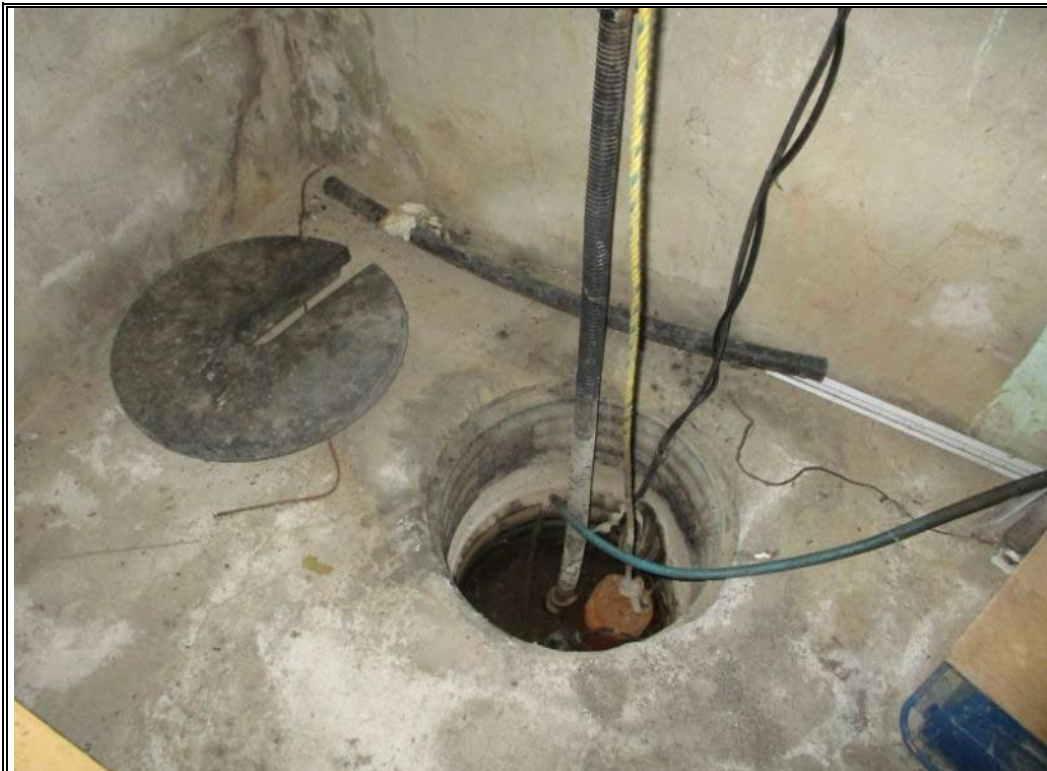
The basement has an operational sump pump that is in poor condition.

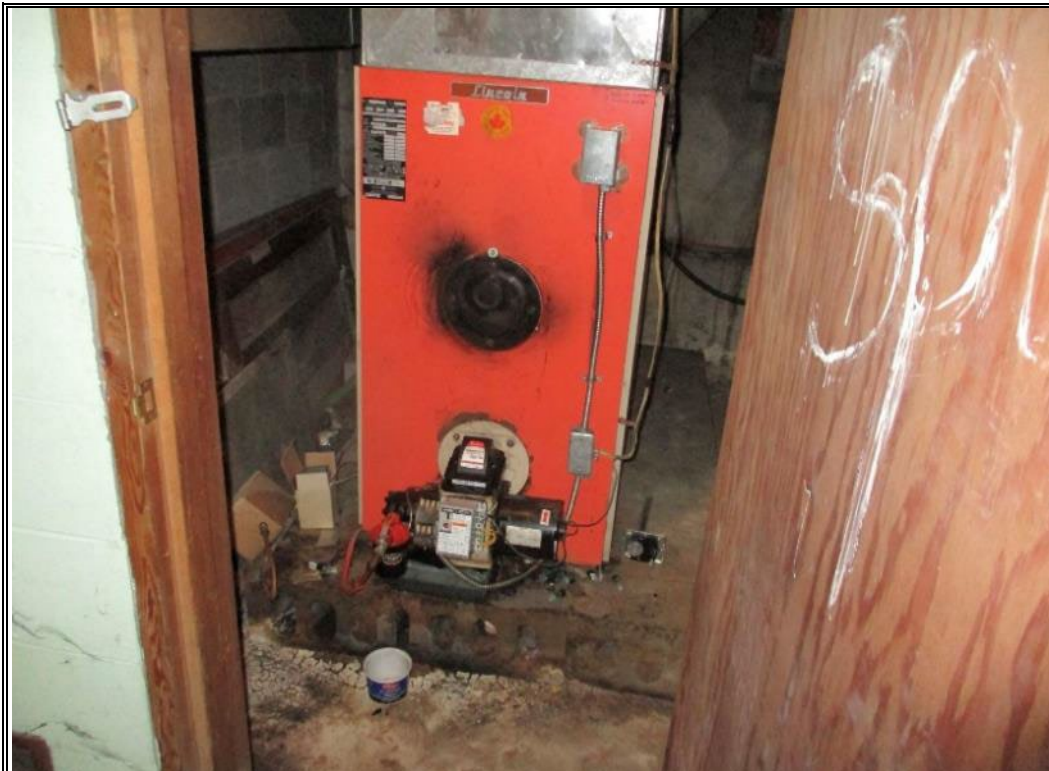
Description:
The oil furnace is original with newer vintage ignitor and controls.

There is scaling and mould around the furnace.

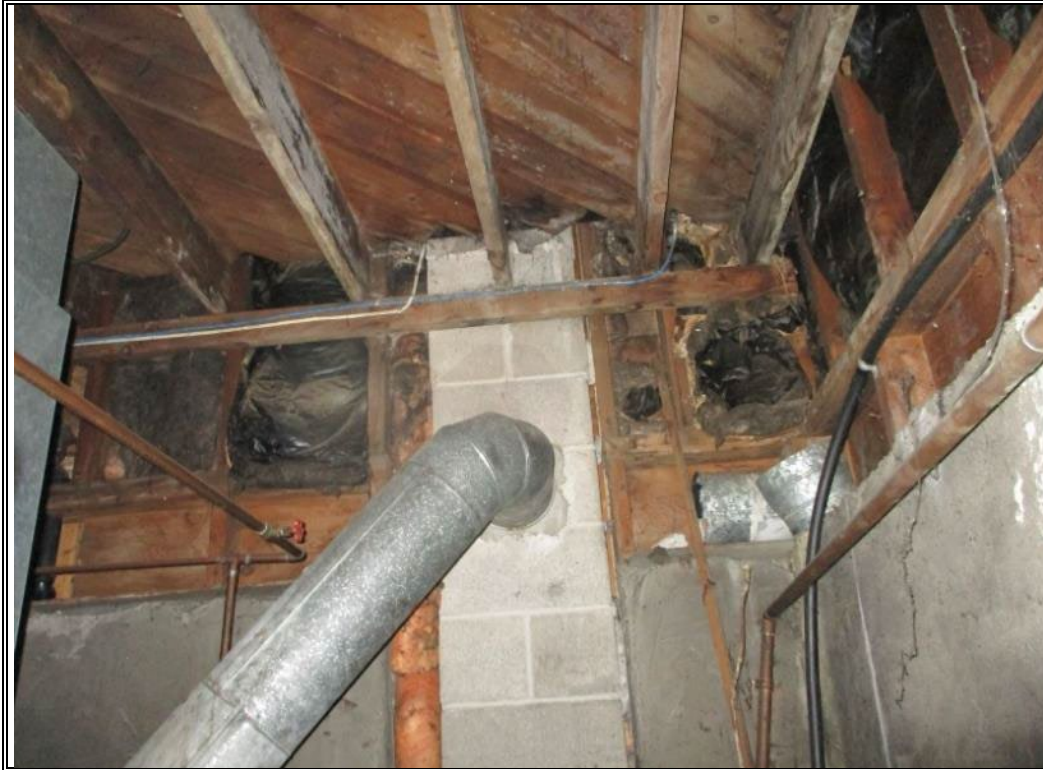
We observed no significant adverse conditions concerning visible superstructure systems; however, there is staining/surface deterioration at the base of the wood columns/posts in the basement and floor/wall framing in the mechanical room of the basement consistent with water penetration. Replacement is not anticipated during the timeline of this report. A budget for repairs has been allowed during the time-period of this study.

Dark discolourations consistent with mould/ water damage was noted in the mechanical room of the basement.

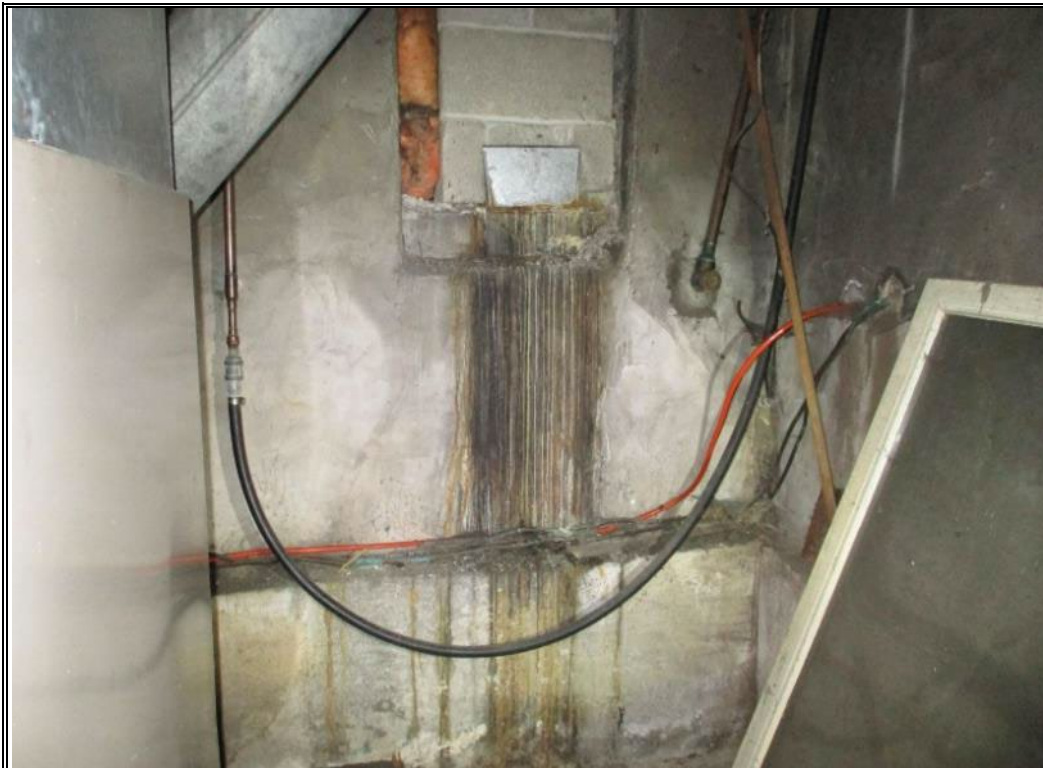
The concrete block chimney is in fair condition with deteriorated mortar joints and leaks at basement level. A budget for repairs has been allowed for during the time-period of this report.

The masonry chimney is leaking.

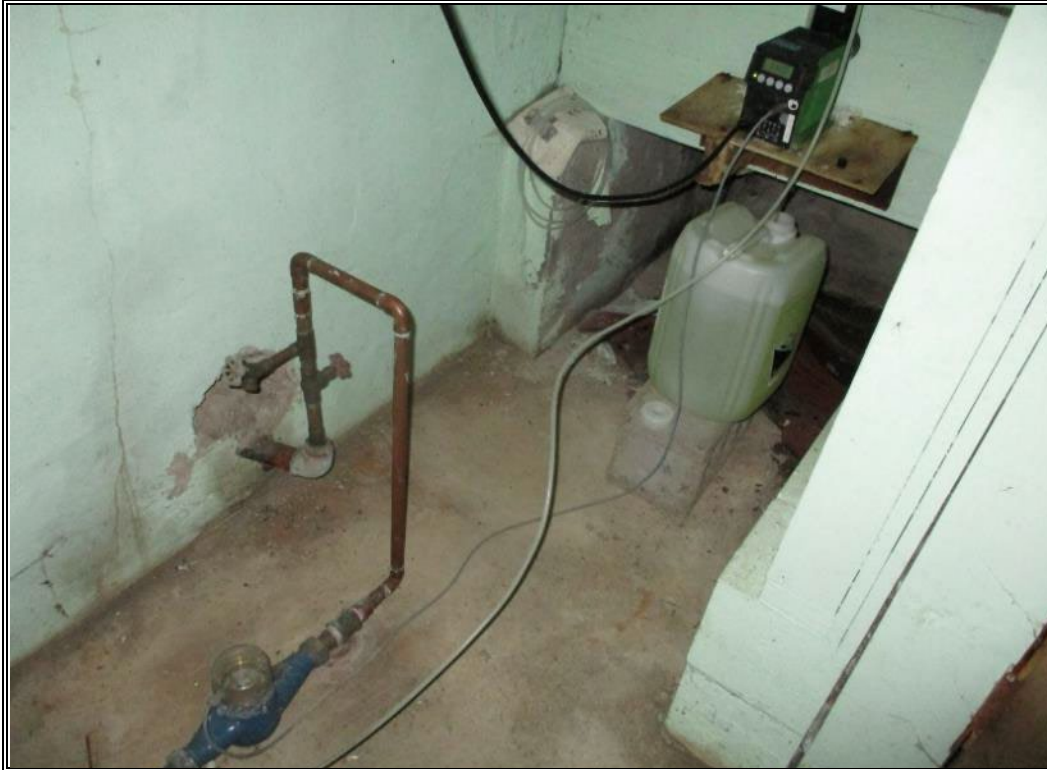
Concrete is
chipped at the
copper piping.

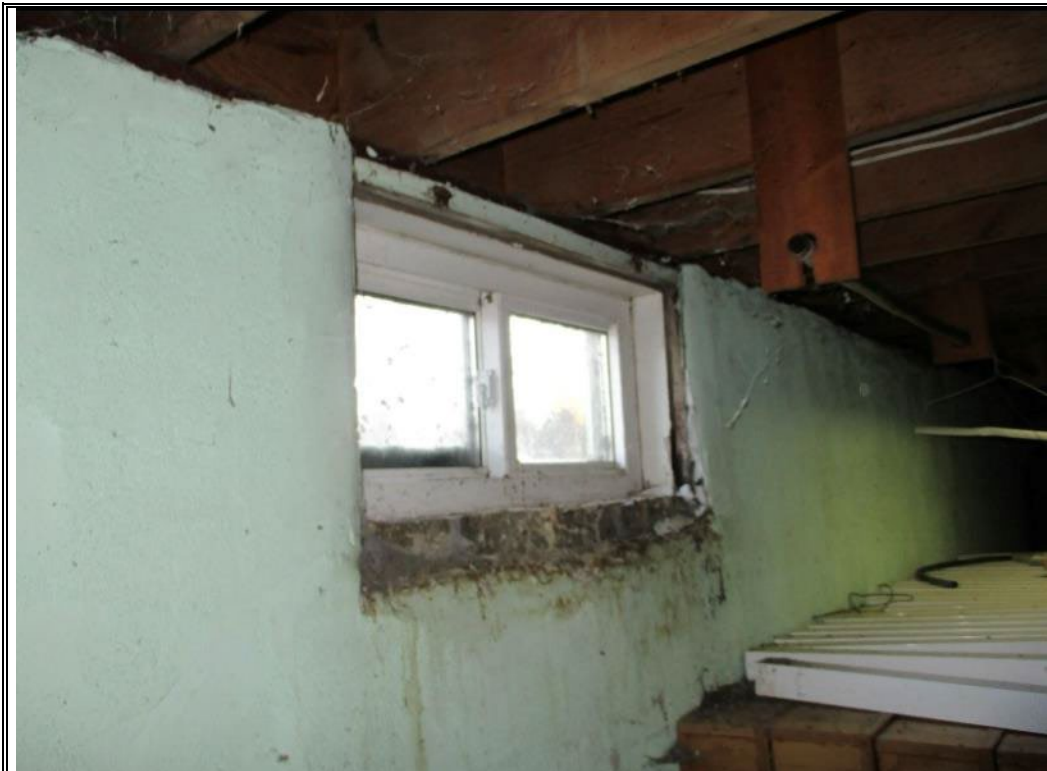
Description:
Basement. The
window frames
are PVC.

Windows and
window frames
are in poor
condition.
