# BUILDING CONDITION ASSESSMENT

SAND/SALT DOME

191274 13<sup>TH</sup> LINE  
EAST GARAFRAXA, ONTARIO

December 15, 2023

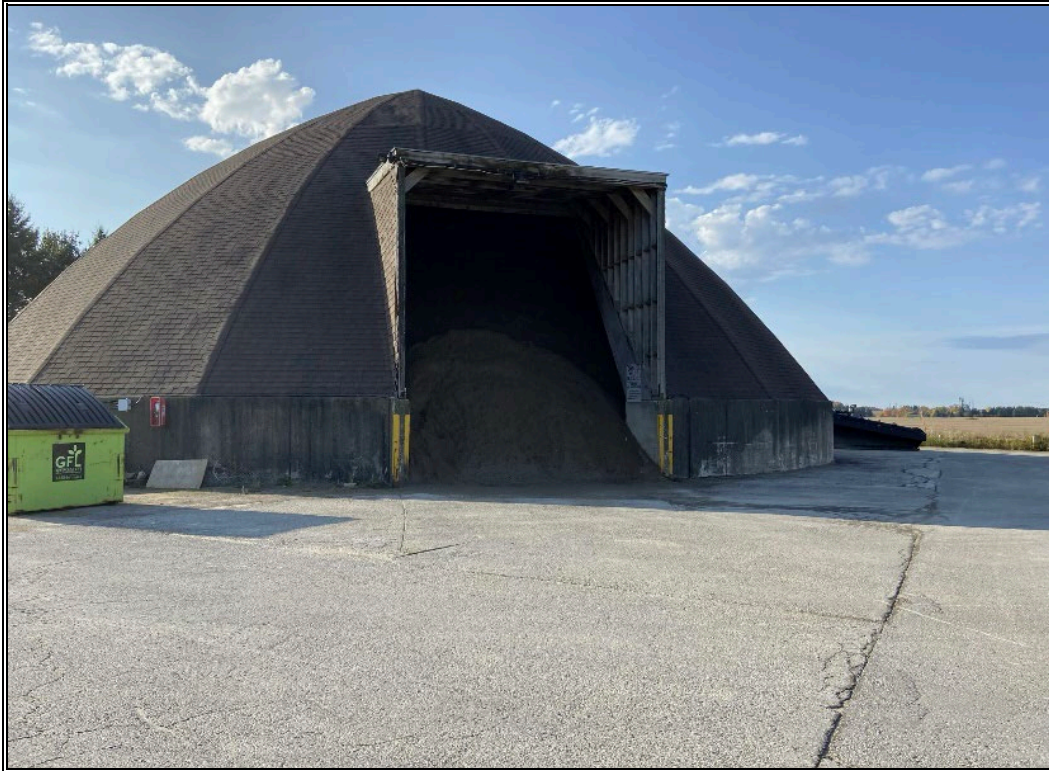
View of the sand dome entrance.

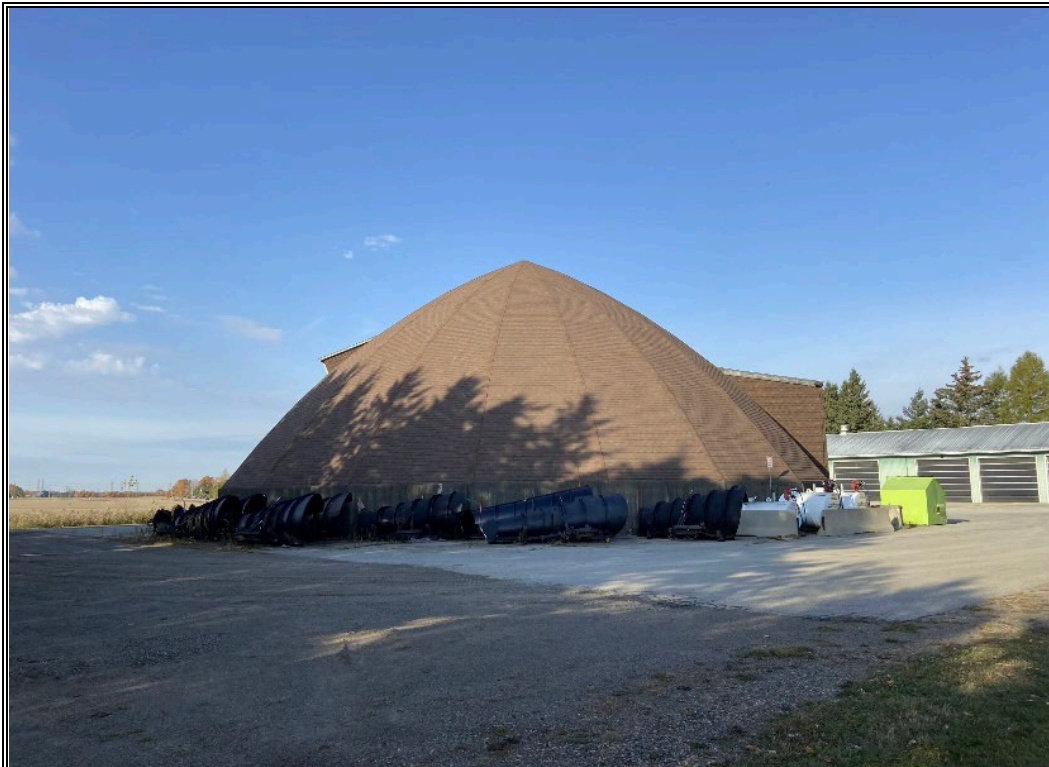
**1**

General view of the sand dome.

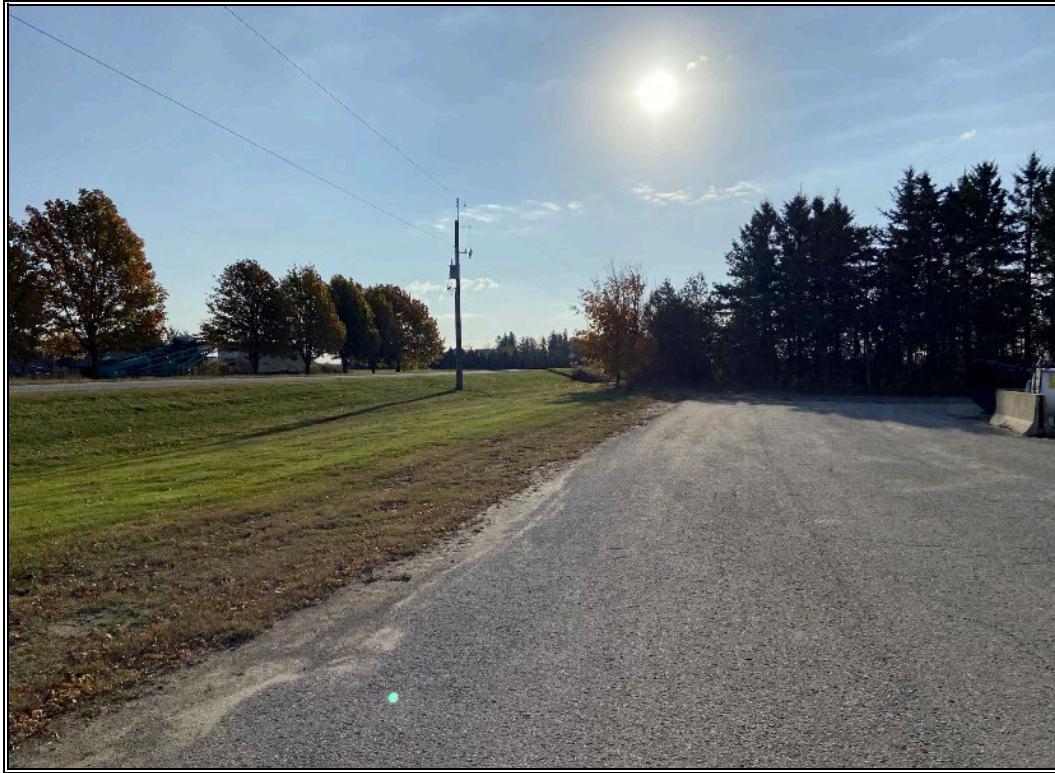
**Description:**  
General view of  
the property.

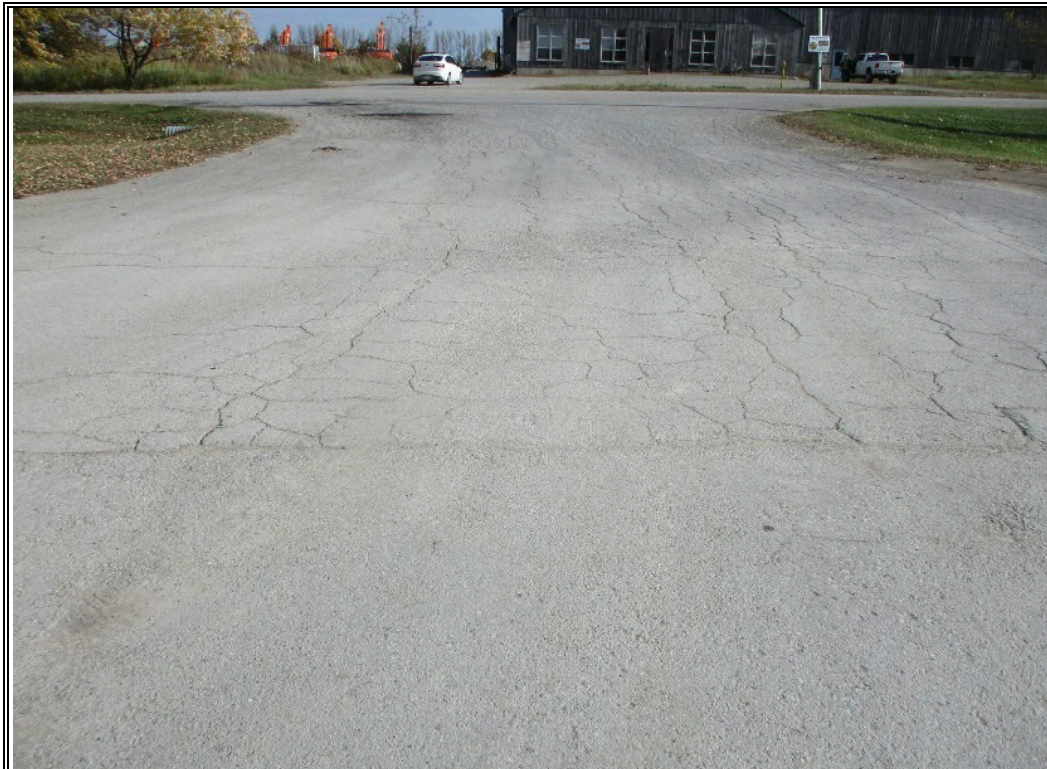
Photo Number  
**3**

The asphalt driveway at the entrance to the main lot, and the main lot are in poor condition with deterioration in the form of longitudinal/transverse cracking, and alligating. A budget for replacement has been allowed for during the time-period of this report.

**Description:**  
Asphalt pavement  
at the entrance  
that provides  
access to the  
works garage and  
salt/sand dome.

The asphalt on the  
driveway is  
cracked and  
deteriorated.  
There are stress  
cracks noted.

Ongoing maintenance is required to keep surfaces renewed, including crack sealing. Once asphalt is replaced, this work should be scheduled for regular maintenance. Typically, pavement resurfacing, or reconstruction is recommended every 20 years depending on the wearing patterns.

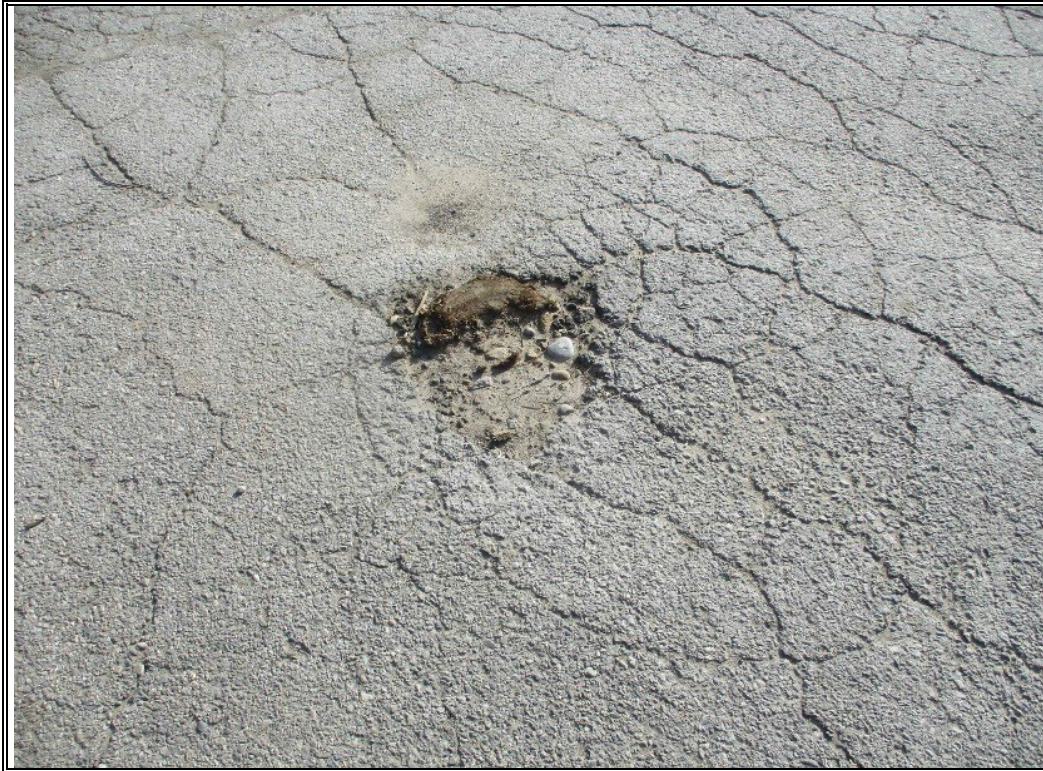
There is a tree stump in the driveway.

The asphalt is cracked and deteriorating around the tree stump.

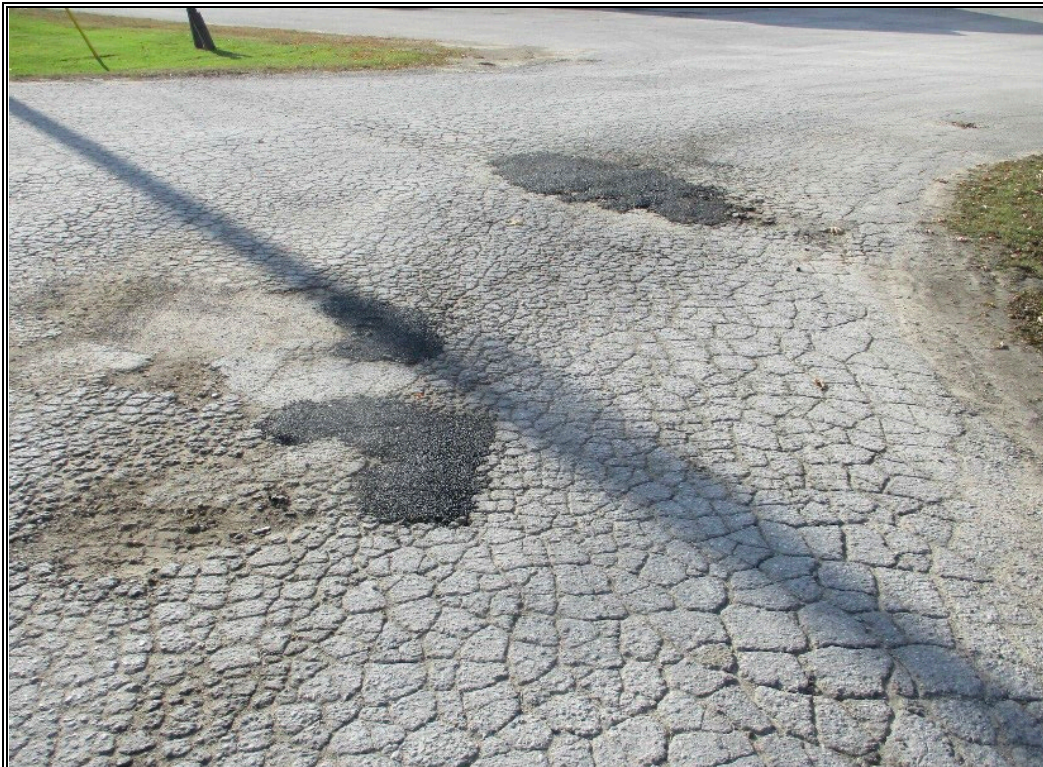
**5**

Small, localized repairs to the asphalt have been completed previously.

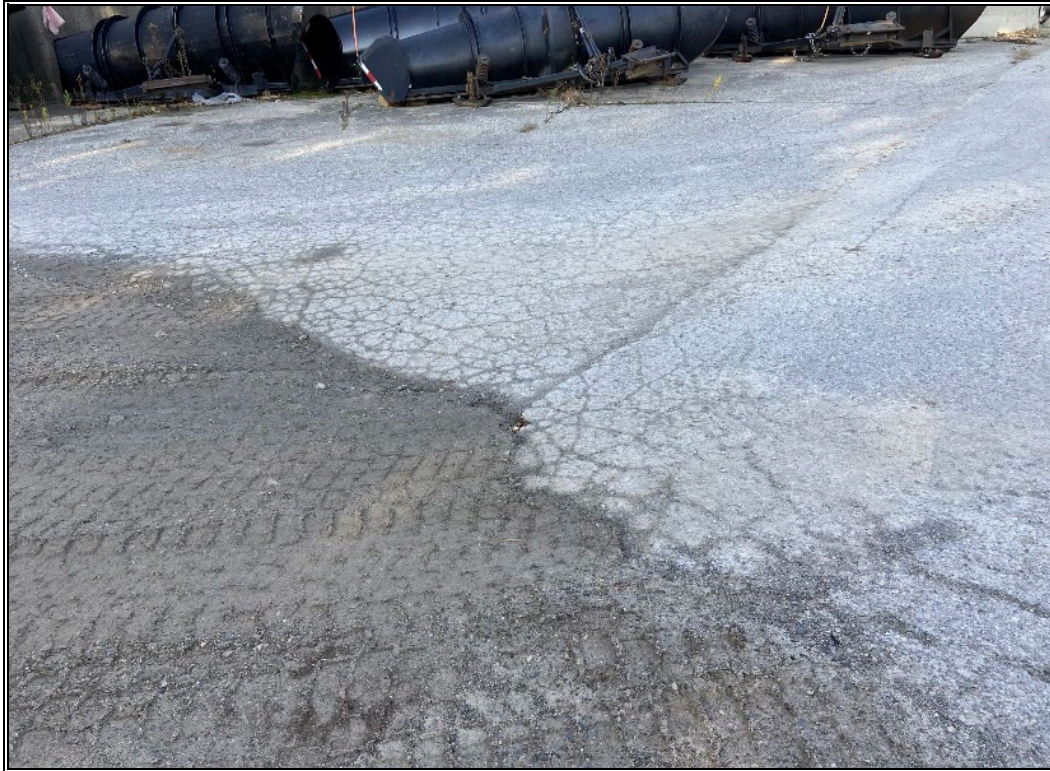
**Description:**  
The asphalt pavement is cracked and deteriorated.

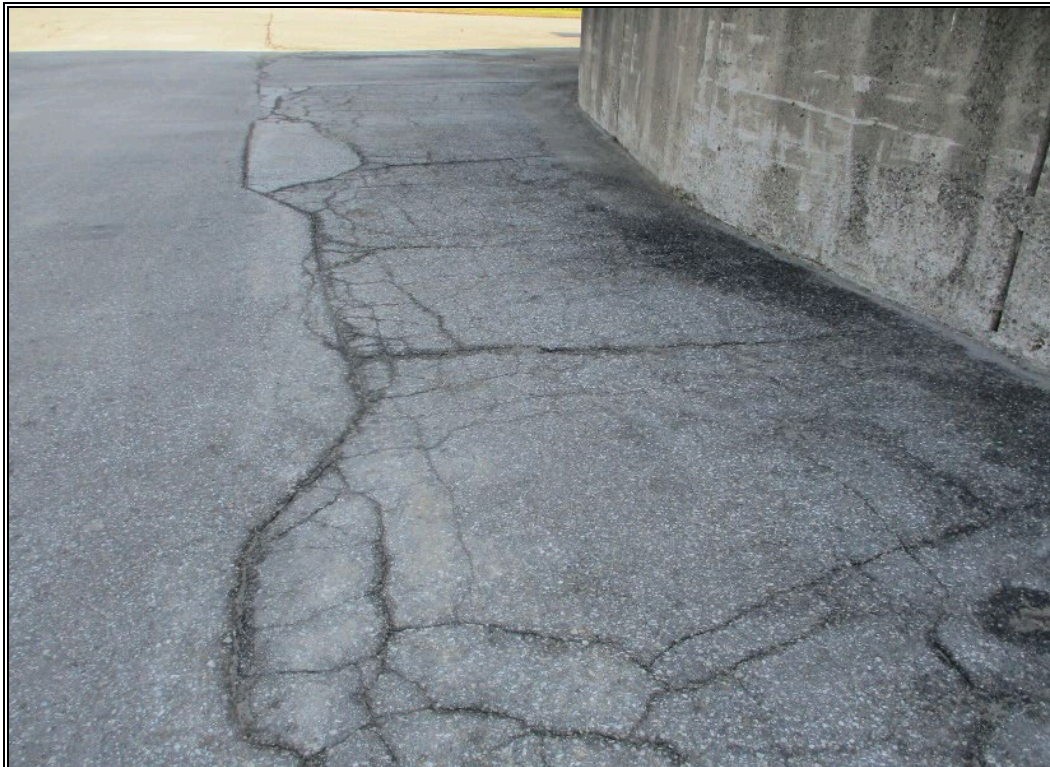
Photo Number  
**7**

**Description:**  
The asphalt is cracked and worn around the dome.

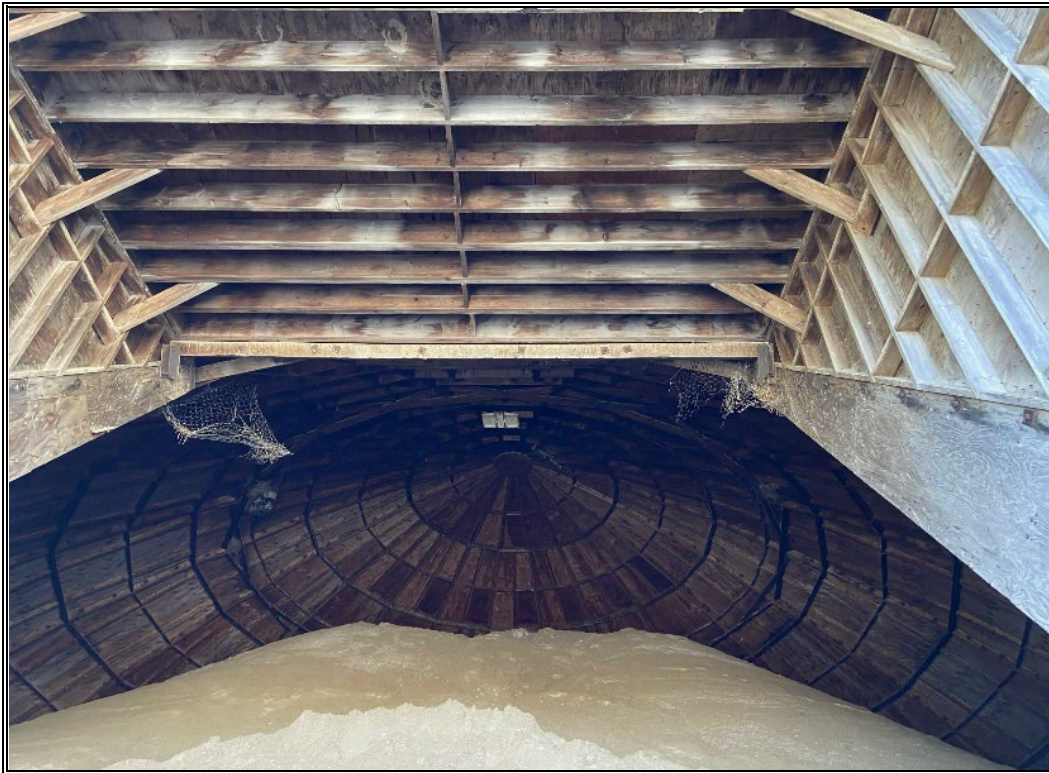
There is an interior light that is manually operated.

The dome is a wood framed structure with wood strapping.

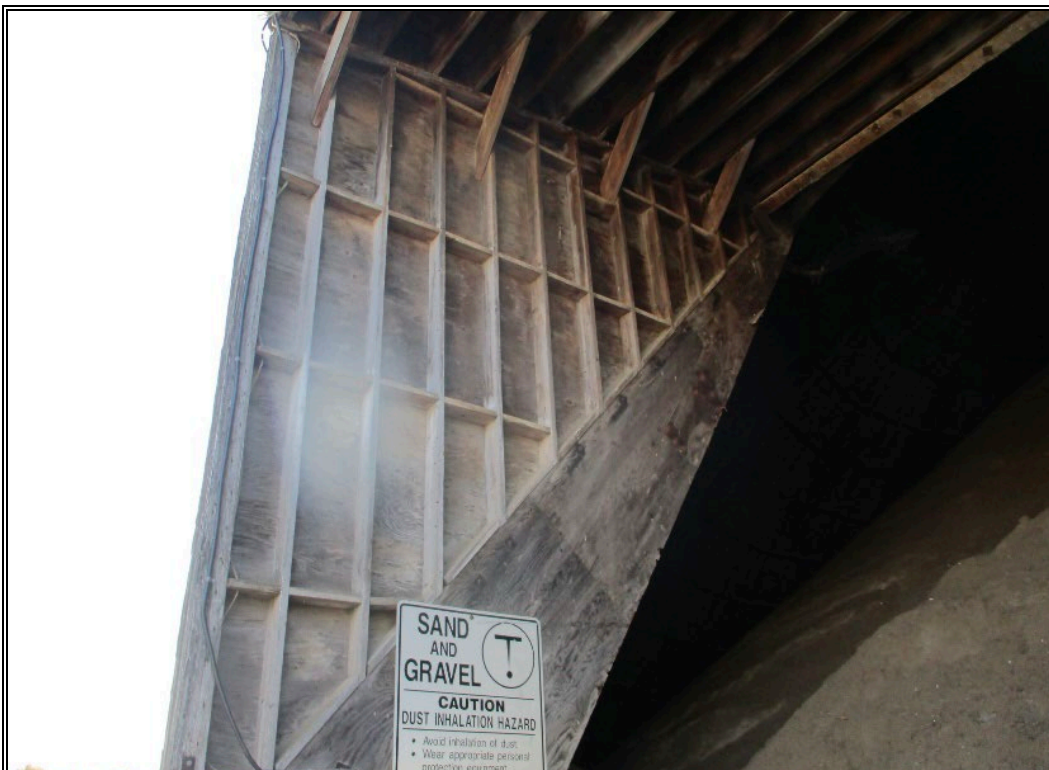
Photo Number  
**9**

Typical interior view of the condition of the wood structure.

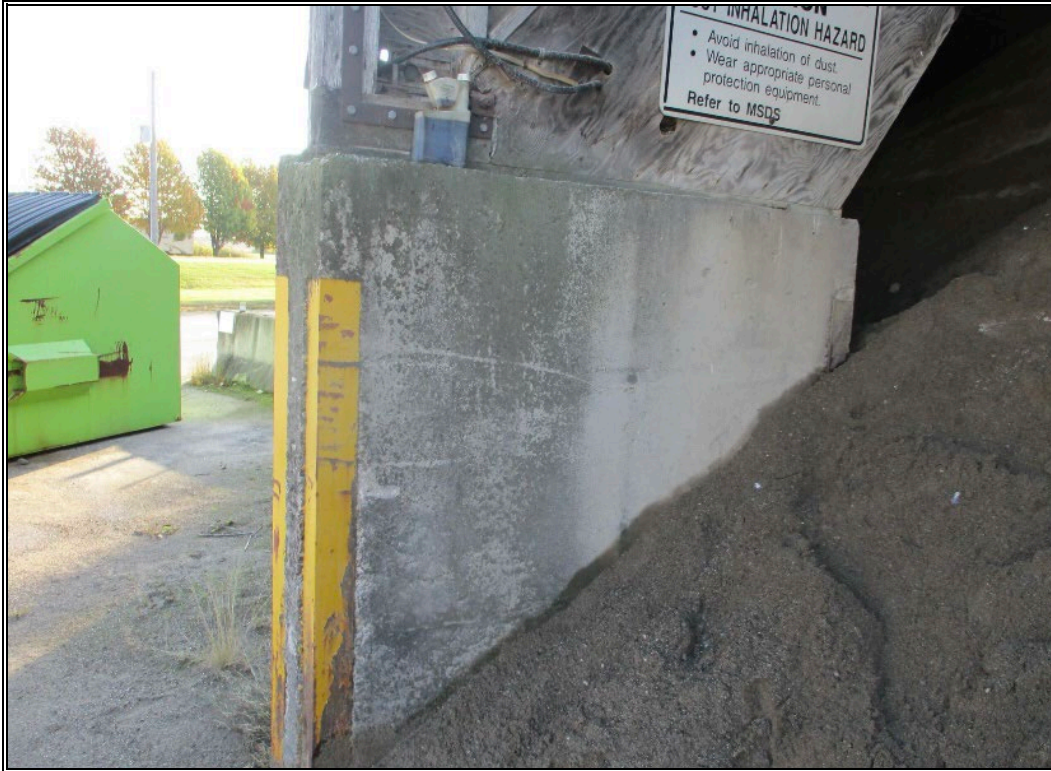
**Description:**  
The entrance walls are scratched and pitted from machinery.

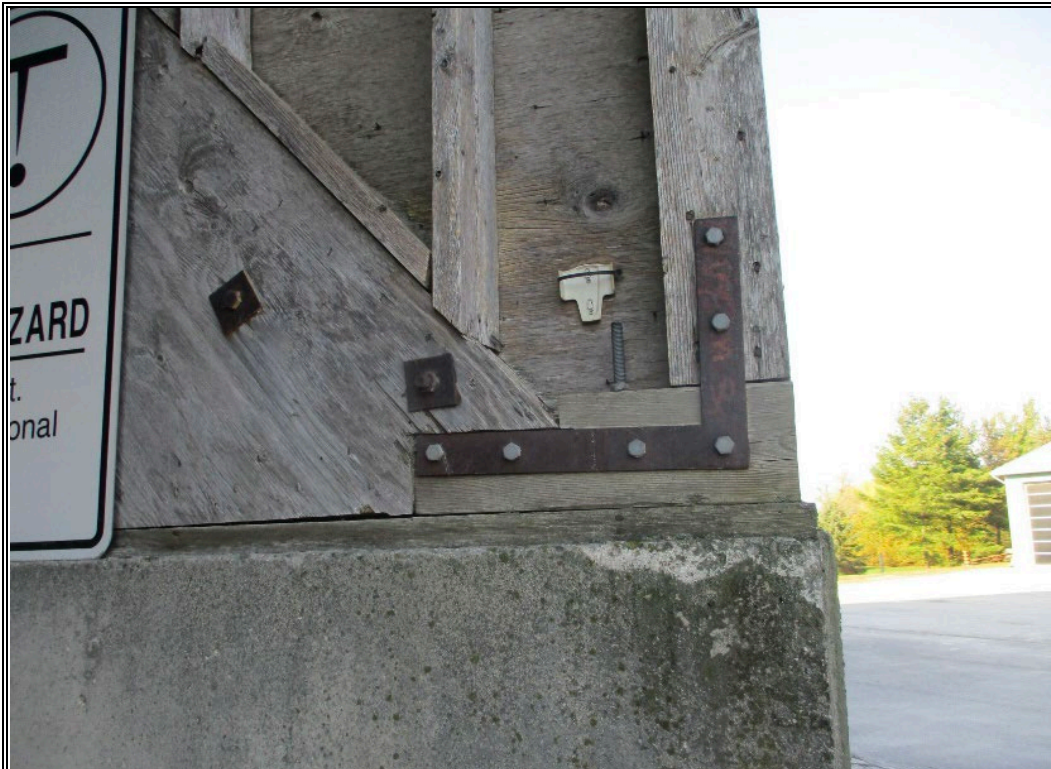
Photo Number  
**11**

**Description:**  
There are metal connections supporting the structure.

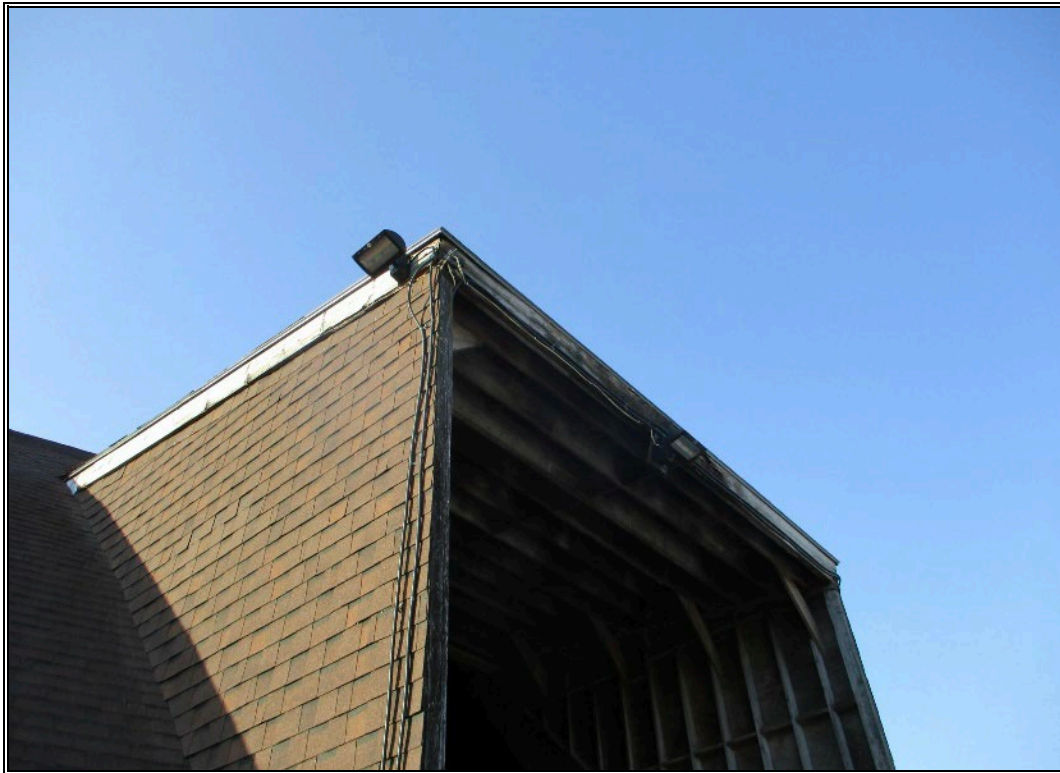
| <p>Observations &amp; Comments</p> | <p>We observed no adverse conditions concerning visible superstructure systems.</p> <p>There are localized holes and wood deterioration in the roof overhang. A budget for localized repairs has been allowed for during the time-period of this study.</p> <p>Replacement of wood superstructures is not anticipated during the timeline of this report. A budget for future localized repairs has been allowed for during the time-period of this study.</p> |

It was reported that installation of new sheet metal, replacement of fascia boards and nail sealants is planned to be completed next month.

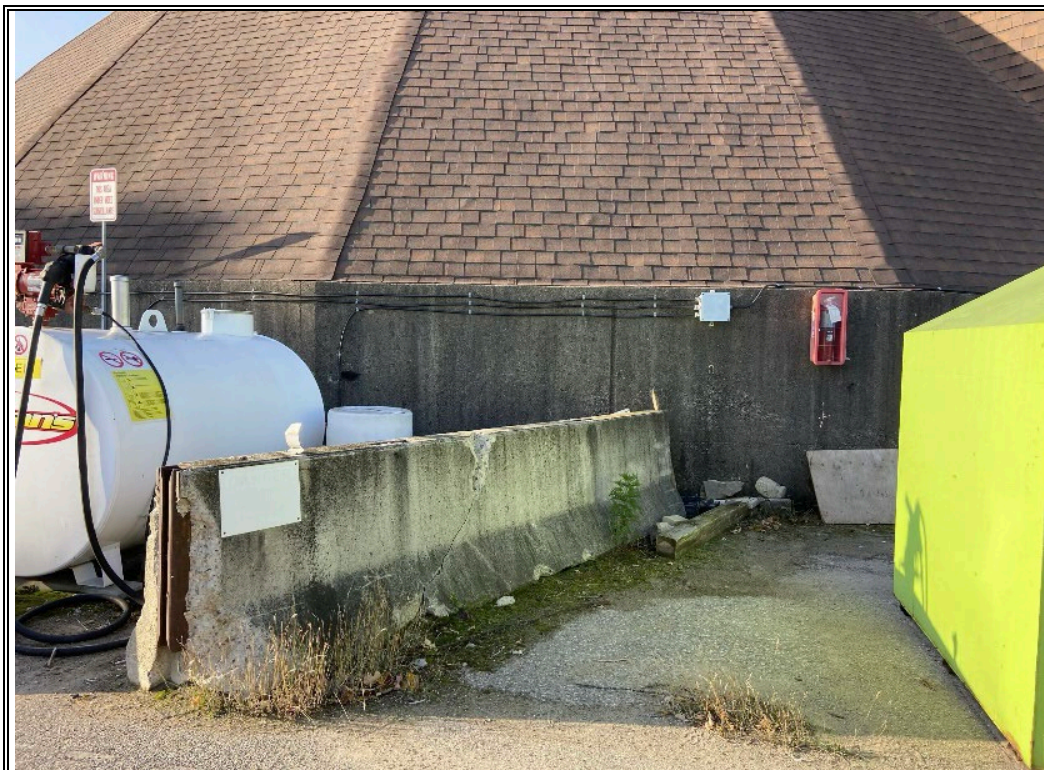
**13**

The precast concrete barricades are in poor condition with damaged, cracked, and stained concrete. A budget for replacement has been allowed for during the time-period of this report.

The concrete barricades are cracked, and pieces of concrete are missing.

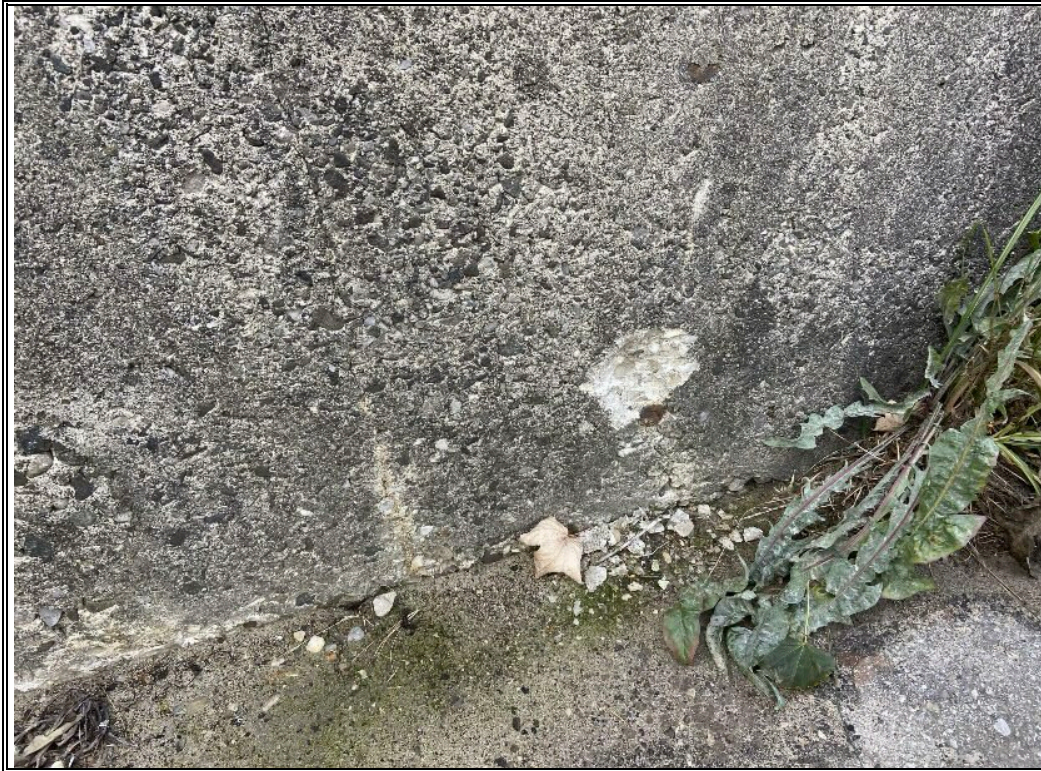
The substructure is in fair condition with localized cracks/fractures, rust stains, moss algae and other discolourations. There is some localized damage likely due to impact from machinery. Replacement is not anticipated during the timeline of this report. A budget for localized repairs has been allowed for during the time-period of this study.

There is localized concrete damage of the walls likely due to impact from operations.

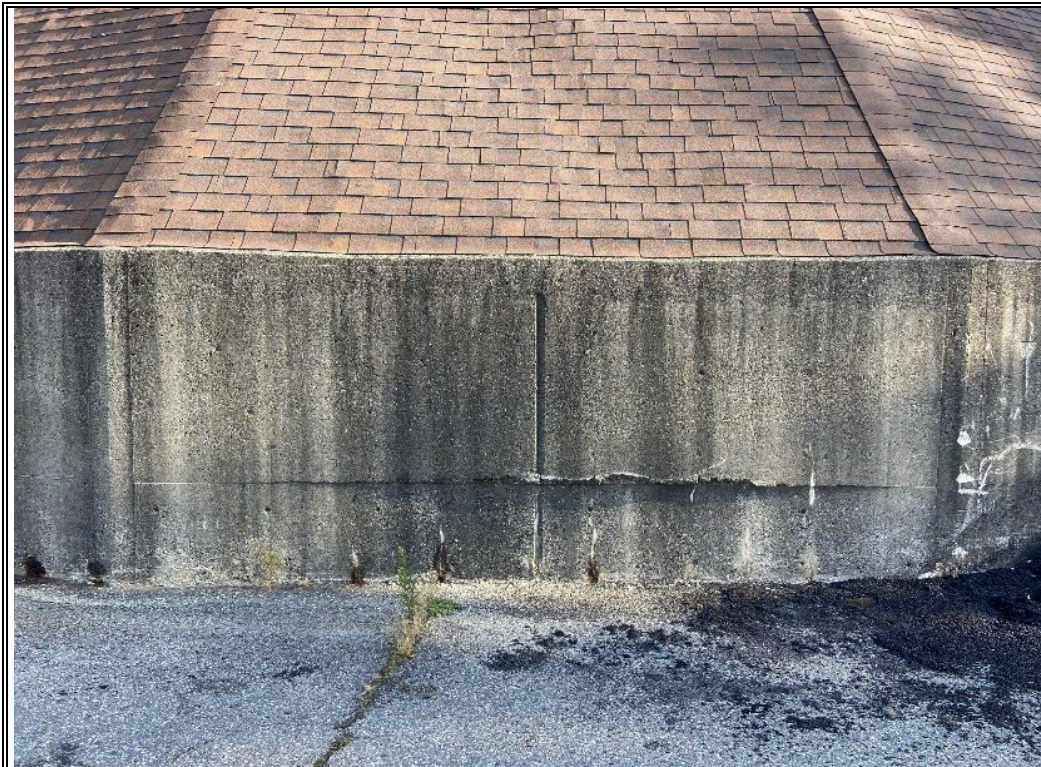
Photo Number  
**15**

There are cracks along the wall.

Walls are stained.

There is rust from corroded reinforcing steel.

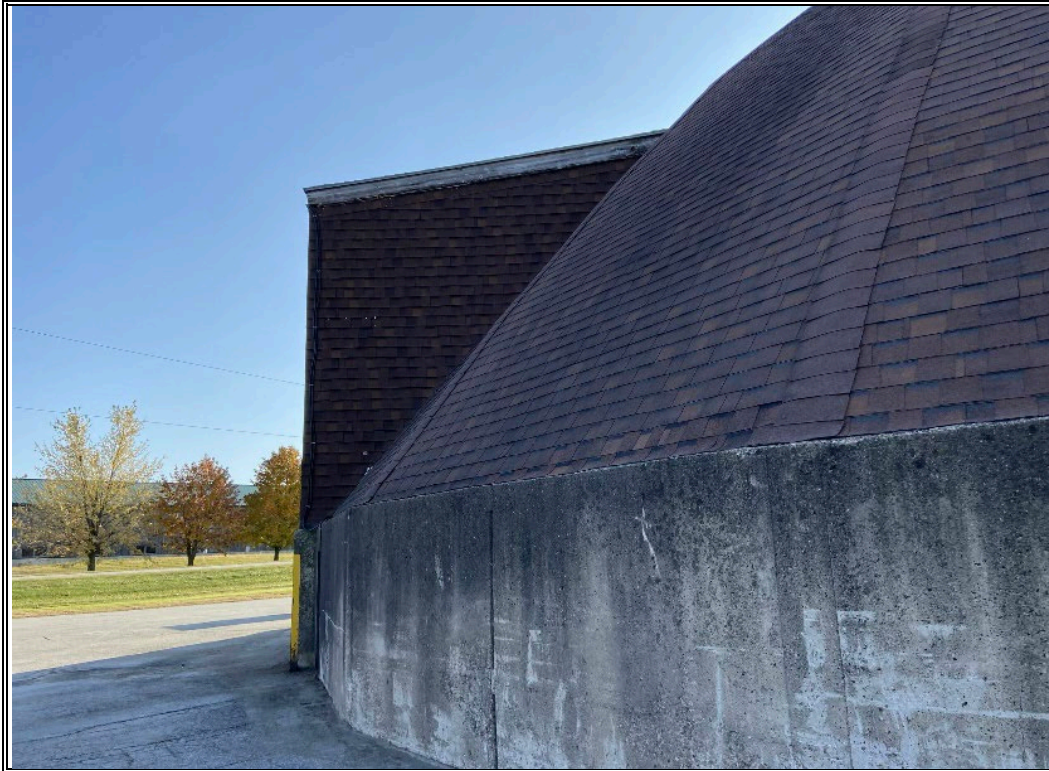
There is damage to the wall from machinery impact.

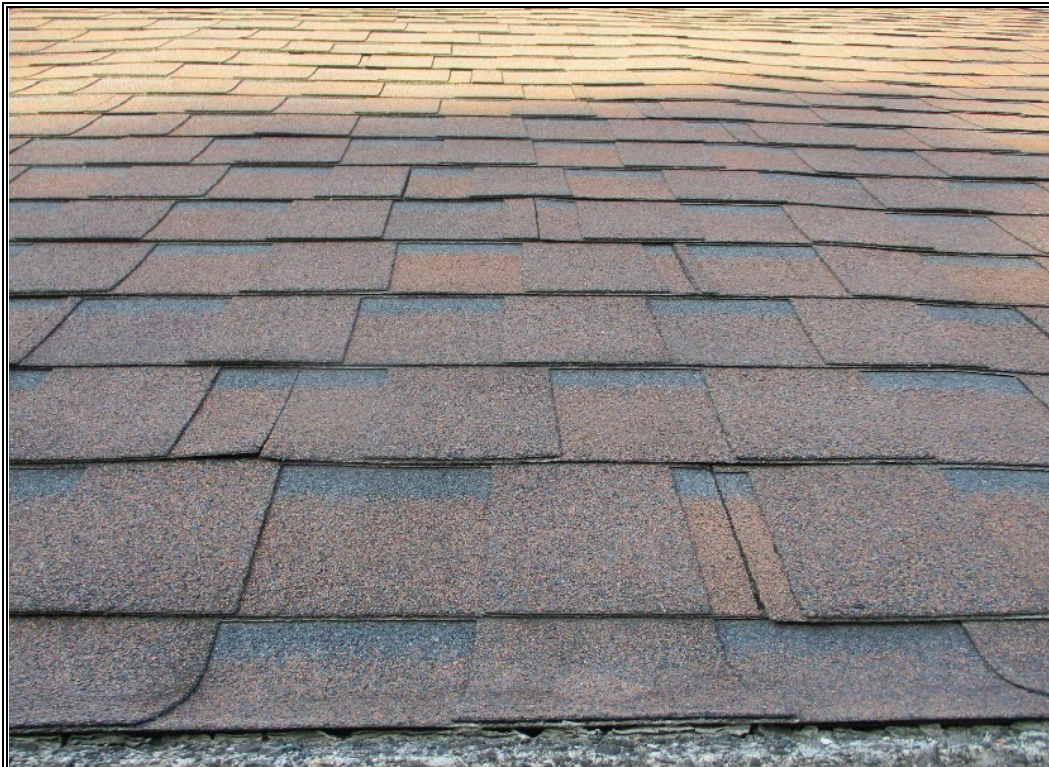
**17**

The dome has single tab laminate shingles.

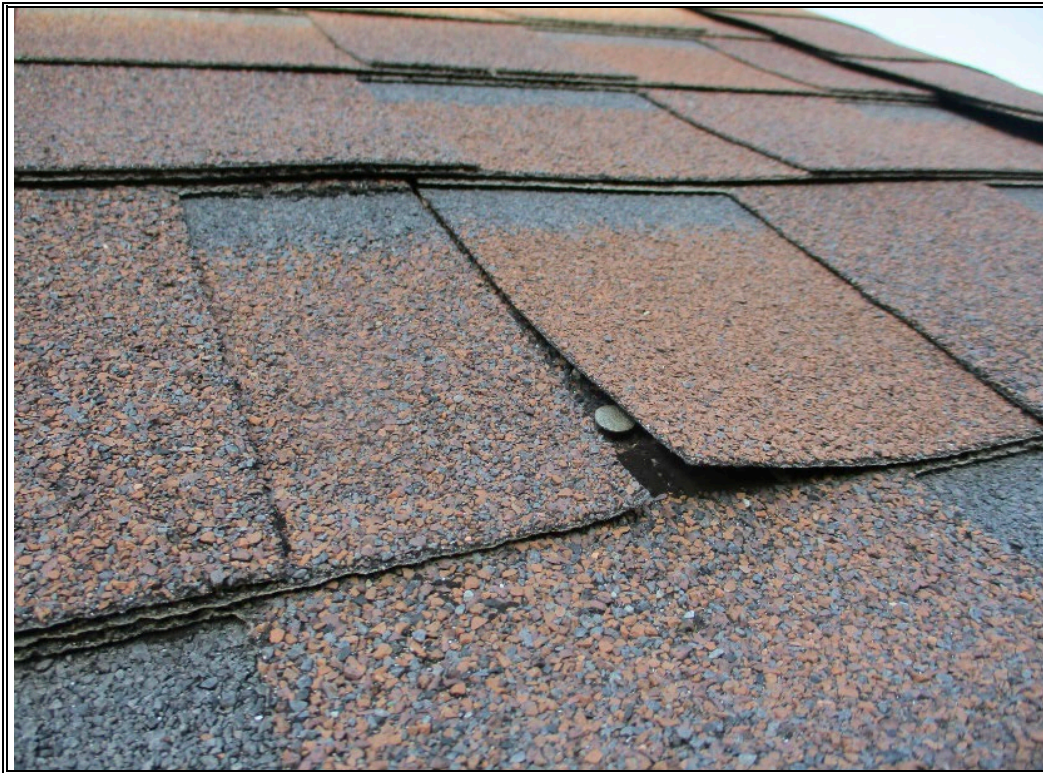
| <p>Observations &amp; Comments</p> | <p>It was reported that localized repairs including shingle replacement as needed has been completed in the past. The shingle roofing condition is consistent with their age with localized curling and granule loss. There are localized shingles that are lifting due to pulled out nails. Replacement is anticipated to occur within the timeframe of this report. The wood sheathing is aged and stained. A budget for replacement has been allowed for during the time-period of this study.</p> <p>There is exposed wood fascia and nail heads near the top of the roof overhang. It was reported that installation of new sheet metal, replacement of fascia boards and nail sealants is planned to be completed next month. Costs associated with repairs are expected to be below the Capital Threshold and are not included.</p> <p>Once the roofing is replaced, further localized repairs, on an as required basis, can be performed at a cost below the Capital Threshold.</p> |

The are localized shingles that are lifting due to pulled out nails.

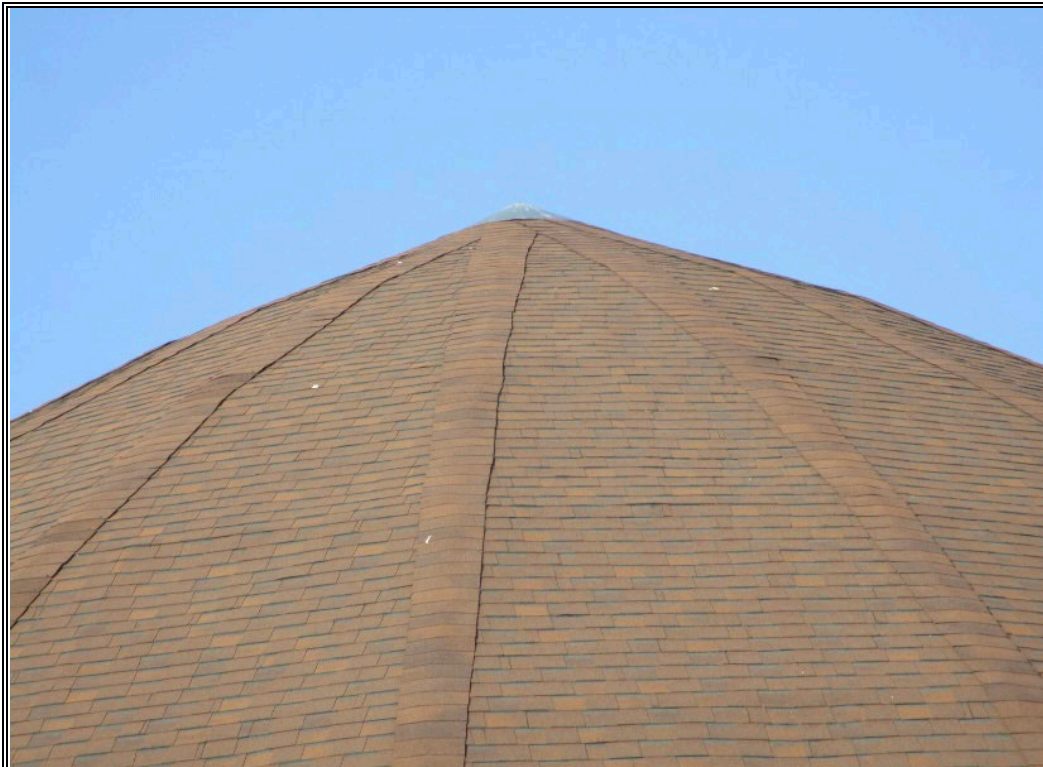
Photo Number  
**19**

The peak of the dome is metal.

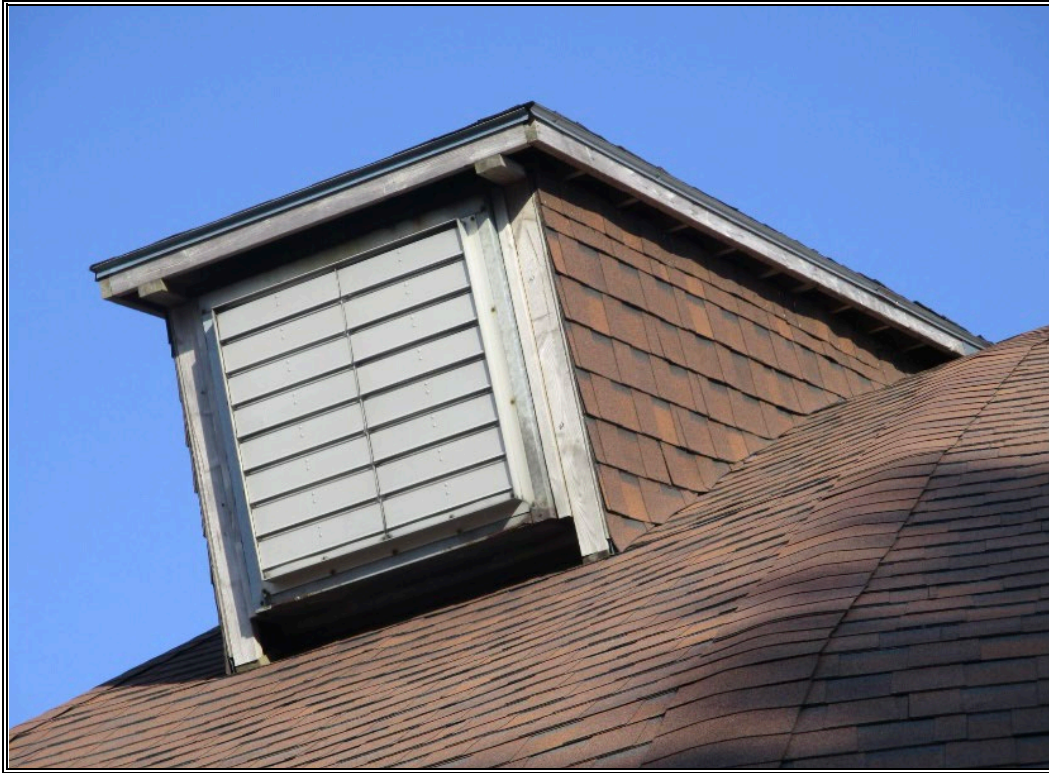
| <p>Observations &amp; Comments</p> | <p>It was reported that the fan received recent maintenance. The fan is in fair condition; however, it will reach the end of its service life within the timeframe of this study. A budget for replacement has been allowed for during the time-period of this report.</p> |

There is a fan at the top of the dome to ventilate moisture from the interior.

The fan belt was recently replaced.

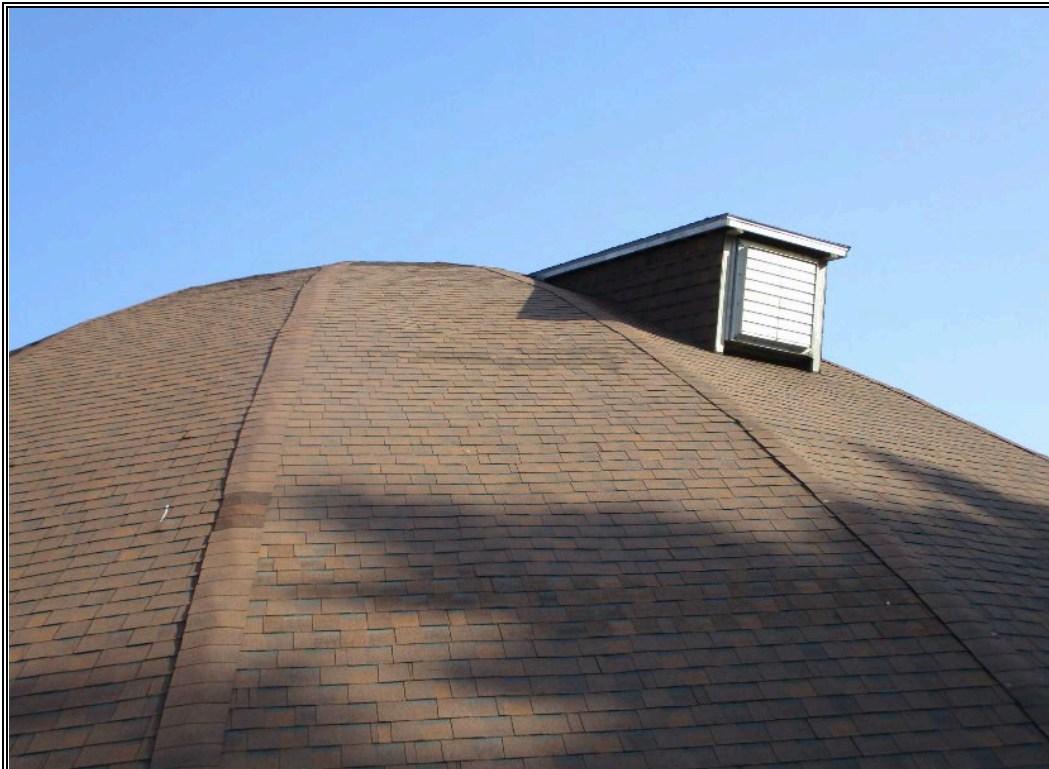
Photo Number  
**21**

Localized shingles have been replaced as needed.

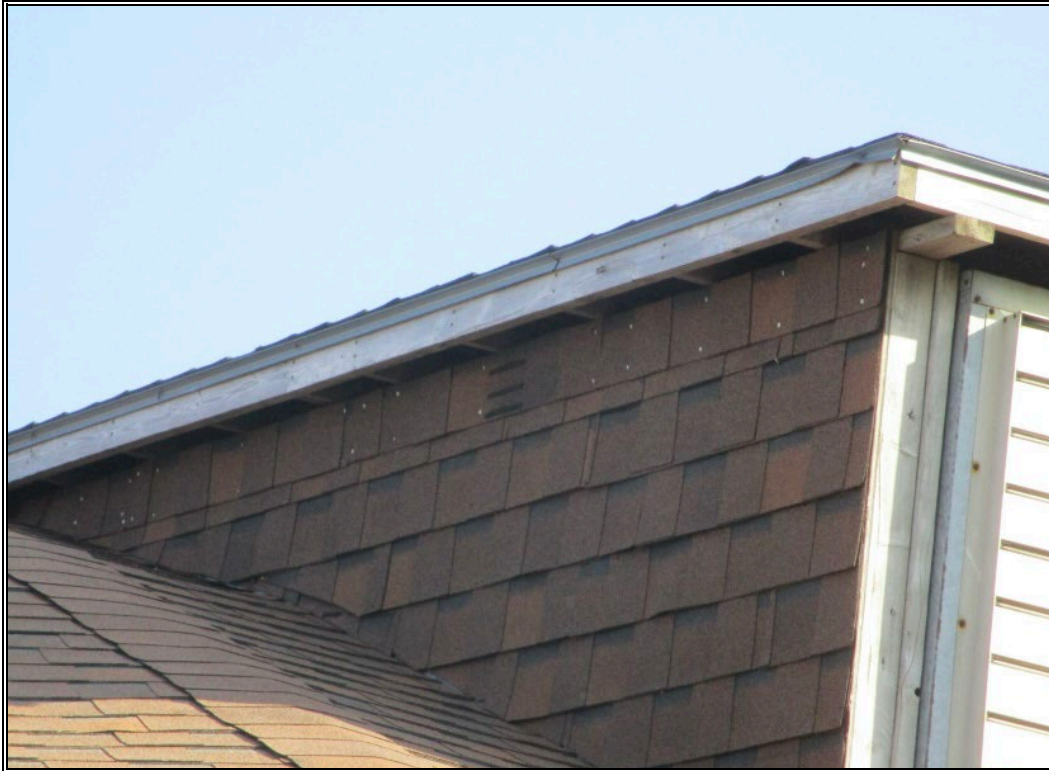
Adhesive is visible from shingles that have blown off and need to be replaced.
