BUILDING CONDITION ASSESSMENT

ORTON PARK PAVILION

6 JOHN STREET, EAST GARAFRAXA
ONTARIO

December 15, 2023

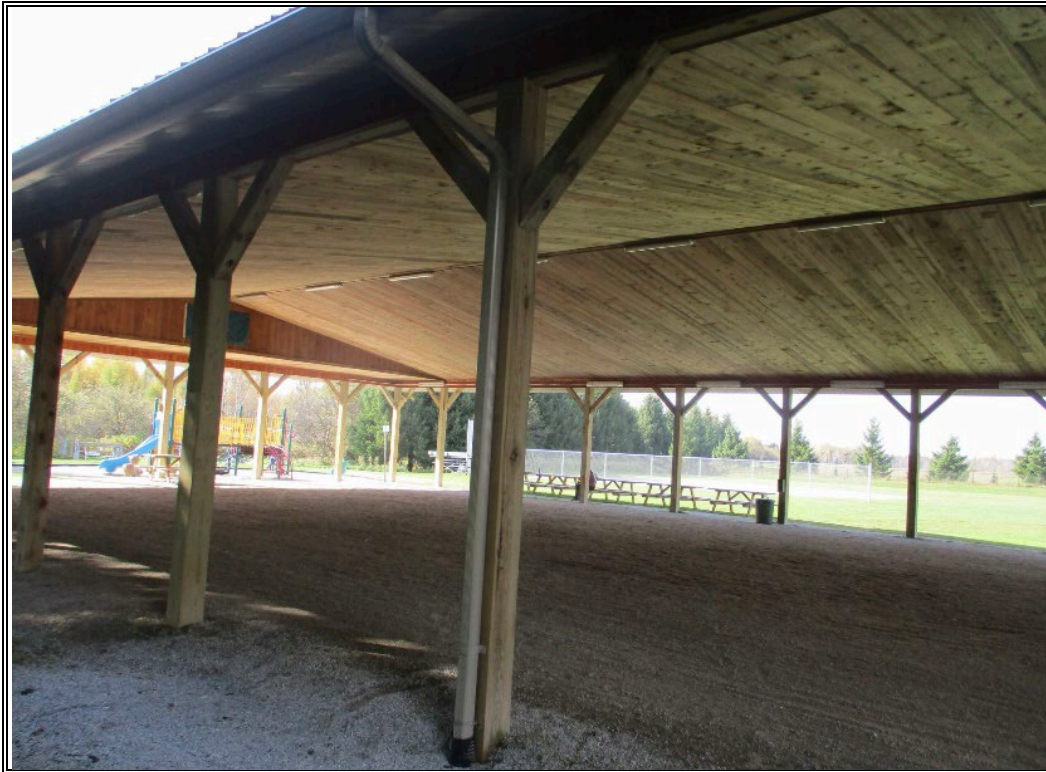
1

View of the pavilion.

The structure is wood framed and has a gravel base.

The pavilion has eavestroughs and rainwater leaders that drain below ground.

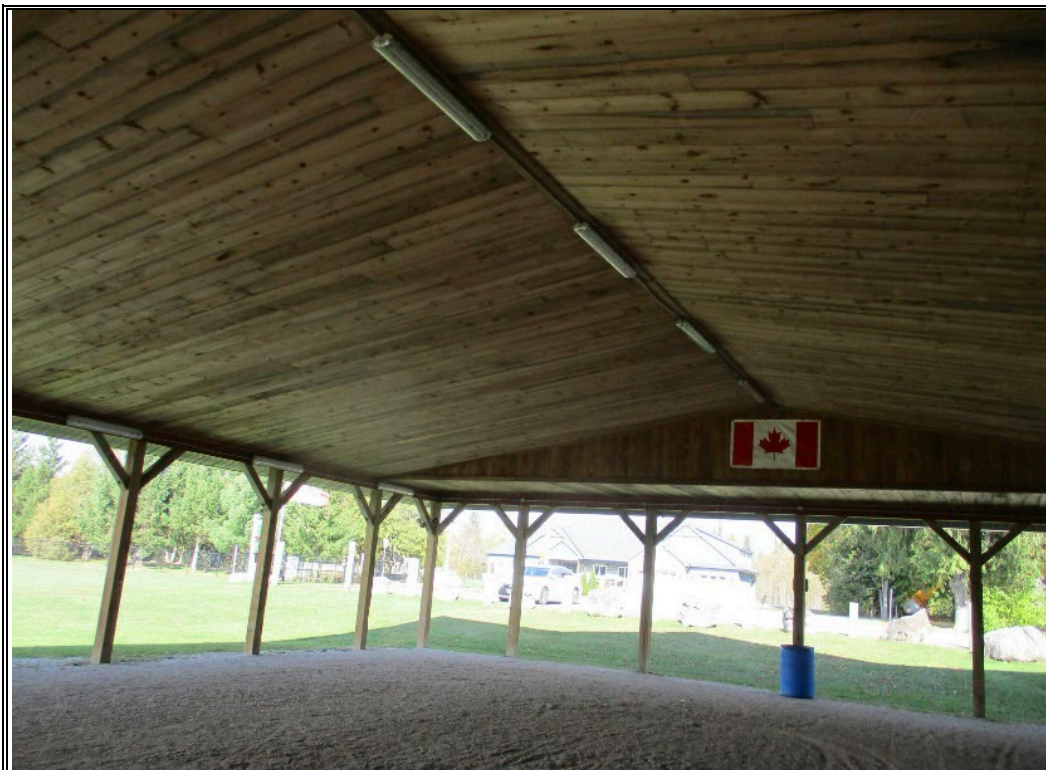
2

There is LED lighting inside of the pavilion.

The underside of the roof is exposed and is composed of wood planks.

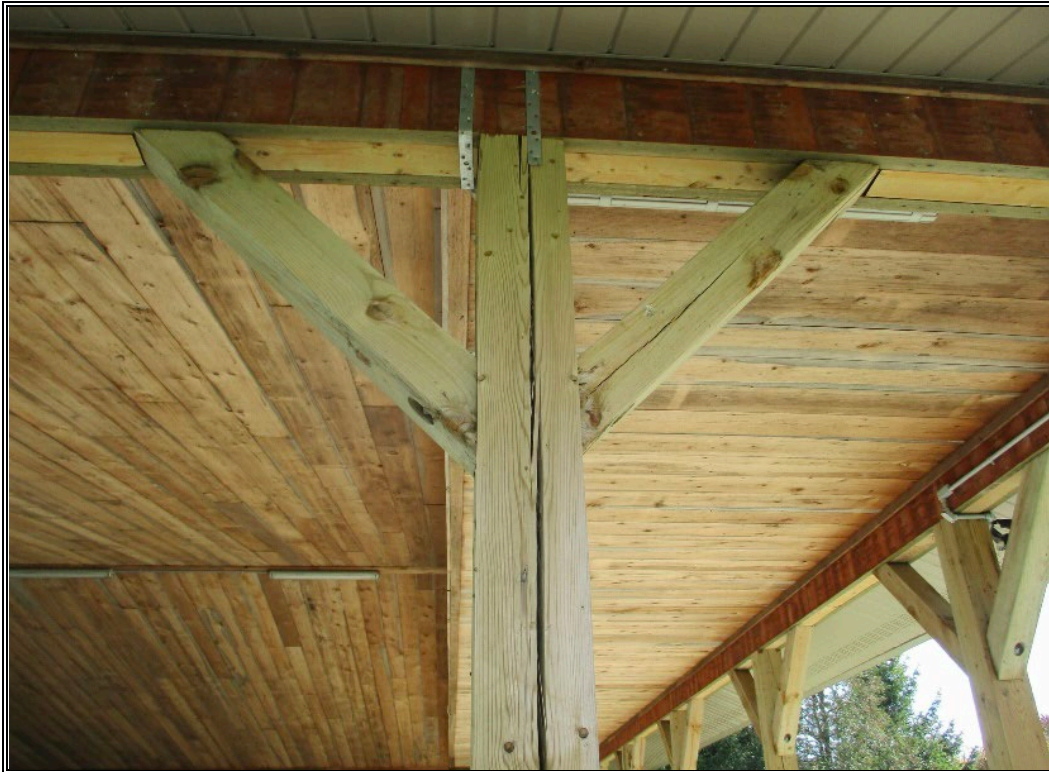
3

There were cracks in most of the wood columns and some of the wood bracing. Replacement is not anticipated during the timeline of this report, however, a budget for future repairs has been allowed for during the time-period of this study.

Many wood columns of the pavilion are split.

The wood bracing is also split.

2.2 Superstructure	Structural Framing - Columns, Beams/Trusses - Repairs	\$ 8,000					\$ 8,000	Fair	40	60	48	Medium	2015	8	30	5	25
2.3 Exterior	Not applicable						\$ -	-	-	-	-	-	-	-	-	-	-

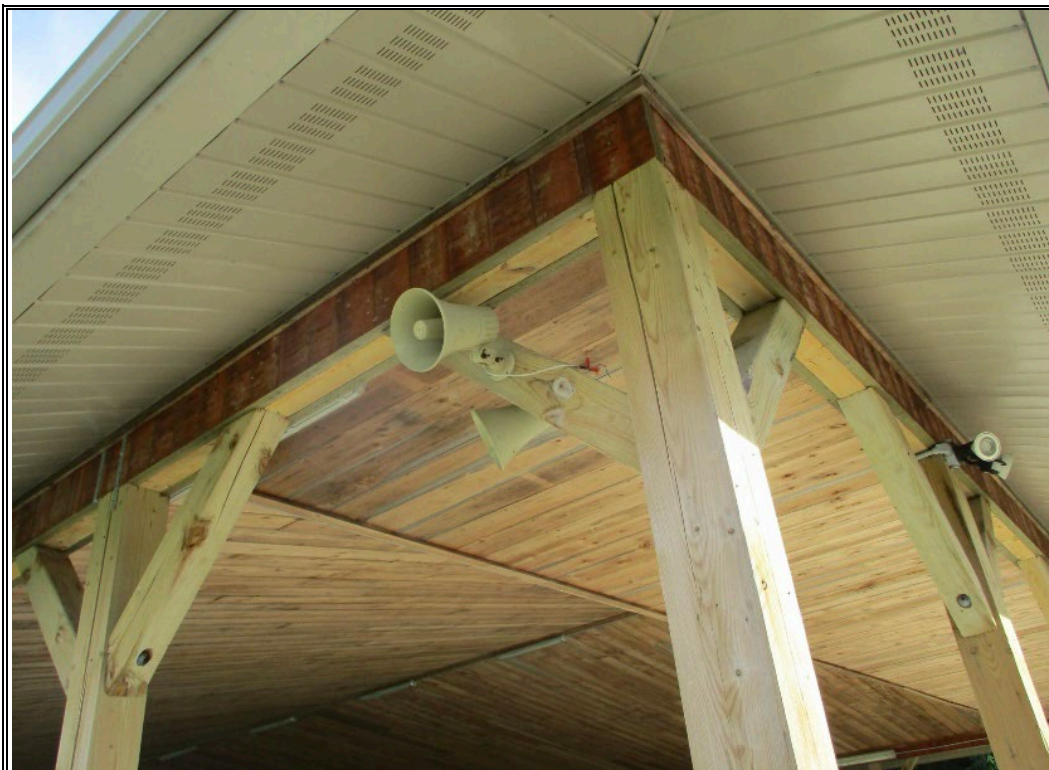
4

There is a loudspeaker system that is not in operation and is disconnected. Costs associated with repairs are expected to be below the capital threshold and are not included.

There are abandoned loudspeakers at the pavilion.

There are a variety of exterior lights.

The roof has perforated metal soffit vents.

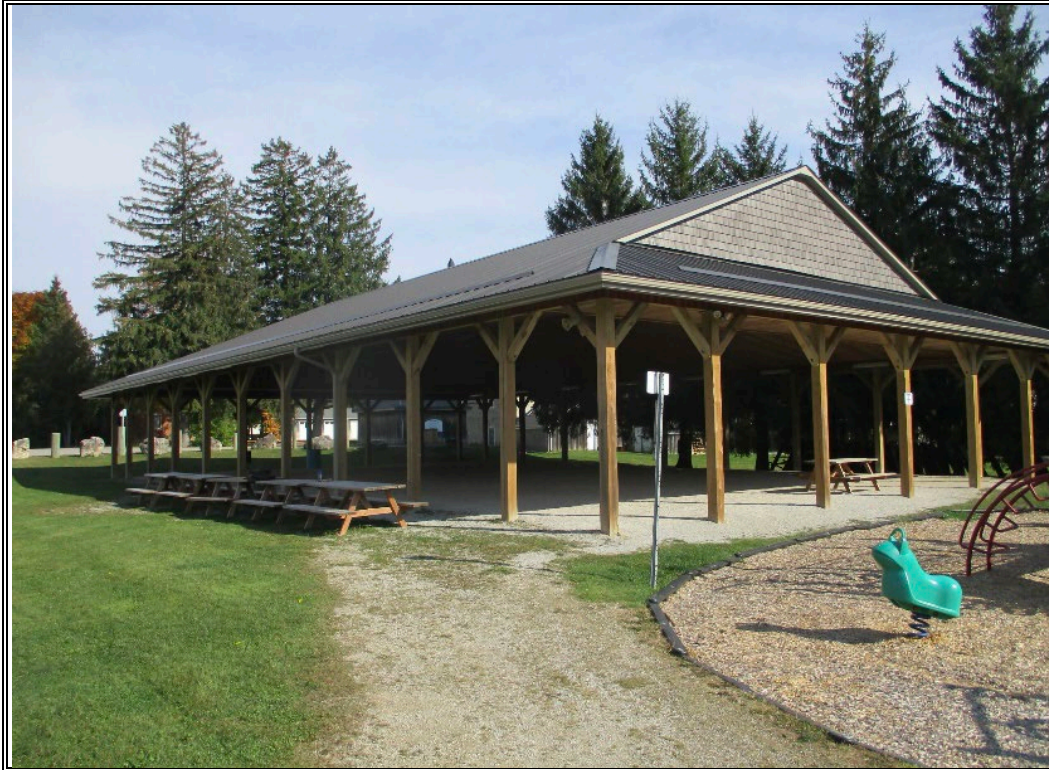
Photo Number
5

Description:
General view of
the pavilion.

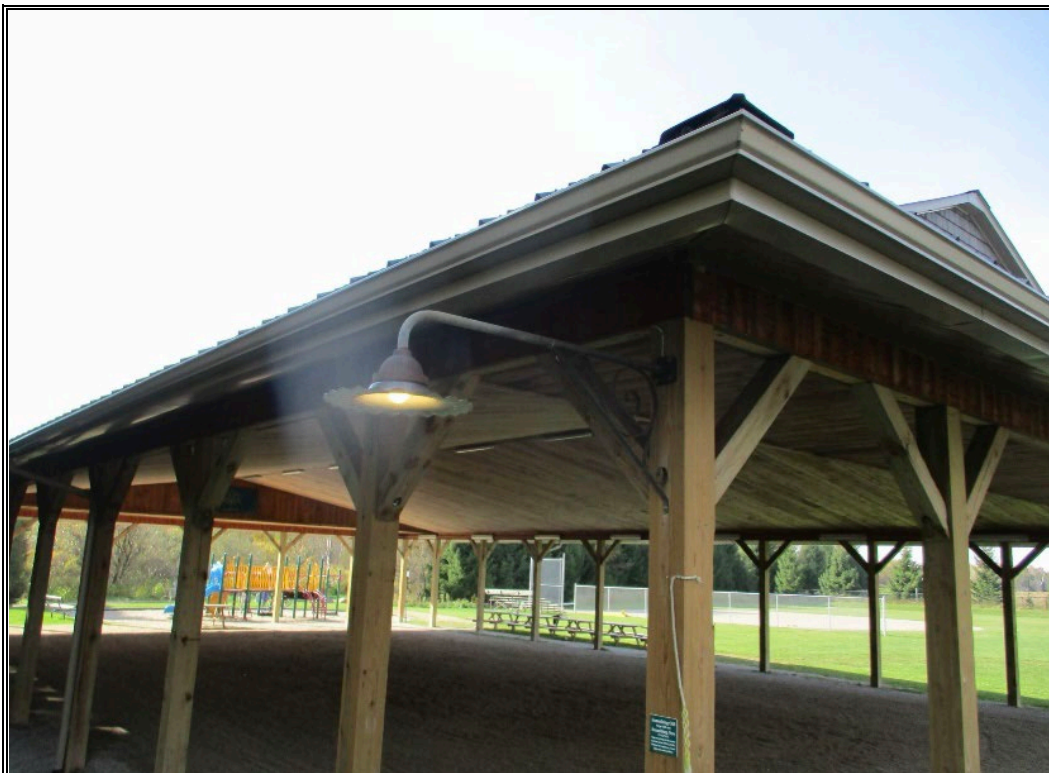
Photo Number
6

Description:
Exterior lights of
the pavilion are
LED.

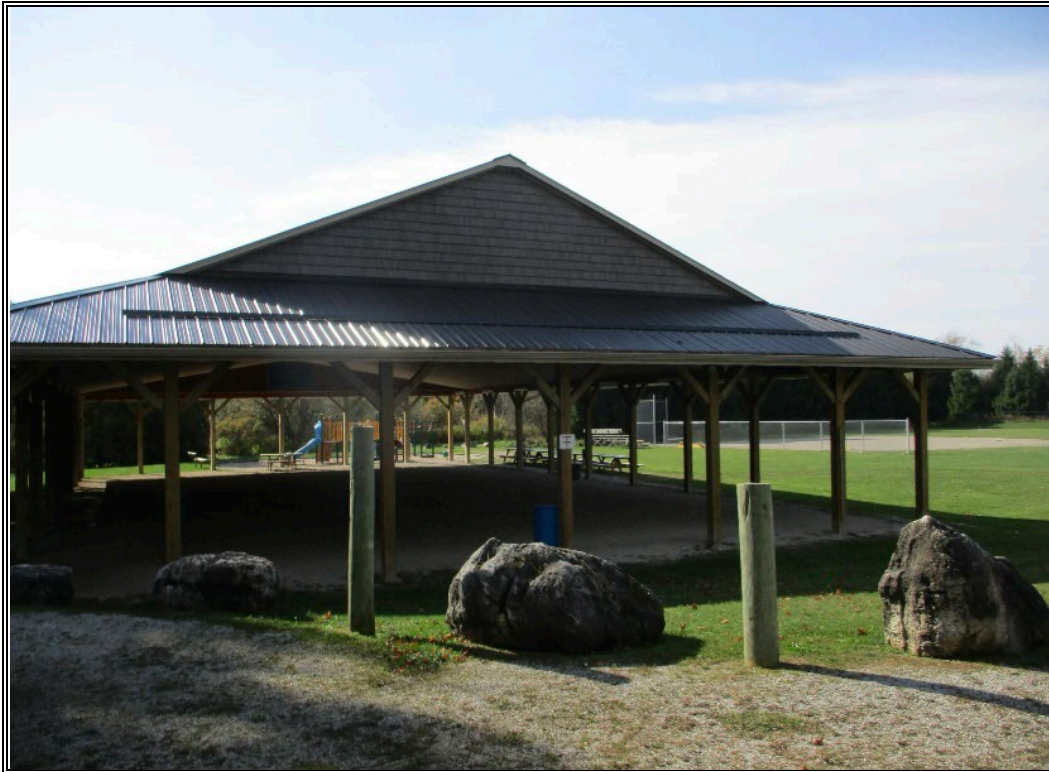
7

Description:
Snow/ice guards
are provided on
the roof.

The end roof
siding is wood.

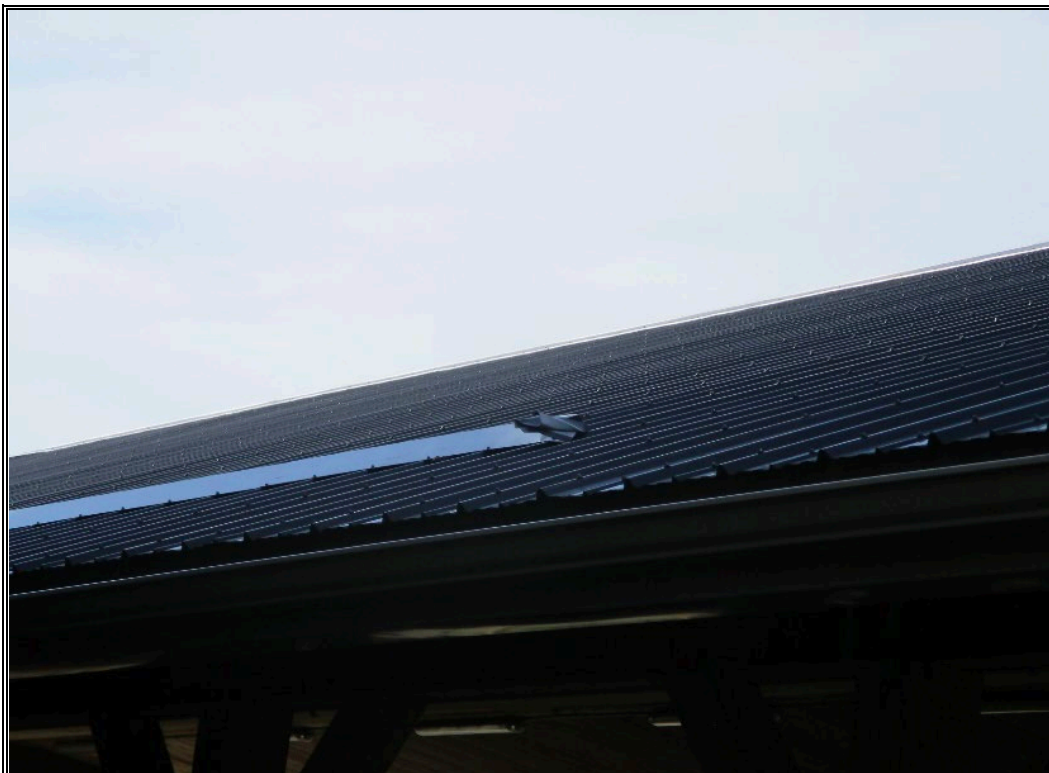
8

The ice/snow guards are in fair condition, with localized damage. Repairs are recommended; however, a budget has not been included as they are below the capital threshold. It is anticipated that these are part of the O/M budget.

Description:
The pavilion has
metal corrugated
roofing.

There is localized
damage to some
snow guards.

Repairs are
considered
maintenance
items.
