BUILDING CONDITION ASSESSMENT

ORTON PARK SHED

6 JOHN STREET, EAST GARAFRAXA
ONTARIO

December 15, 2023

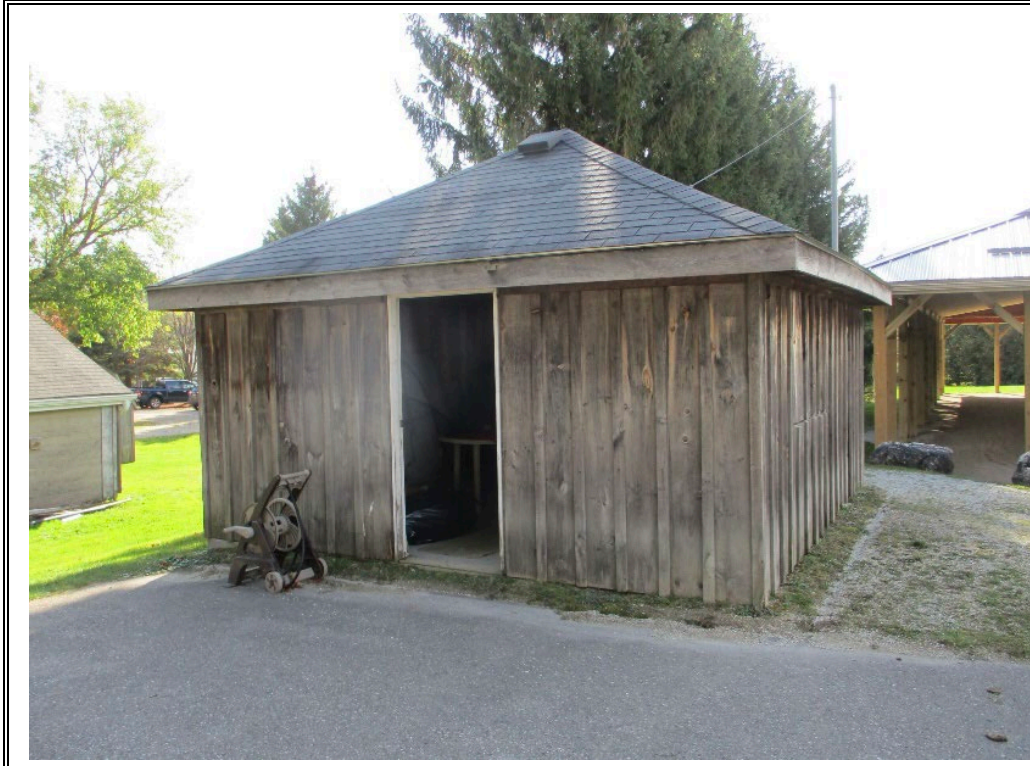
1

Front elevations of the storage shed.

The electrical service is from a mast overhead.

The service then feeds the pavilion adjacent underground.

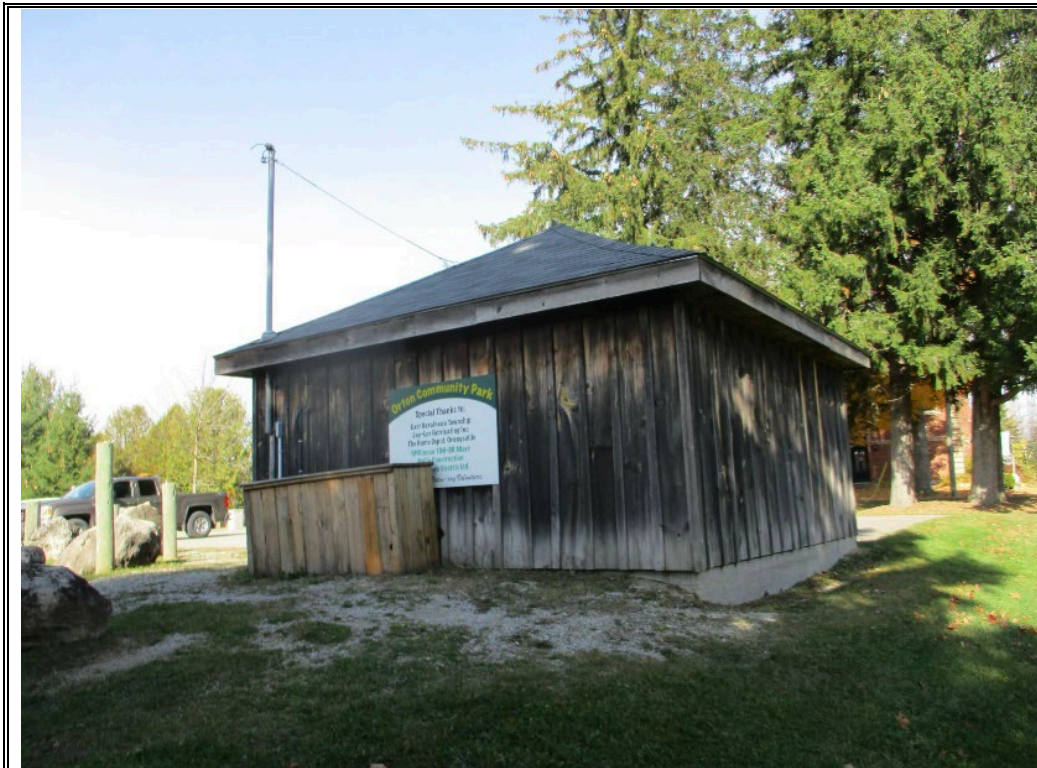
2

The exterior cladding system is original and is in fair condition. The siding appears to be stained/coloured and some batten strips are loose. Repairs are expected to be below the capital threshold. Replacement is anticipated to occur within the timeframe of this study. A budget for replacement has been allowed for during the time-period of this report.

Back elevations of the storage shed.

The wood siding is aged and discoloured.

Cladding is wood siding and is in fair condition with surface discolourations and some loose batten strips.

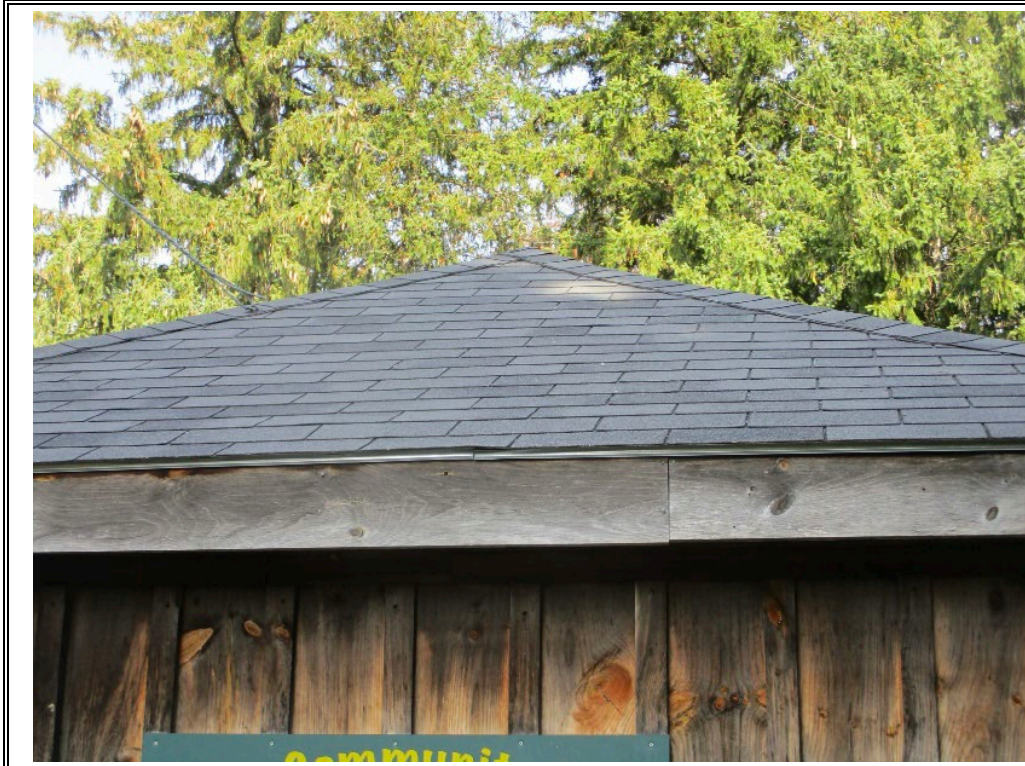
3

Sloped asphalt shingle roof.

The shingles are in good condition.

Fascia sheet metal is not provided.

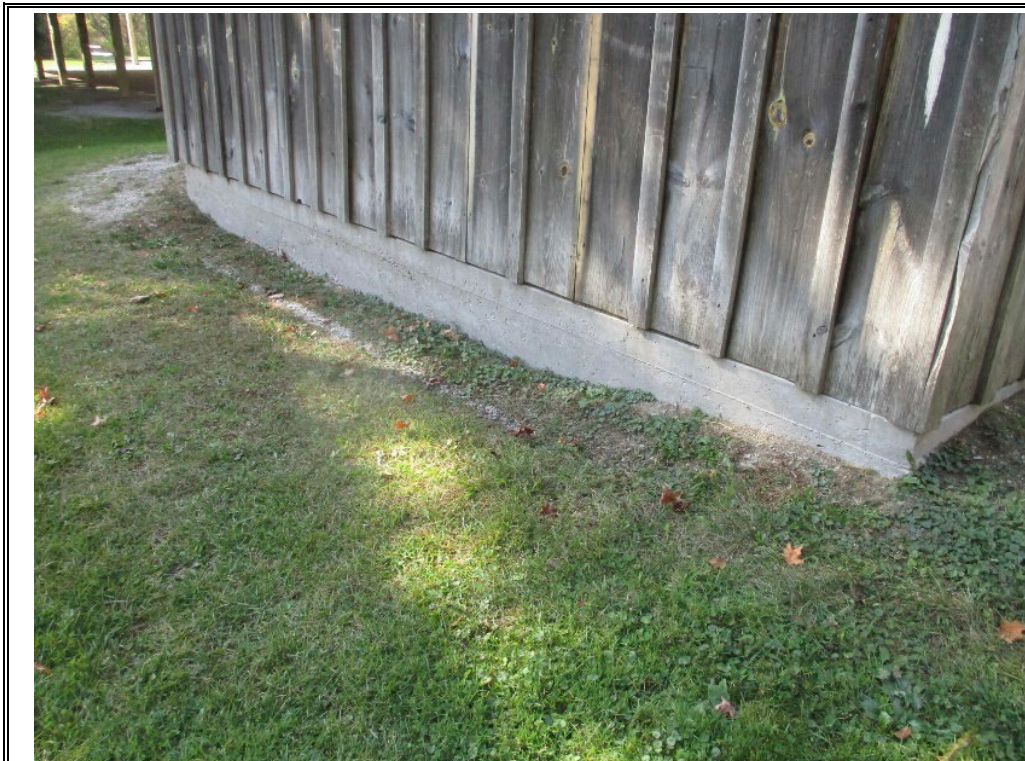
4

The slab-on-grade is in good condition. Replacement is not anticipated during the timeline of this report.

The foundation is a cast in place concrete slab.

Foundation appears to be in good condition.

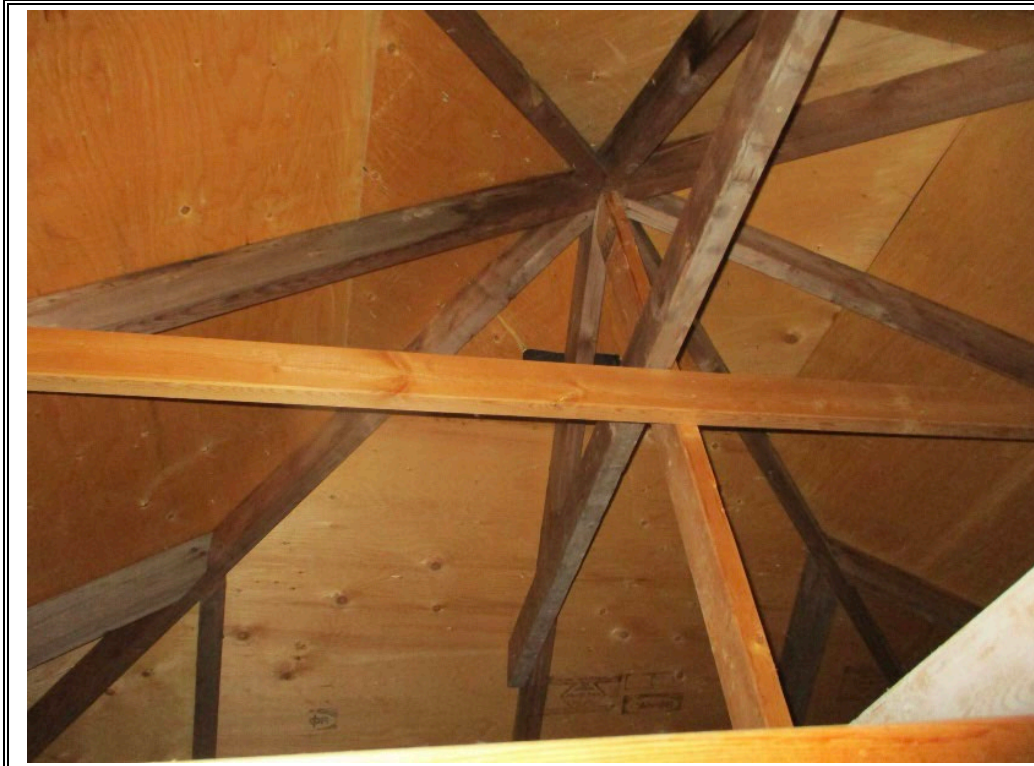
5

We observed no adverse conditions concerning visible superstructure systems. Replacement is not anticipated during the timeline of this report.

The structure is supported by wood joists, framing and wood sheathing.

Wood framing is in good condition.

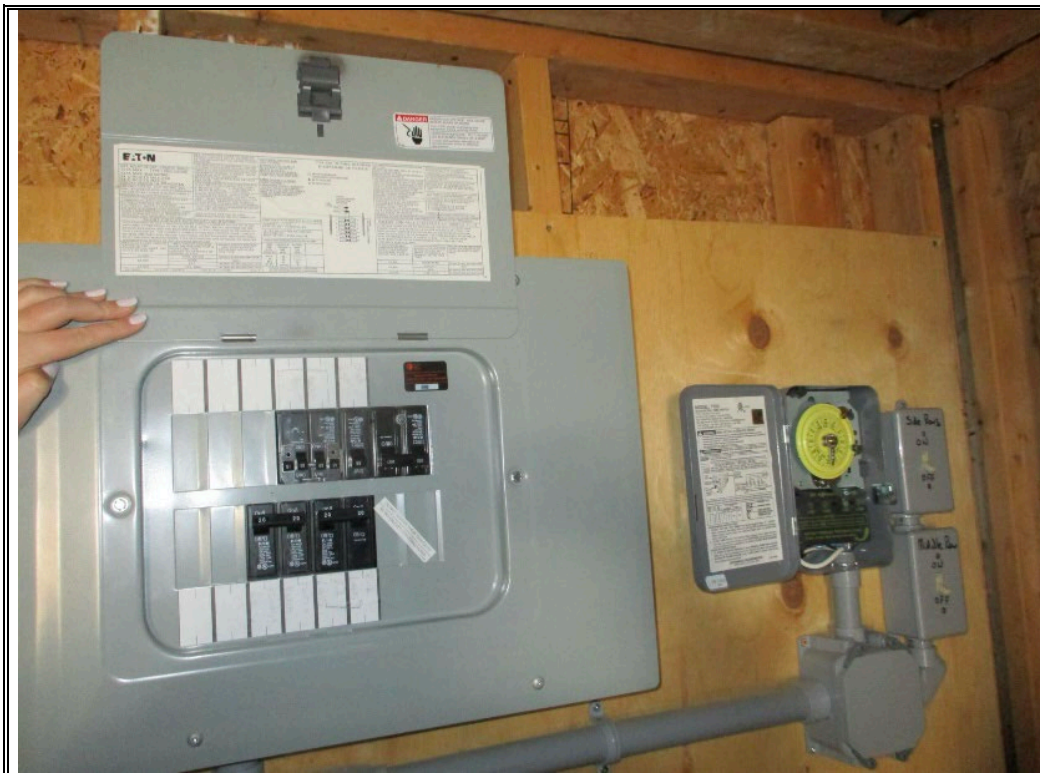
6

The main electrical breaker and timer for the lights.

Electrical service is 125A and 120/240V.

The panel appears to be in good condition.

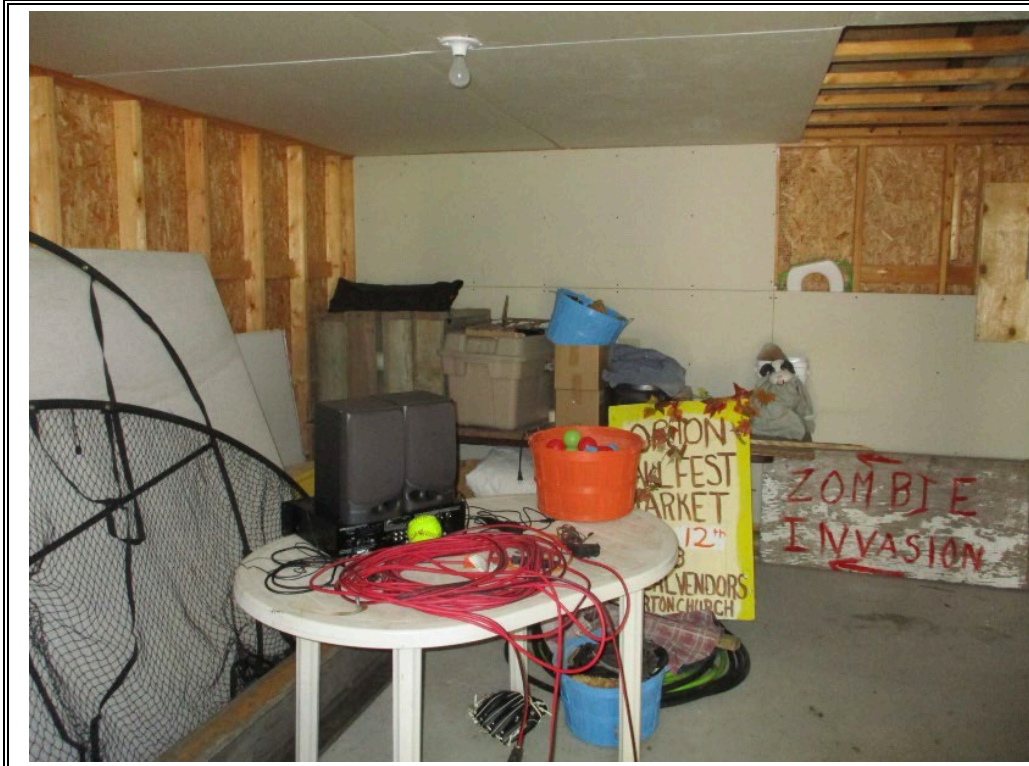
7

Interior walls are mostly unfinished.

The drywall is only on a portion of the interior.

There is an interior light fixture.

Walls are uninsulated.
