BUILDING CONDITION ASSESSMENT

SHED 1 AT GRAVEL PIT

351028 17TH LINE
EAST GARAFRAXA, ONTARIO

December 15, 2023

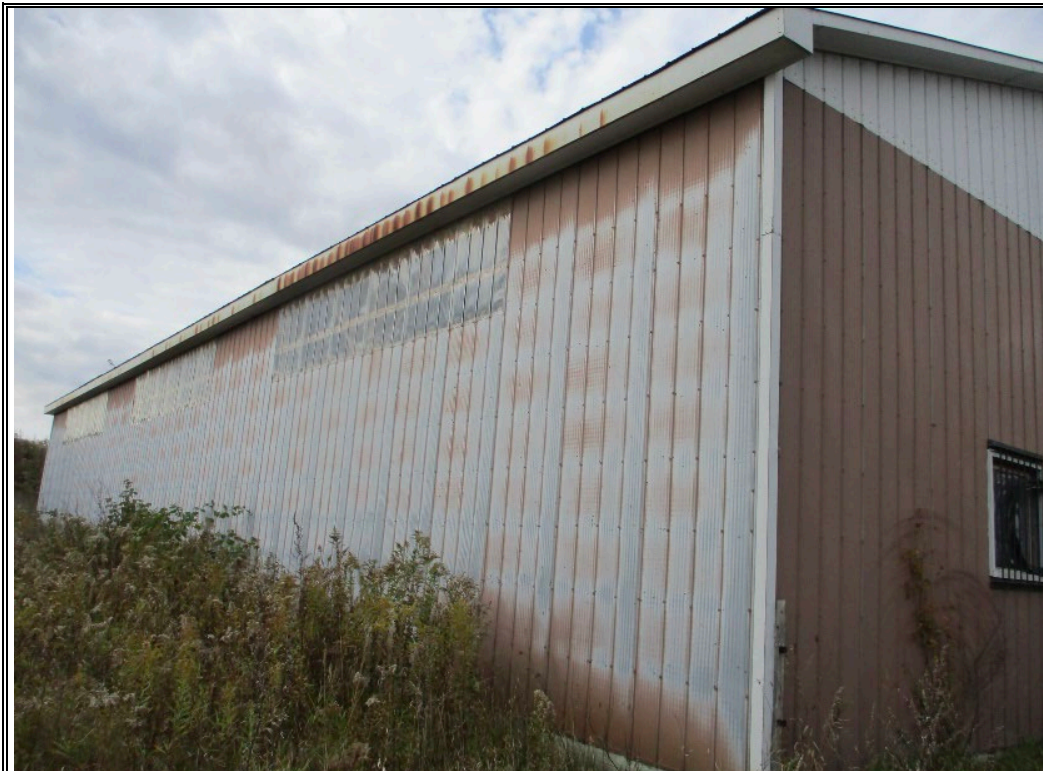
South elevation (rear) of the shed building.

Translucent glass fibre panels windows are provided and are in poor condition.

Paint coatings of the siding and sheet metal fascias are faded, deteriorated and surfaces are rusted.

Paint coatings of the metal siding and sheet metal is in poor condition with faded, rusted, and deteriorated surfaces. A budget for metal siding paint coatings restoration has been allowed for during the time-period of this report.

The windows and glassfibre panel windows are aged and are operating beyond their expected service life. One of the windows is missing a windowpane. The window frames are damaged and deteriorated. A budget for the replacement of windows and frames has been allowed for during the time-period of this report.

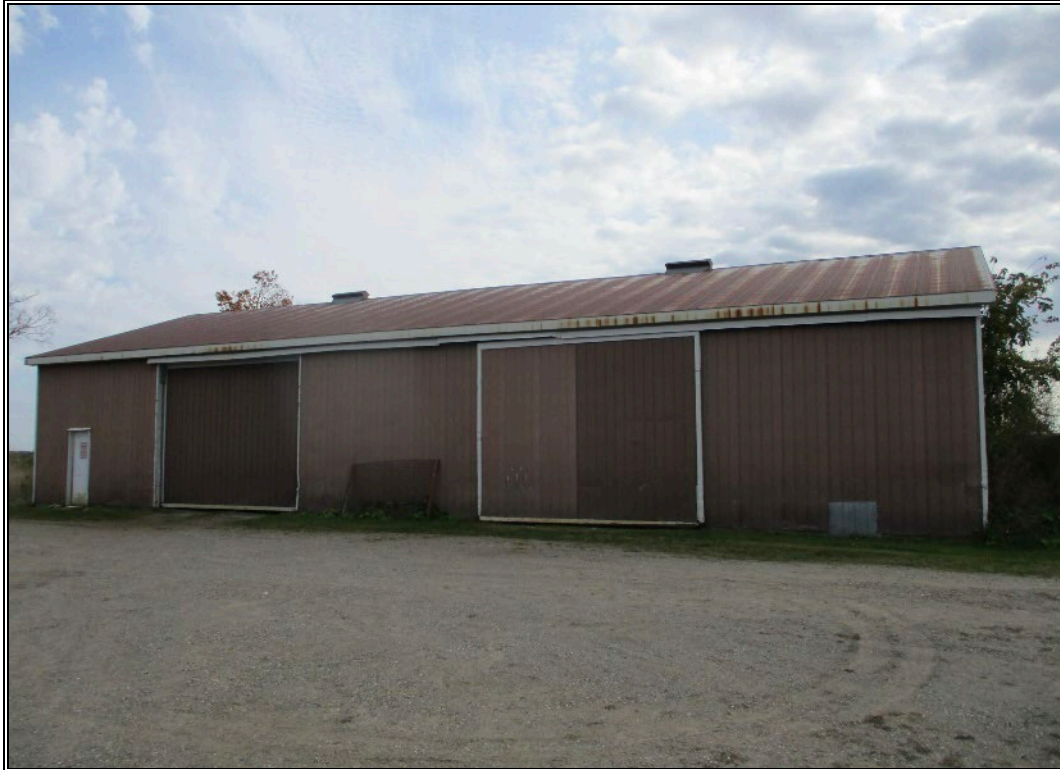
North (front) elevation of the shed building.

The metal roof paint coatings are deteriorated, and metal panel surfaces are rusted.

Ridge vents surfaces appear to be rusted.

Paint coatings of the sheet metal fascias are faded, deteriorated and surfaces are rusted.

Paint coatings of the metal roof is in poor condition with faded, rusted, and deteriorated surfaces. A budget for metal roof paint coatings restoration has been allowed for during the time-period of this report.

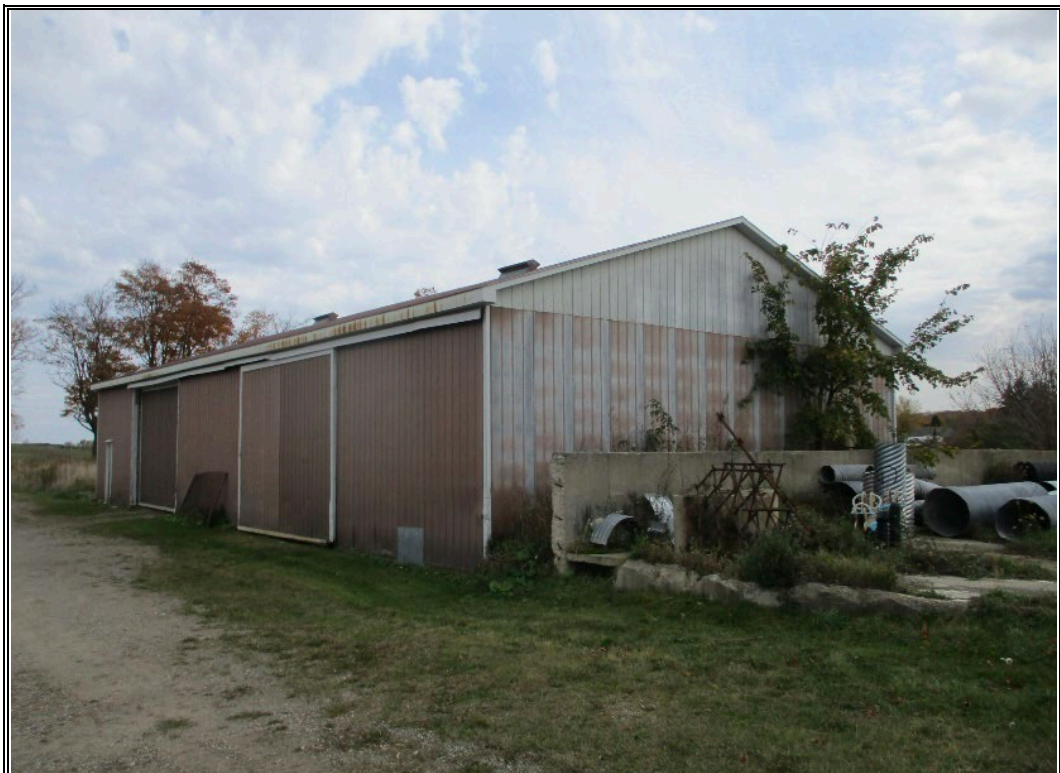
West elevation of the shed.

Paint coatings of the siding and sheet metal fascias are faded, deteriorated and surfaces are rusted.

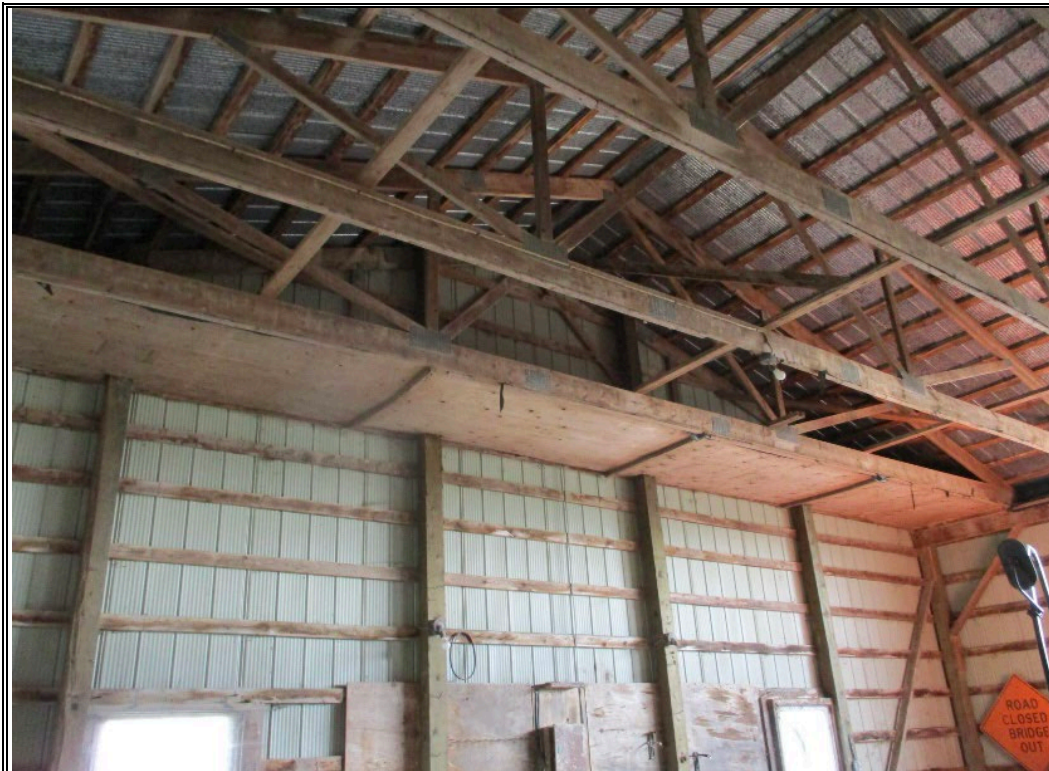
The superstructure is wood, including roof slats, columns, and bracing.

The structure is in fair condition.

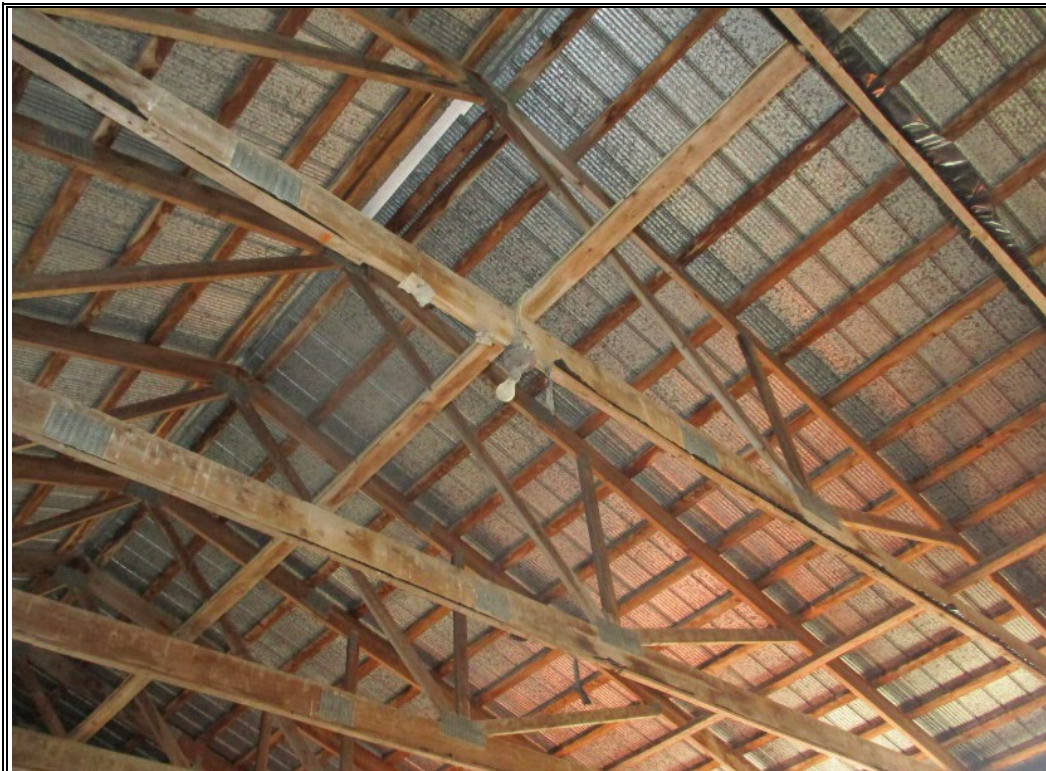
Interior lighting is abandoned and not working.

The electrical systems are disconnected. Interior lighting is provided but not in operation. Exterior lights are not provided. A budget for electrical systems replacement including installation of exterior lighting and thermographic scanning has been allowed for during the timeframe of this study.

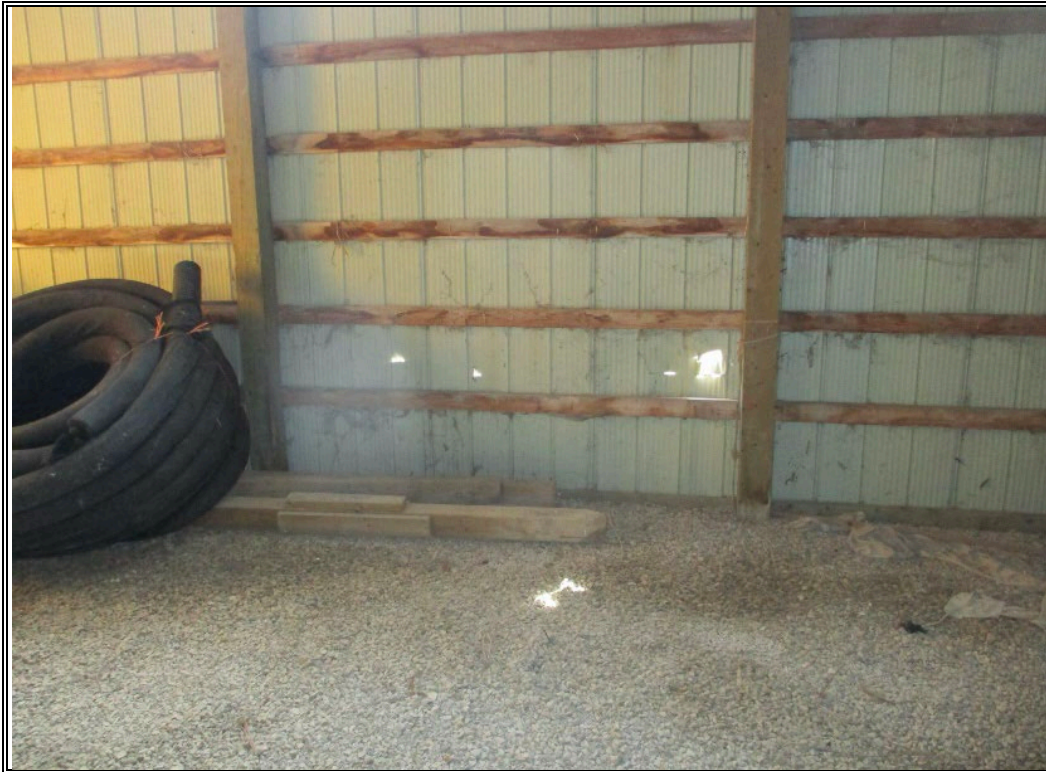
There are holes in the siding, likely from impact damage.

The metal panels should be replaced.

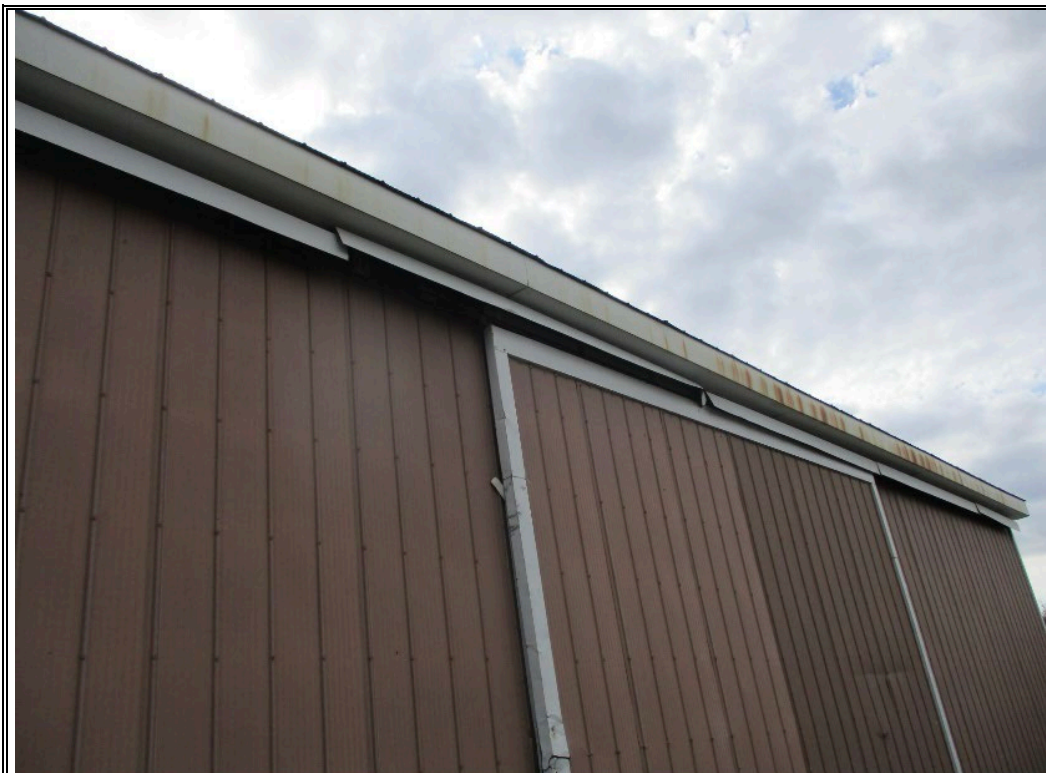
Some sheet metal components are loose, damaged/dislodged.

There is localized damage to the barn doors and weatherstripping and although operational appear to require repairs.

There is localized damage to the barn doors and weatherstripping and although operational appear to require repairs. A budget for repairs has been allowed for during the timeframe of this study.

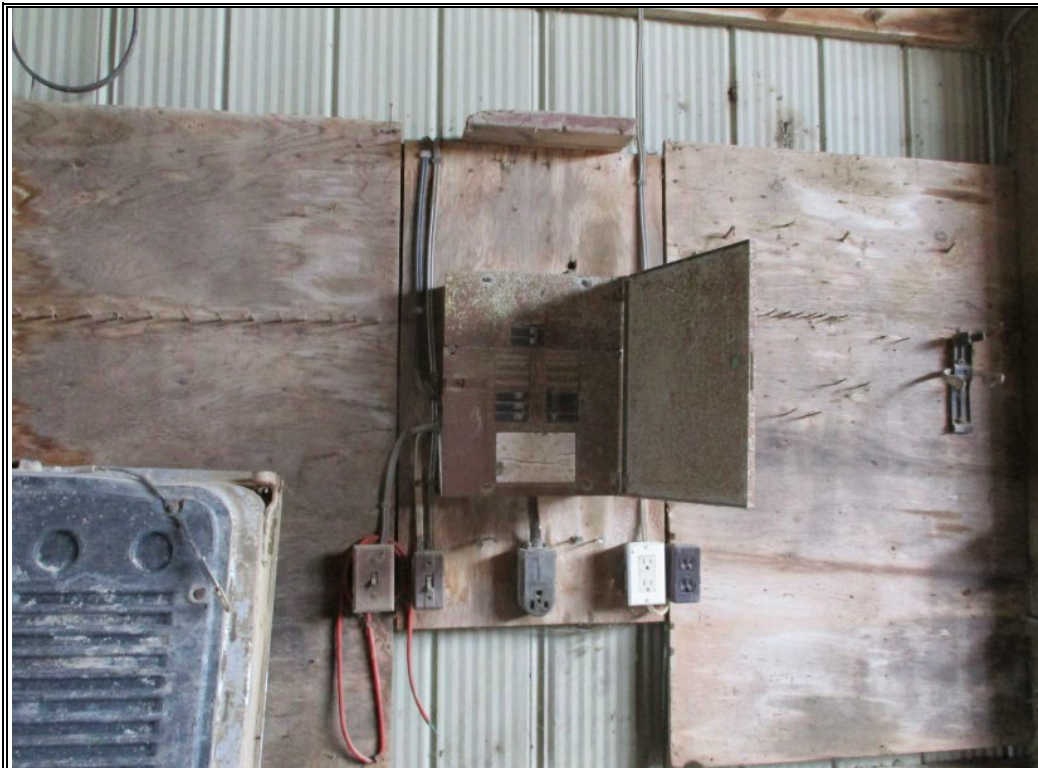
Description:
The electrical
system is
abandoned and not
in operation.

The building does
not have HVAC,
plumbing or other
services.

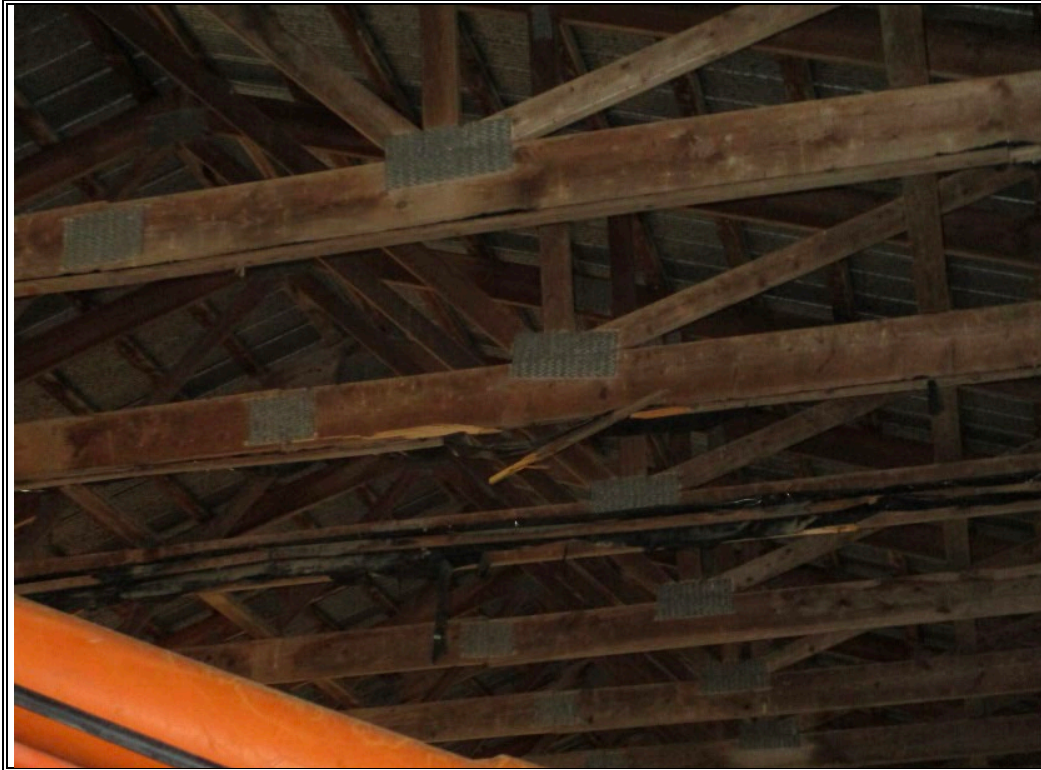
Some bottom chords of the trusses are damaged, likely impact damage.

There are ad-hoc repairs to some damaged chords.

We observed no significant adverse conditions concerning visible superstructure systems; however, there are some damaged columns and truss chords consistent with impact damage. Replacement is not anticipated during the timeline of this report. A budget for repairs has been allowed during the time-period of this study.

Due to localized damage of some structural components and the age of the building, we recommend that a structural study be completed to provide reporting, review, and recommendations. A budget for a structural study has been allowed for as an urgent item.

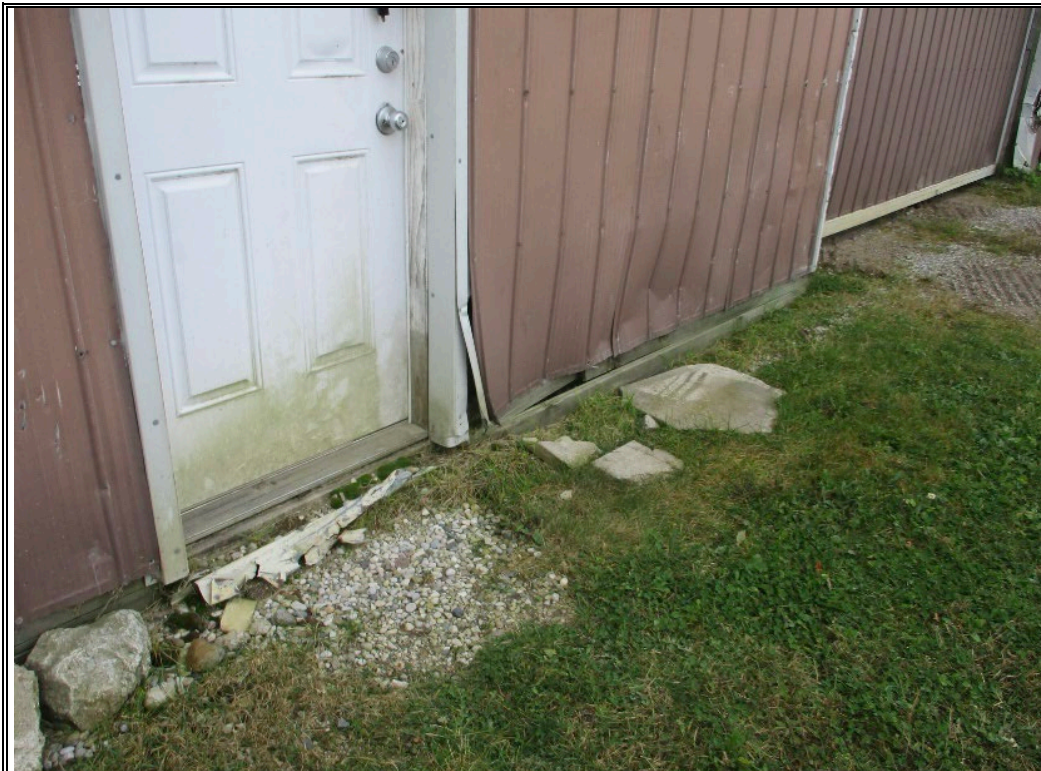
There is damage to the siding, likely from impact.

The metal siding and sheet metal are in fair condition with damage in the form of dents and holes. Replacement is not anticipated to occur with the timeframe of this study. A budget for repairs has been allowed for during the time-period of this report.

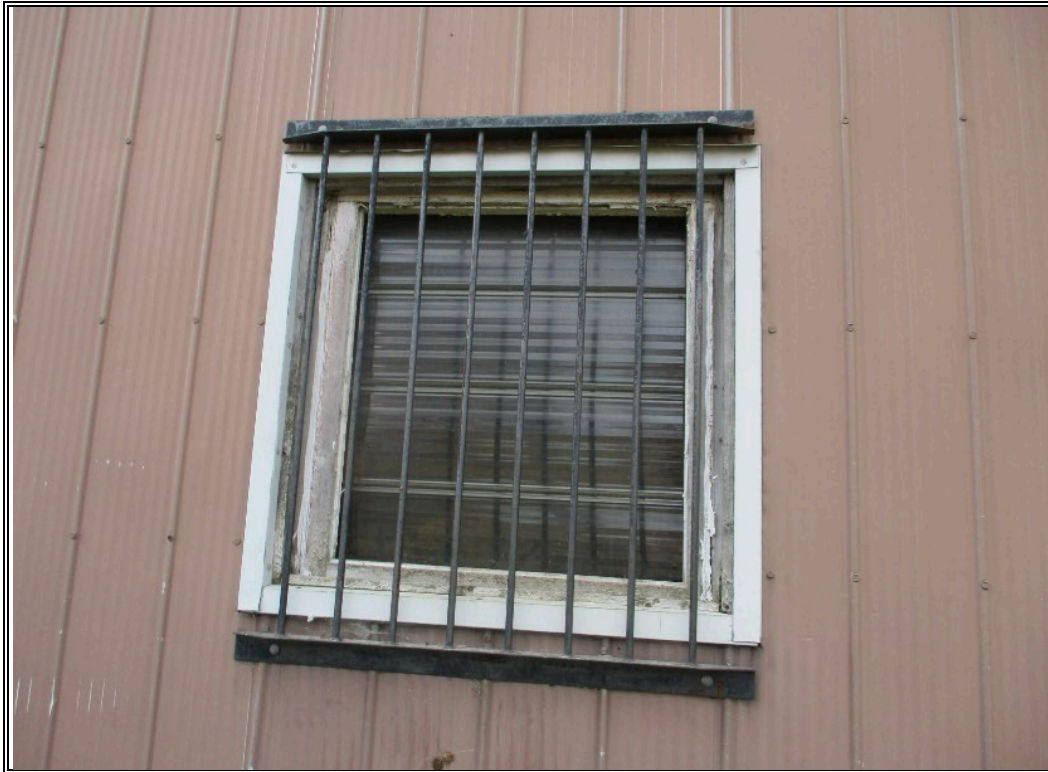
The windows are original wood framed and in poor condition.

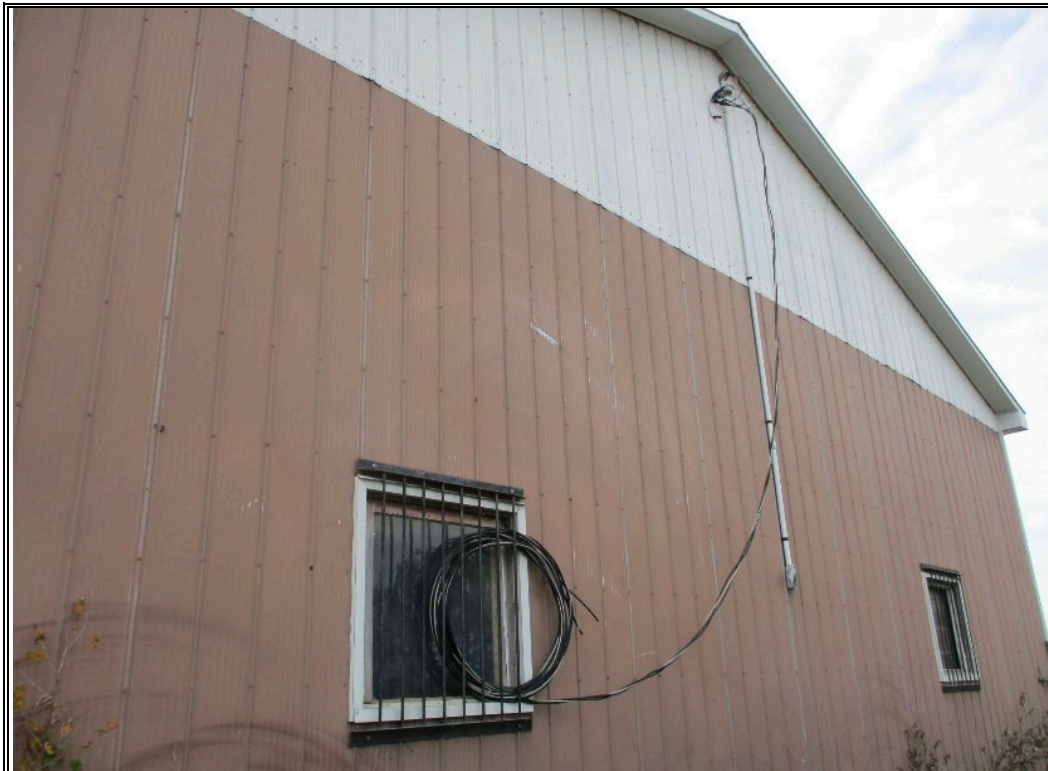
Main electrical feed to the building is disconnected.

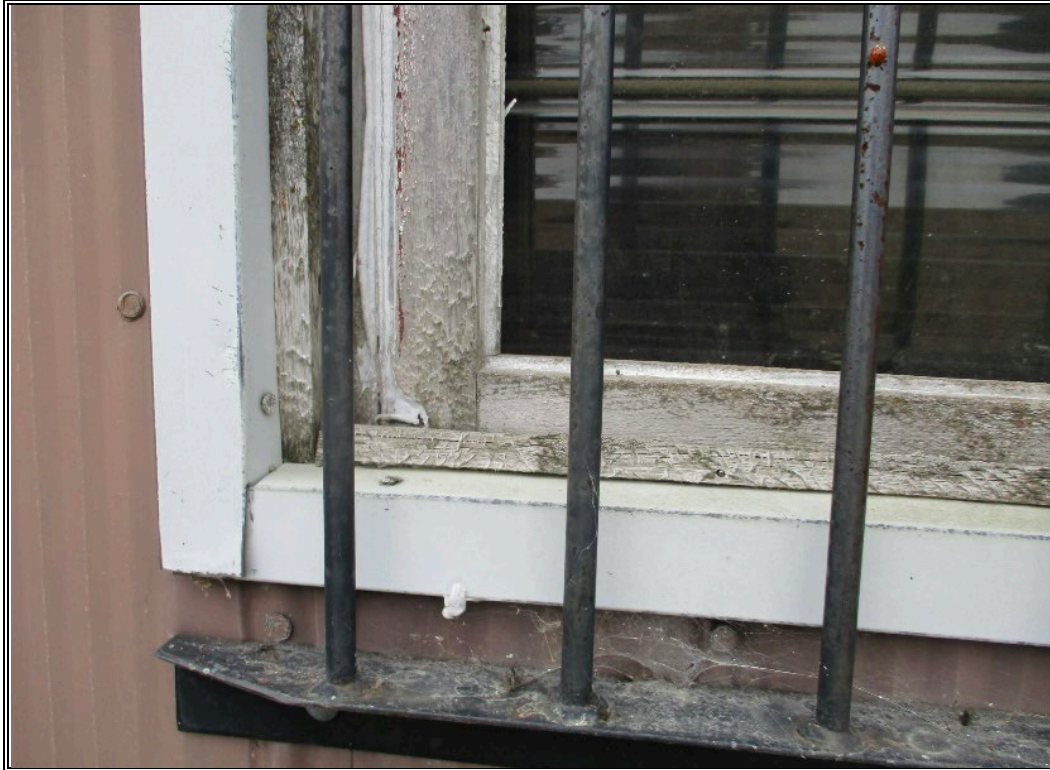
The wood framing, sheet metal panning and sealants of windows are aged and in poor condition.

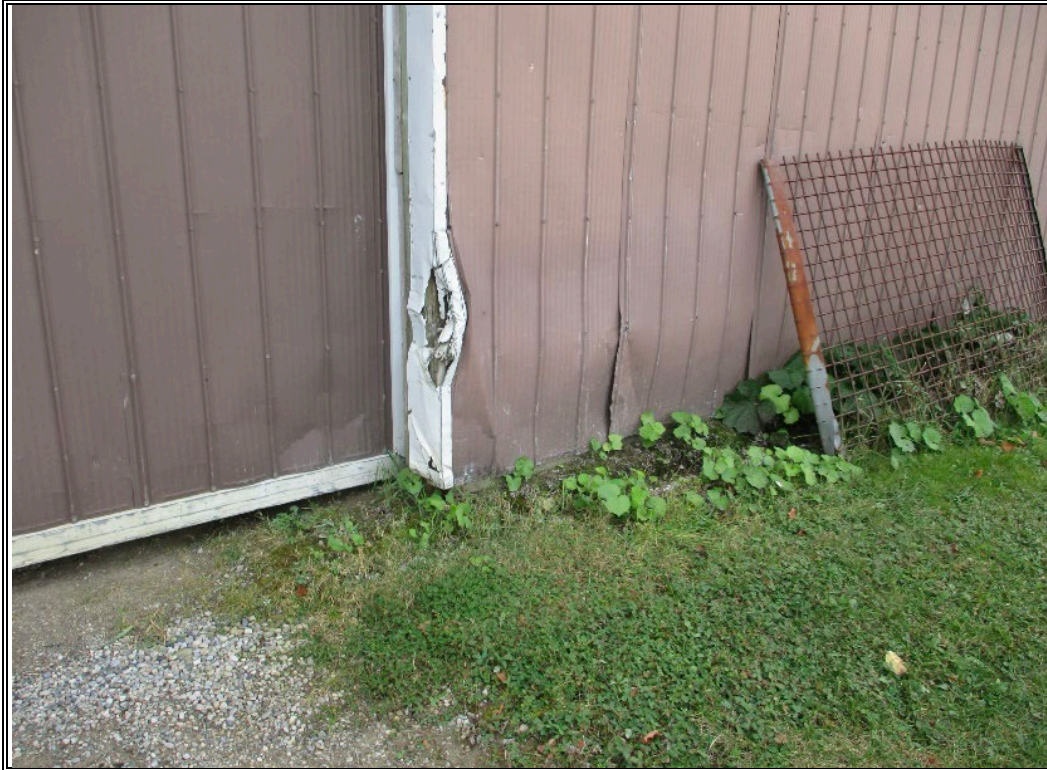
Description:
The columns and siding have damage, likely from impact damage.
