BUILDING CONDITION ASSESSMENT

SHED 2 AT GRAVEL PITS

351028 17TH LINE
EAST GARAFRAXA, ONTARIO

December 15, 2023

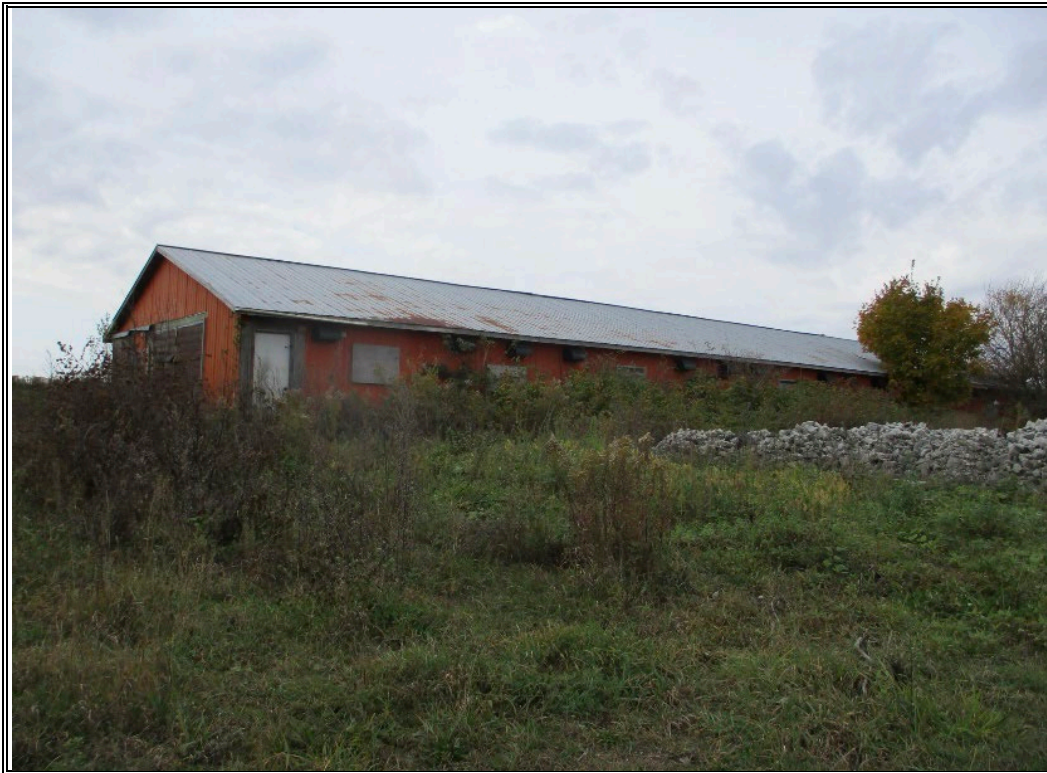
1

South and west sides of the third shed.

The shed has metal siding, sloped metal roof with vents, sheet metal flashings, wood windows, service doors and sliding barn doors.

There are ventilation fan hoods along the exterior wall.

The windows are boarded up.

The building is dilapidated and is abandoned.

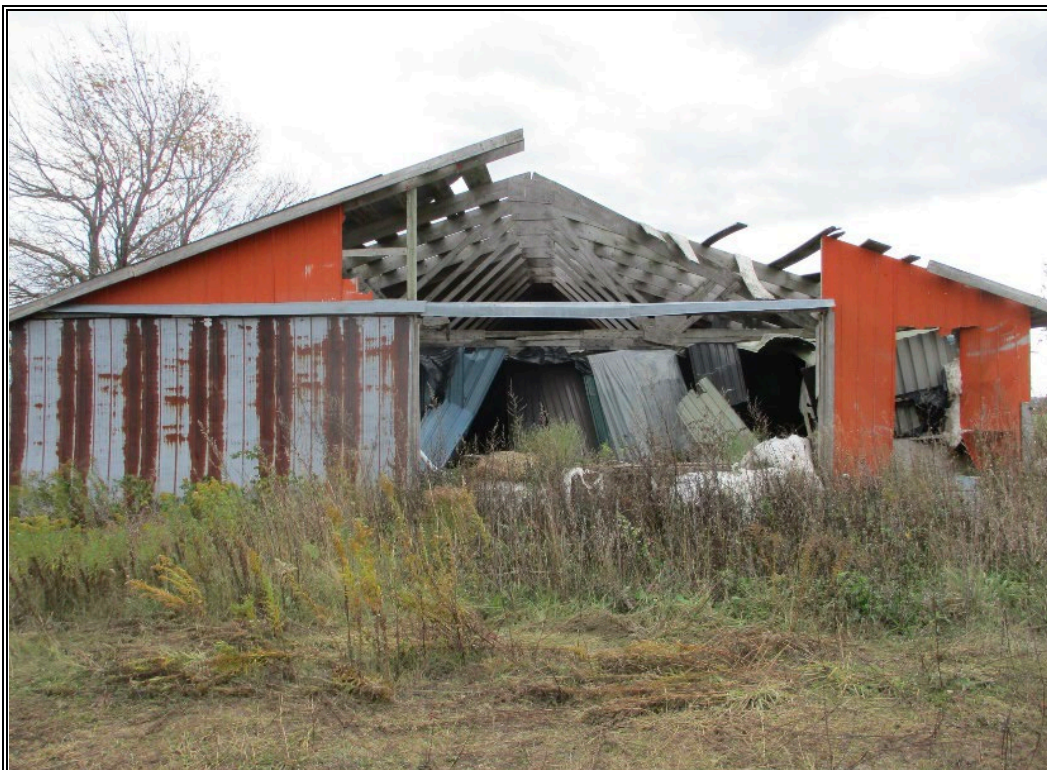
2

North elevation.

The metal roof and building structure is collapsed. The building is in failure mode.

The shed is surrounded by plant overgrowth.

The structural framing has collapsed and has failed. A budget for replacement has been allowed for during the timeframe of this study as an urgent item.

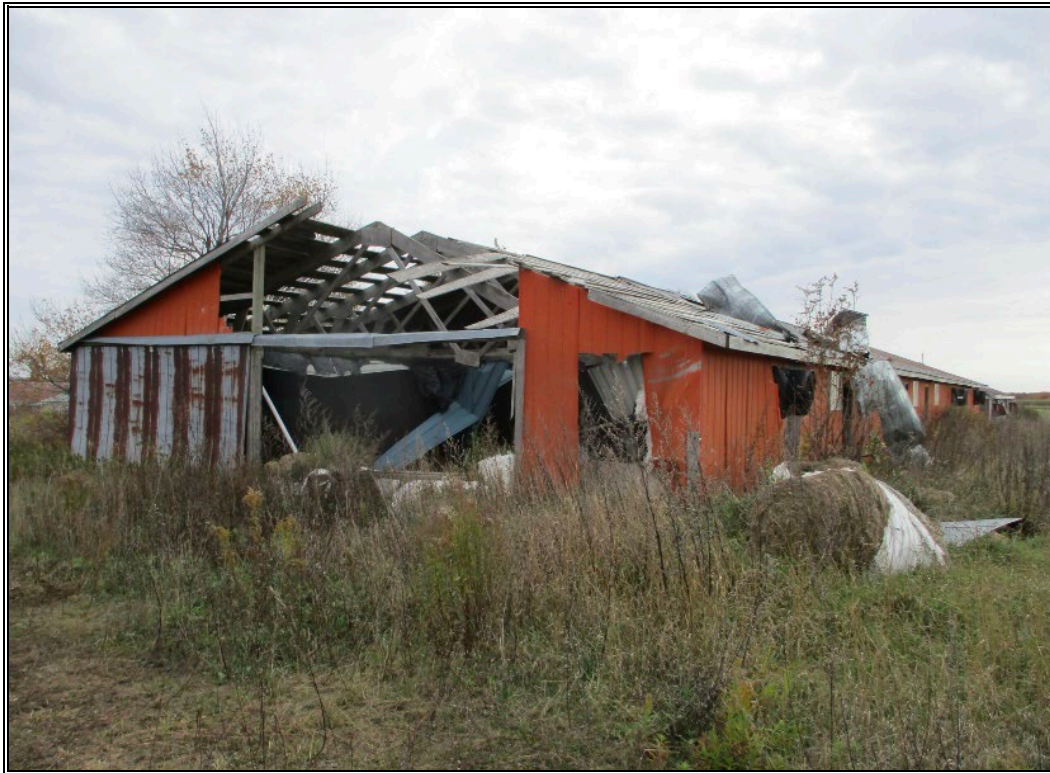
3

All building components and systems not safe and is no longer functional.

The metal roof is detached, the structure is missing siding and the large sliding door.

Due to safety concerns, we were not able to review conditions up close and the interior.

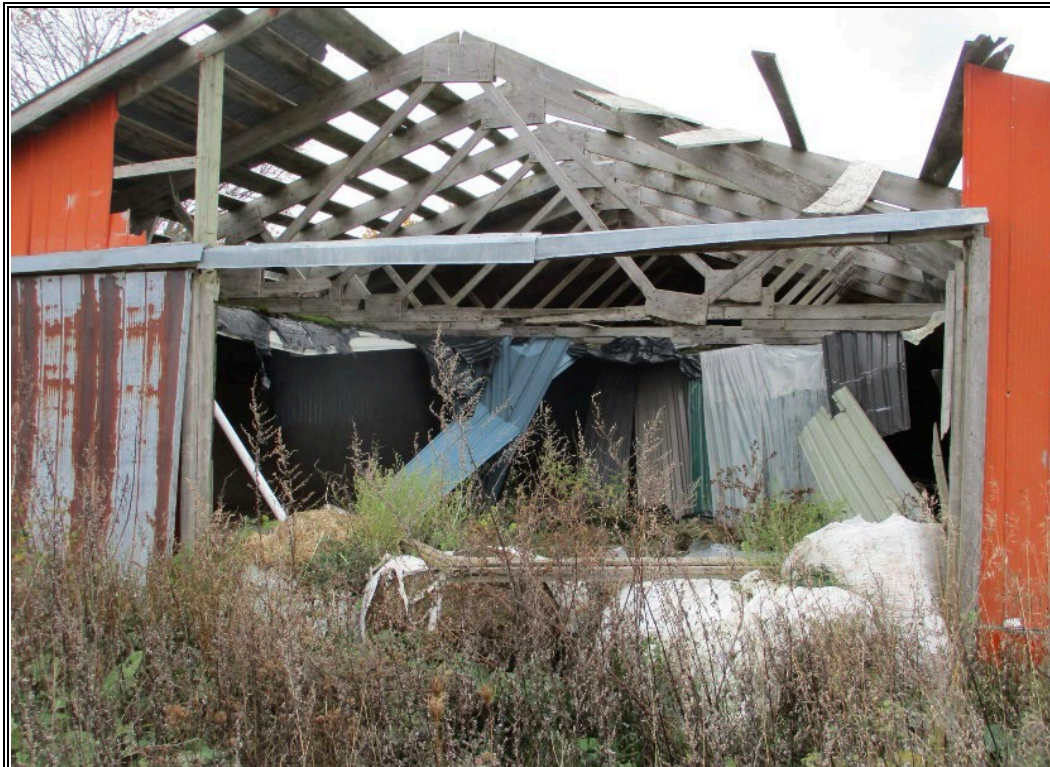
4

All building components and systems not safe and is no longer functional.

The metal roof is detached, the structure is missing siding and the large sliding door.

Due to safety concerns, we were not able to review conditions up close and interior.

The structure is in critical condition.
