BUILDING CONDITION ASSESSMENT

SHED 3 AT GRAVEL PITS

351028 17TH LINE
EAST GARAFRAXA, ONTARIO

December 15, 2023

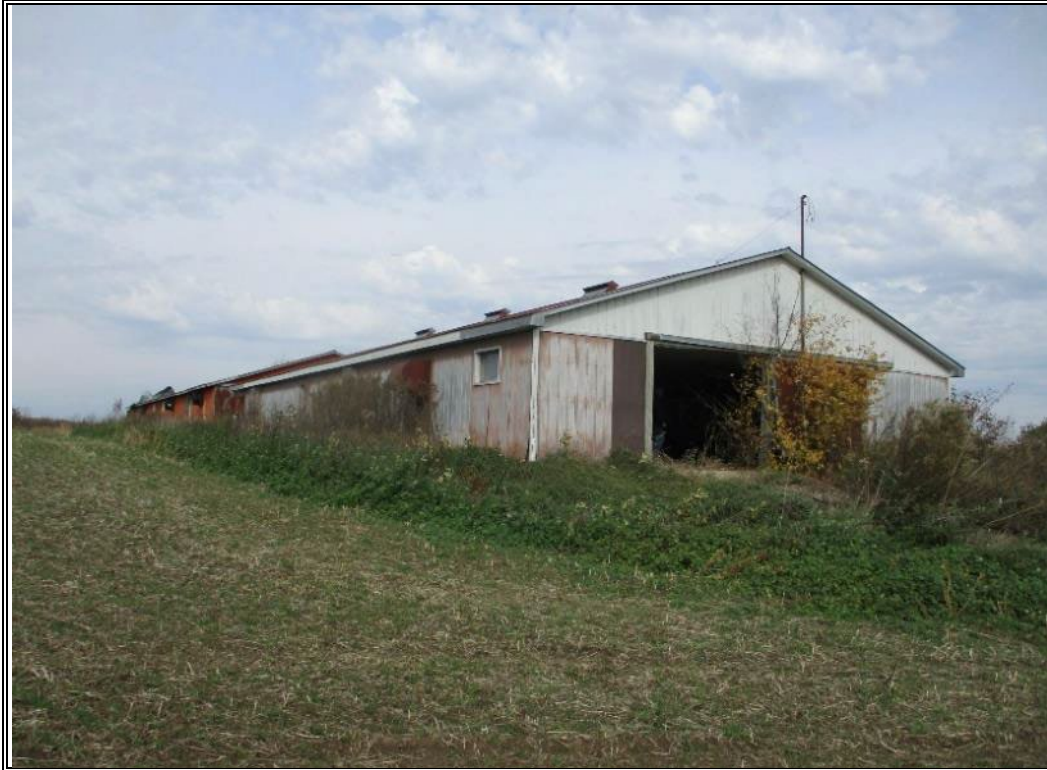
South and west sides of the third shed.

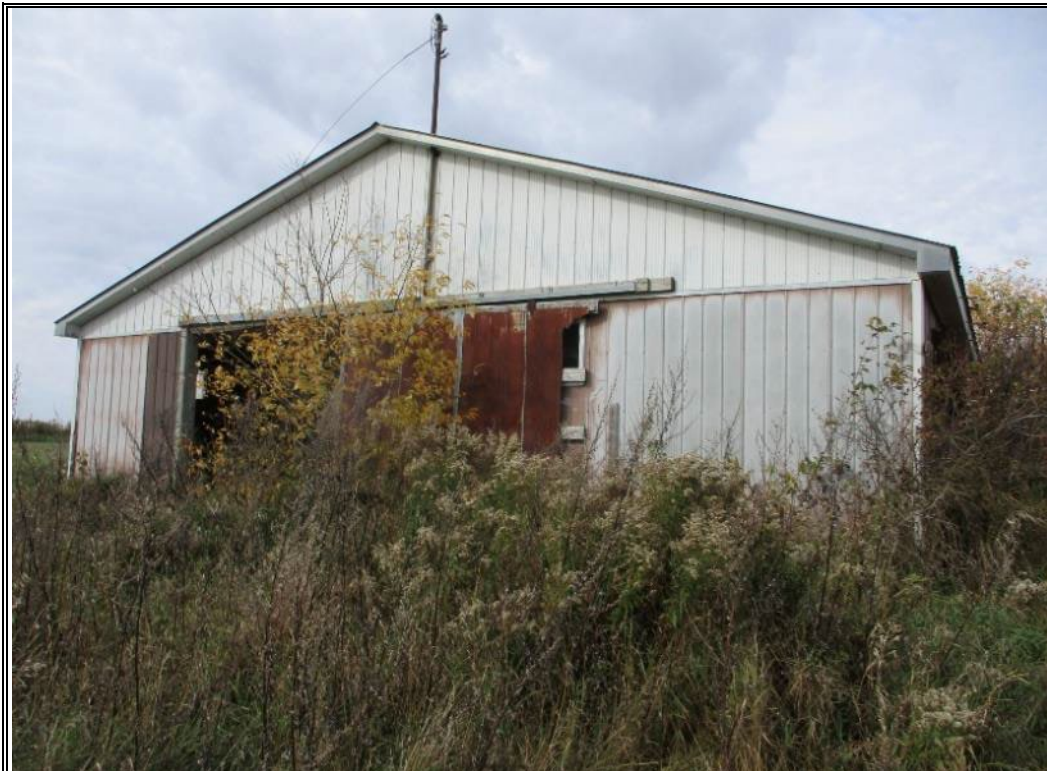
1

South elevation of the shed.

The sliding barn door is corroded, deteriorated and not operational.

Sheet metal panning and flashings are missing at some door frame locations.

The sliding barn doors are damaged/deteriorated, corroded, and portions of the doors are missing. The doors are not operational. A budget for replacement has been allowed for during the time-period of this report.

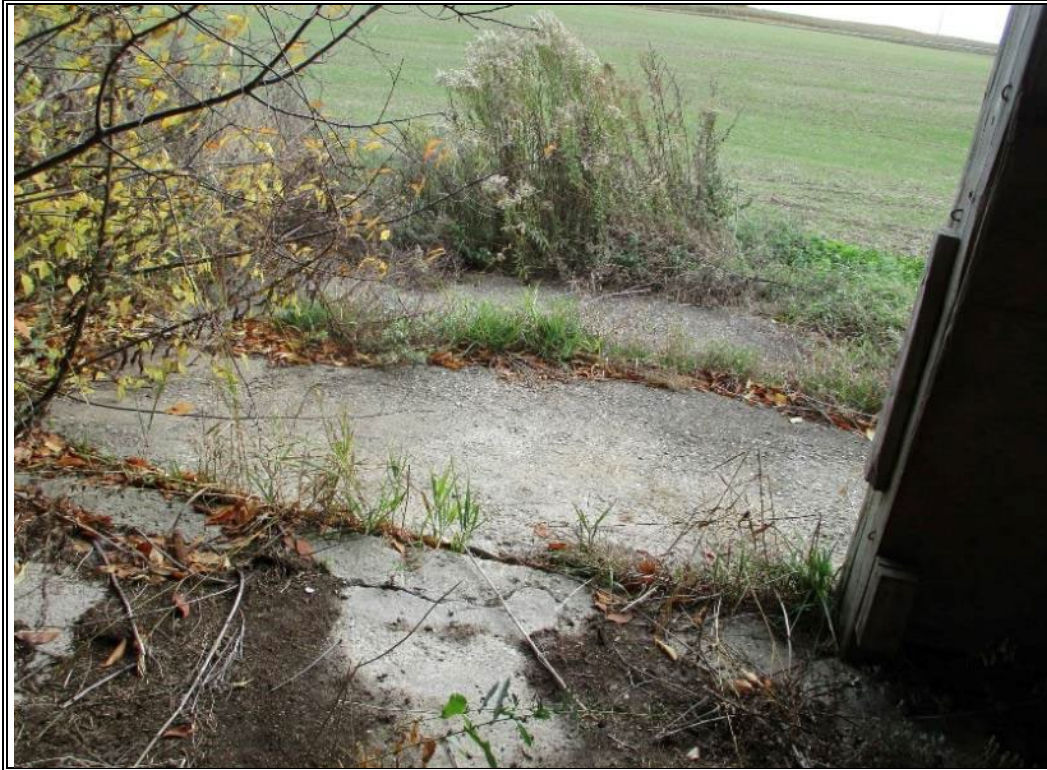
The concrete slab-on-grade at south barn door entrance is cracked and there is plant overgrowth.

The concrete slab-on-grade at south barn door entrance is cracked, deteriorated and there is plant overgrowth. A budget for replacement has been allowed for during the timeframe of this study.

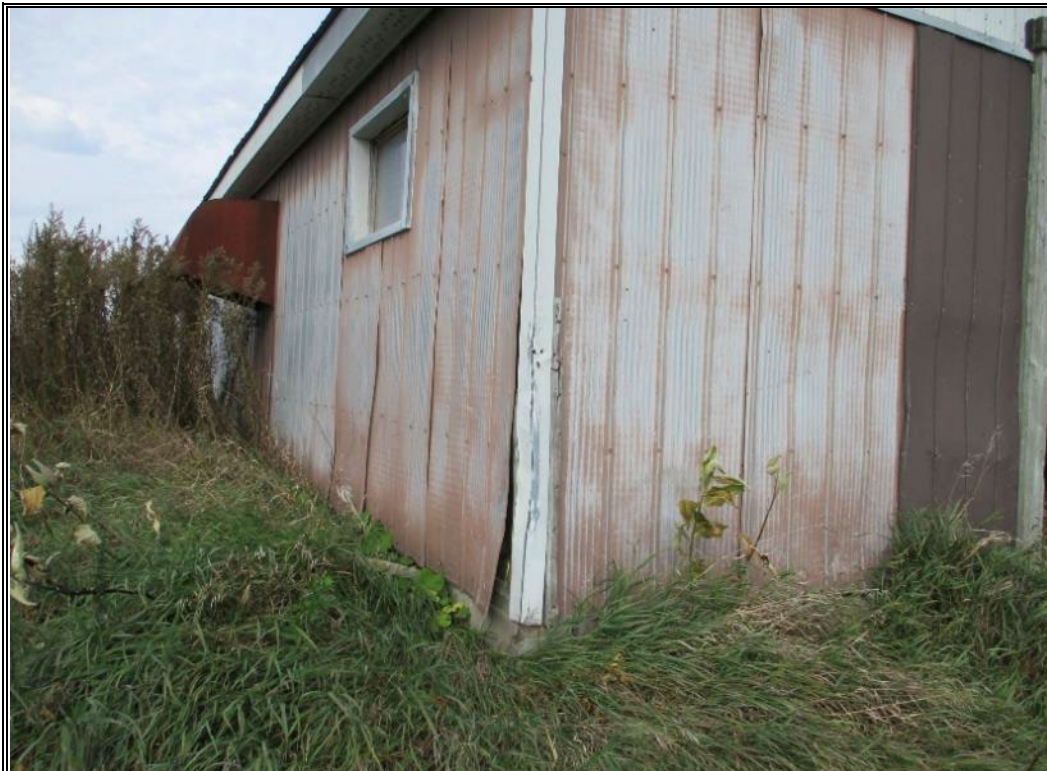
3

The metal siding is in poor condition and is rusted, damaged, deformed and detaching from the building.

The metal siding is in poor condition with damage in the form of dents, holes and paint coatings deterioration and rust. Wall insulation is exposed at some wall damage locations. A budget for replacement has been allowed for during the timeframe of this report as an urgent item.

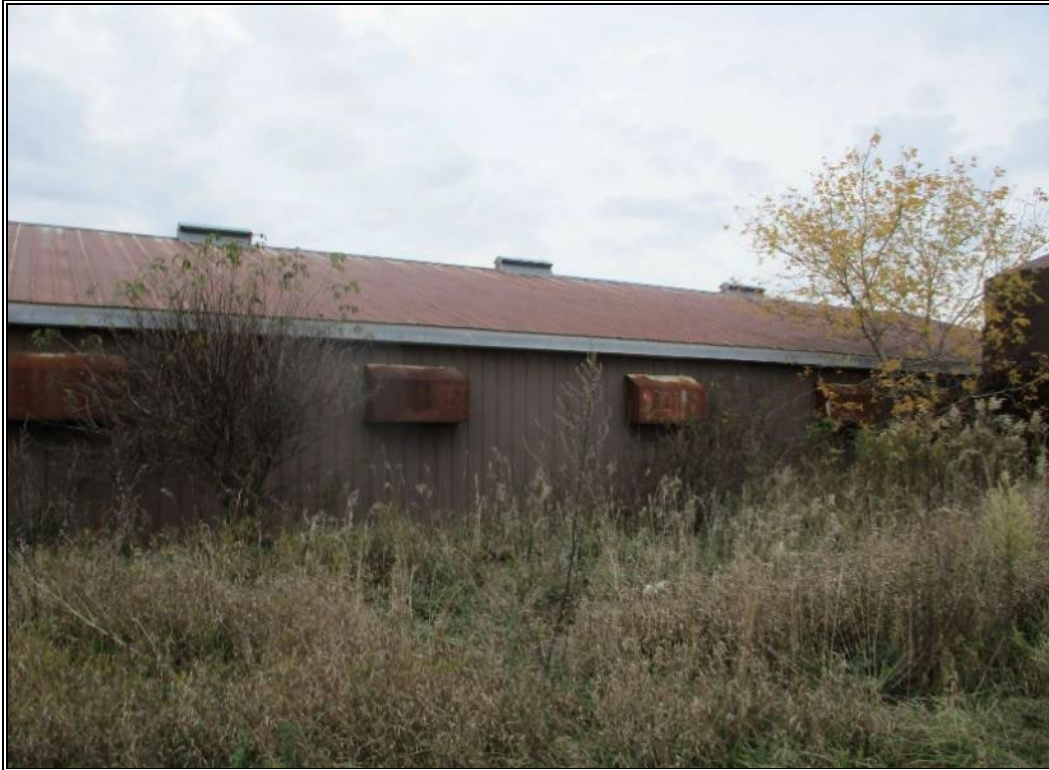
East elevation.

The ventilation fan hoods are corroded (Chore-Time).

The metal roof is rusted and in poor condition.

The metal roof panels, and roof vents appear to be original and are in poor condition with damage in the form of deformed sheet metal and surface deterioration. A budget for replacement has been allowed for during the timeframe of this study as an urgent item.

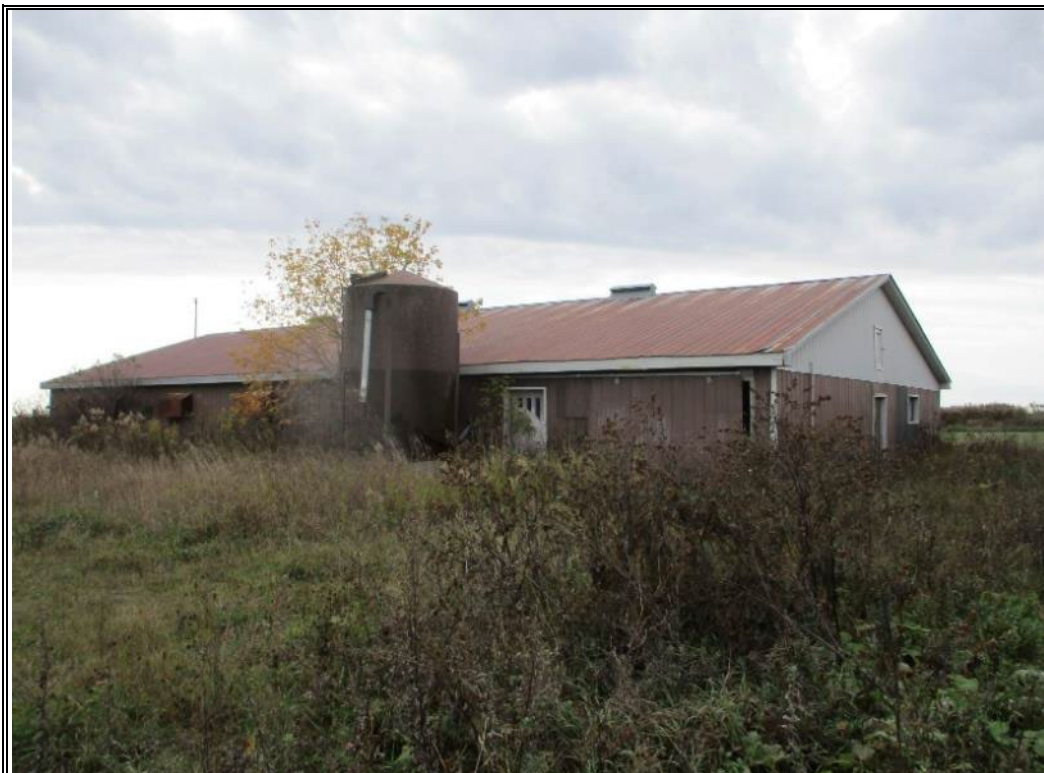
5

East and north elevations of the third shed.

There is an abandoned feed storage hopper that is in disrepair and corroded.

A feed storage hopper & feeder system is provided that is in poor condition and not in operation. A budget for replacement has been allowed for during the time-period of this report.

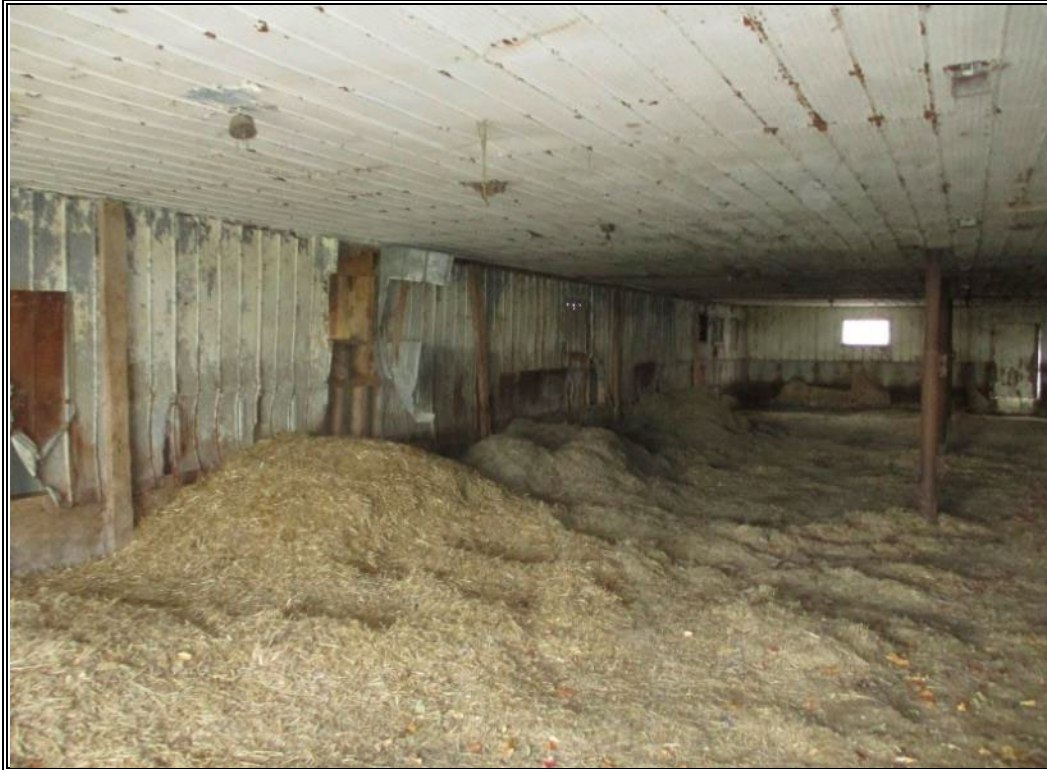
Interior.

The foundation is slab-on-grade concrete, and the walls and ceiling are metal panels. Floor slab is covered in hay and not visible.

The metal wall panels are damaged, surfaces have localized corrosion, and paint coatings are deteriorated.

The slab-on-grade was covered by hay and is not visible; however, based on age & general building condition it is assumed to be in poor condition. A budget for replacement has been allowed for during the time-period of this study.

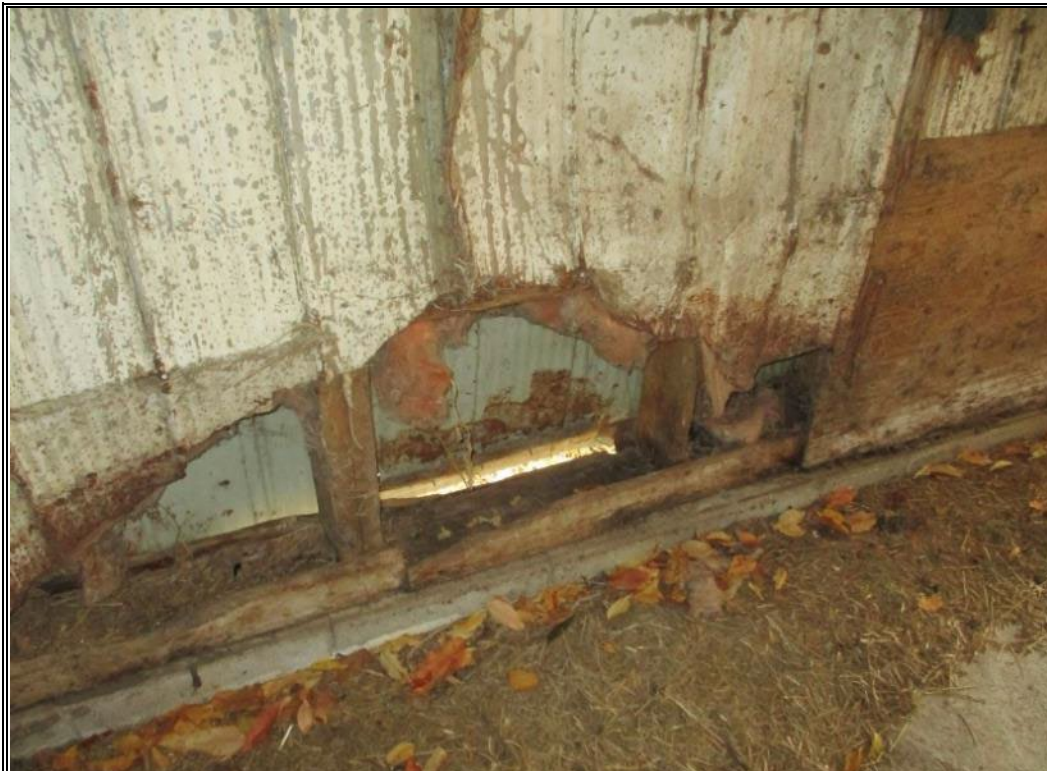
7

The walls are corroded and damaged.

The walls are in poor condition, with corrosion and damage in the form of dents, holes, and missing sections. A budget for replacement has been allowed for during the time-period of this report.

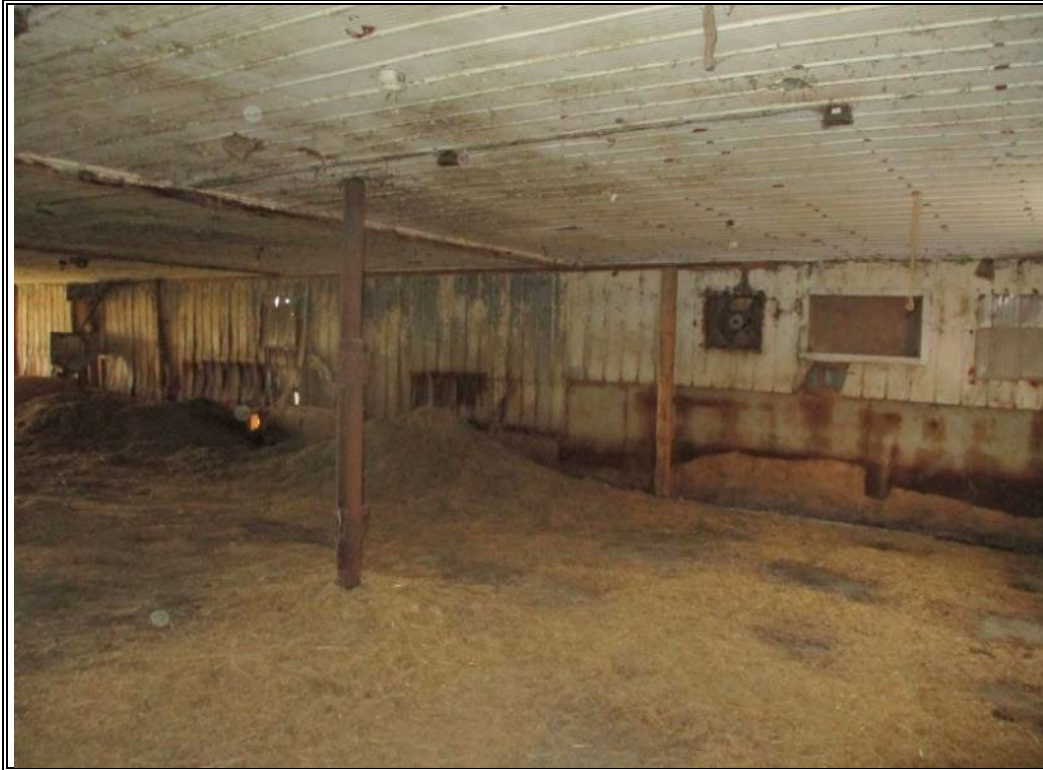
Support columns in the centre of the structure are metal and are rusted.

There are damaged & corroded columns and given the age & general condition of the building including building envelope deterioration that will result in water penetration and damage over time, we assume the structure is in poor condition. A budget for replacement has been allowed during the timeframe of this study as an urgent item.

Due to the deteriorated condition of the building, and the age of the building, we recommend that a structural study be completed to provide reporting, review, and recommendations. A budget for a structural study has been allowed for as an urgent item.

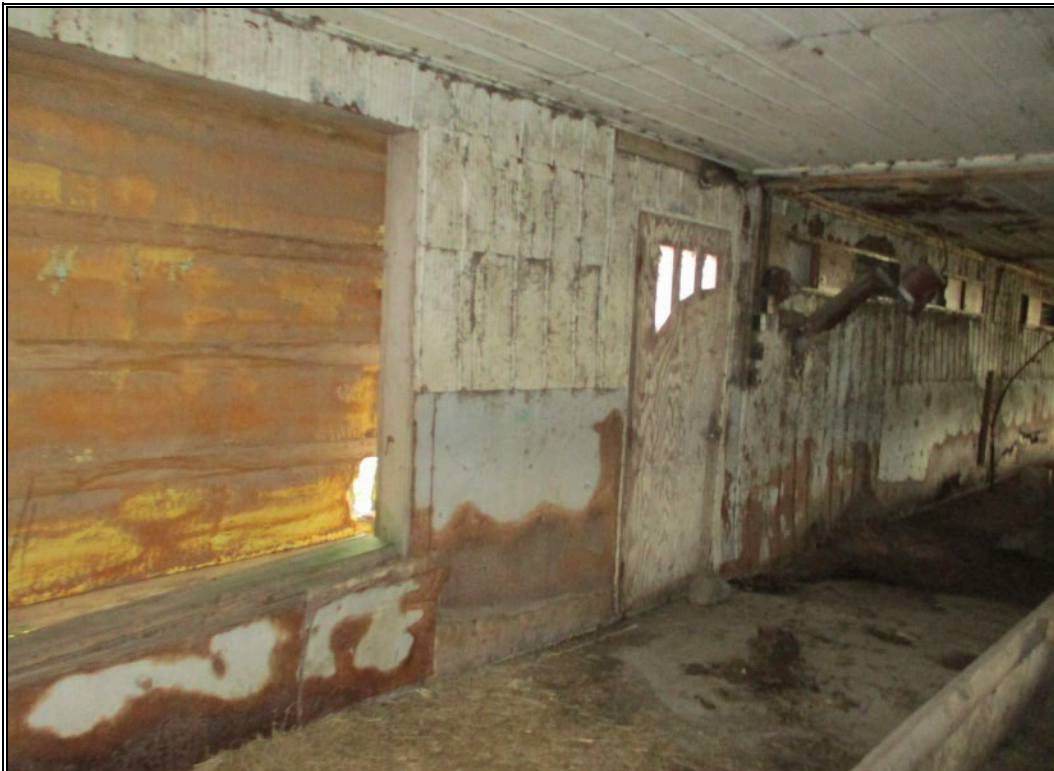
9

The wood doors are deteriorated and inoperable.

Exterior swing doors are in poor condition and at the end of their service life, one door being non-operational. Costs associated with replacement are expected to be below the Capital Threshold and are not included.

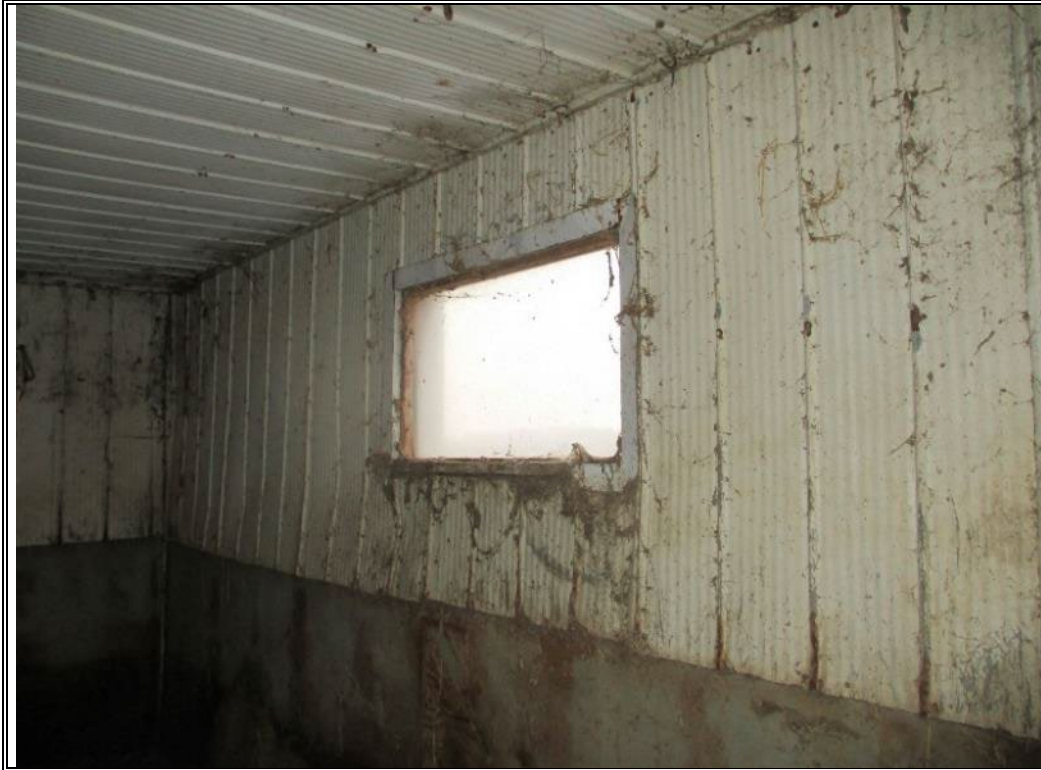
The wood windows are deteriorated and glazed with plexiglass panels.

Wood framing and sealants are in poor condition.

The windows are in poor condition, some with missing windowpanes and boarded by wood panels. A budget for replacement has been allowed for during the timeframe of this report as an urgent item.

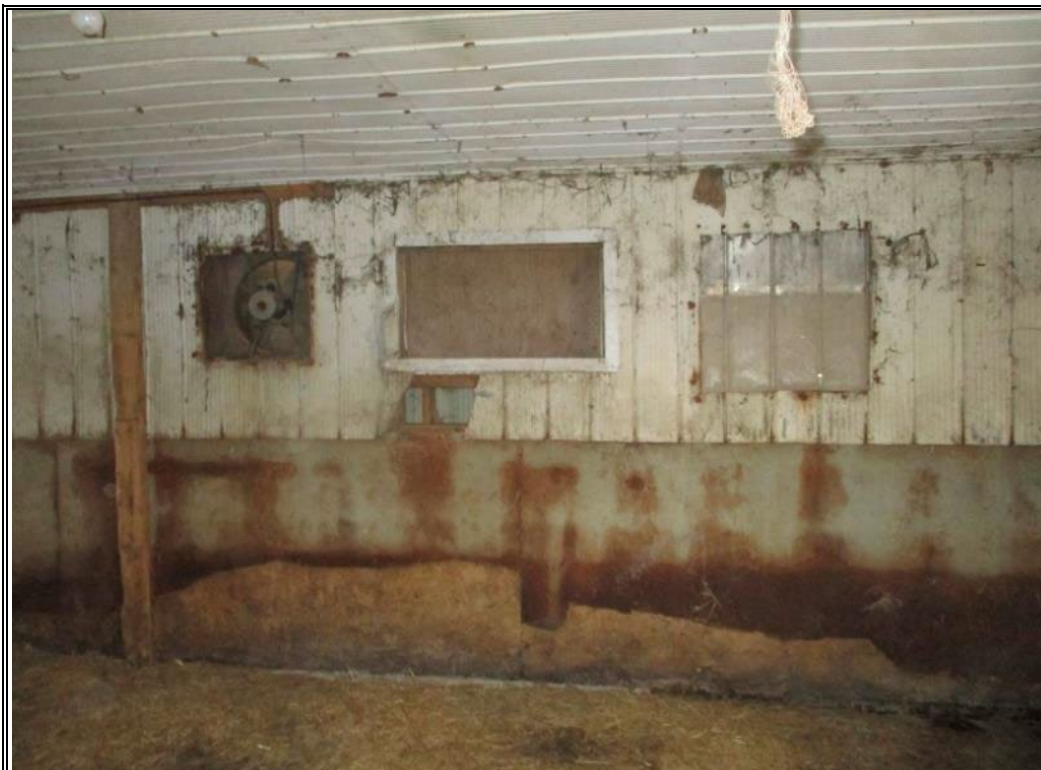
11

Ventilation fans are inoperable and damaged.

Localized metal wall panel repairs have been completed.

The ventilation fans and systems are not operational. A budget for replacement has been allowed for during the timeframe of this study.

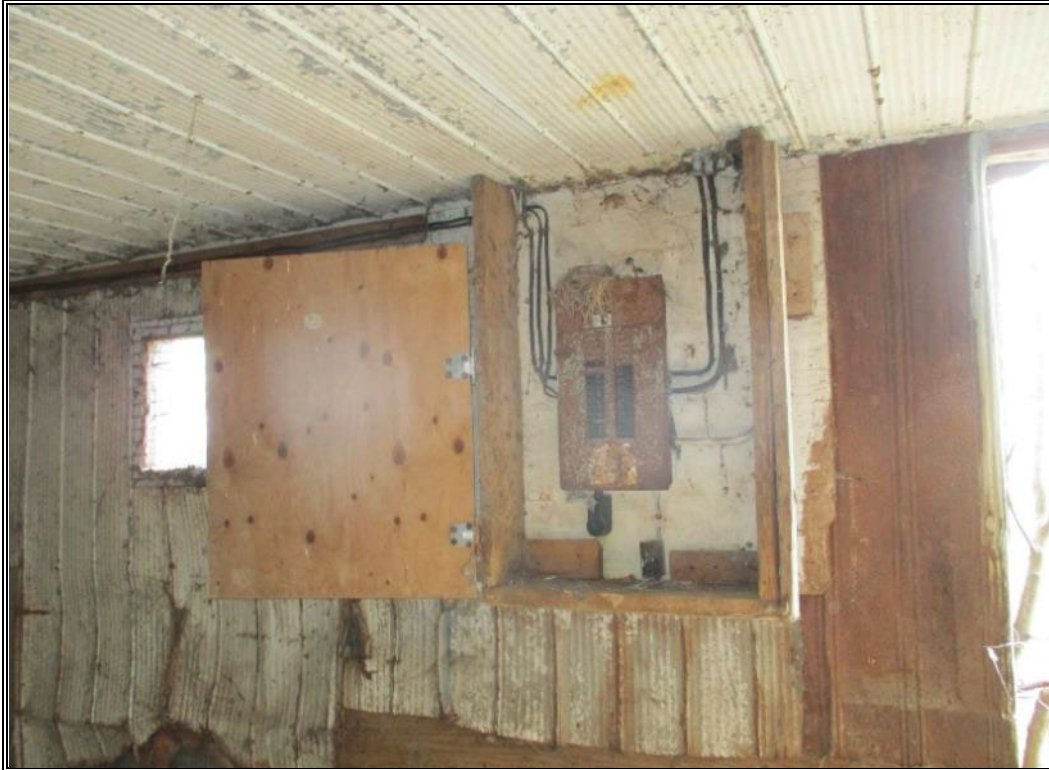
The electrical system is abandoned and not in operation.

The electrical systems are disconnected and not operational. A budget for electrical systems replacement including installation of lighting and thermographic scanning has been allowed for during the timeframe of this study as an urgent item.

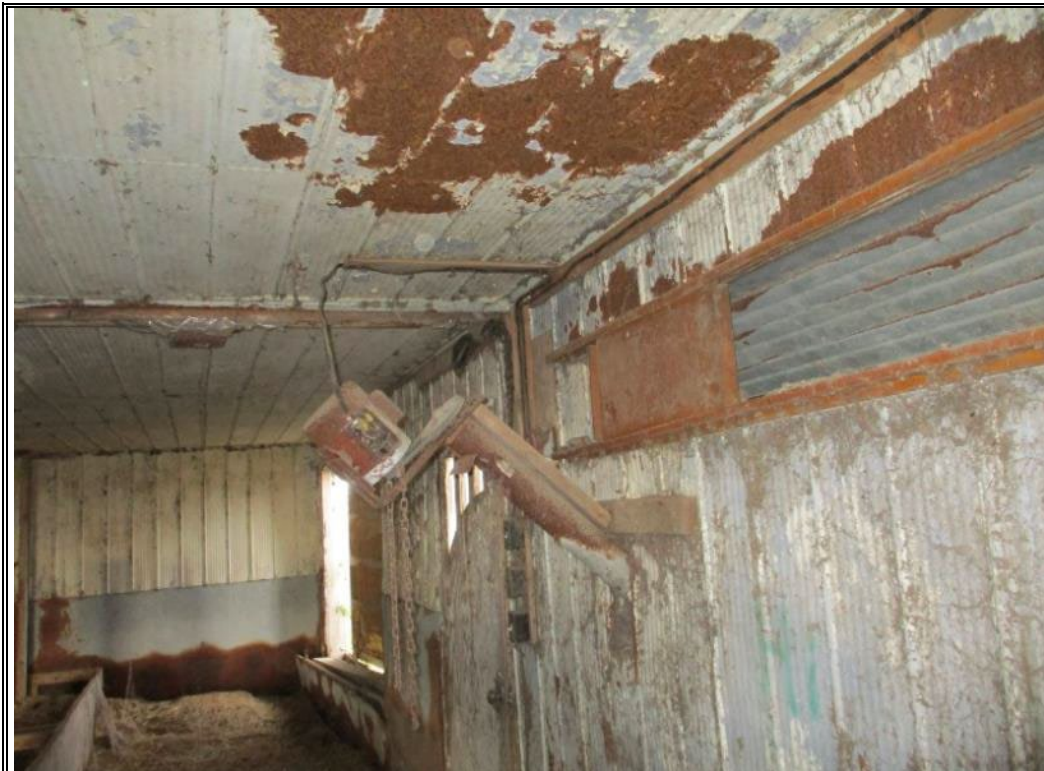
13

Animal feed system connected to the feed hopper is inoperable and damaged.

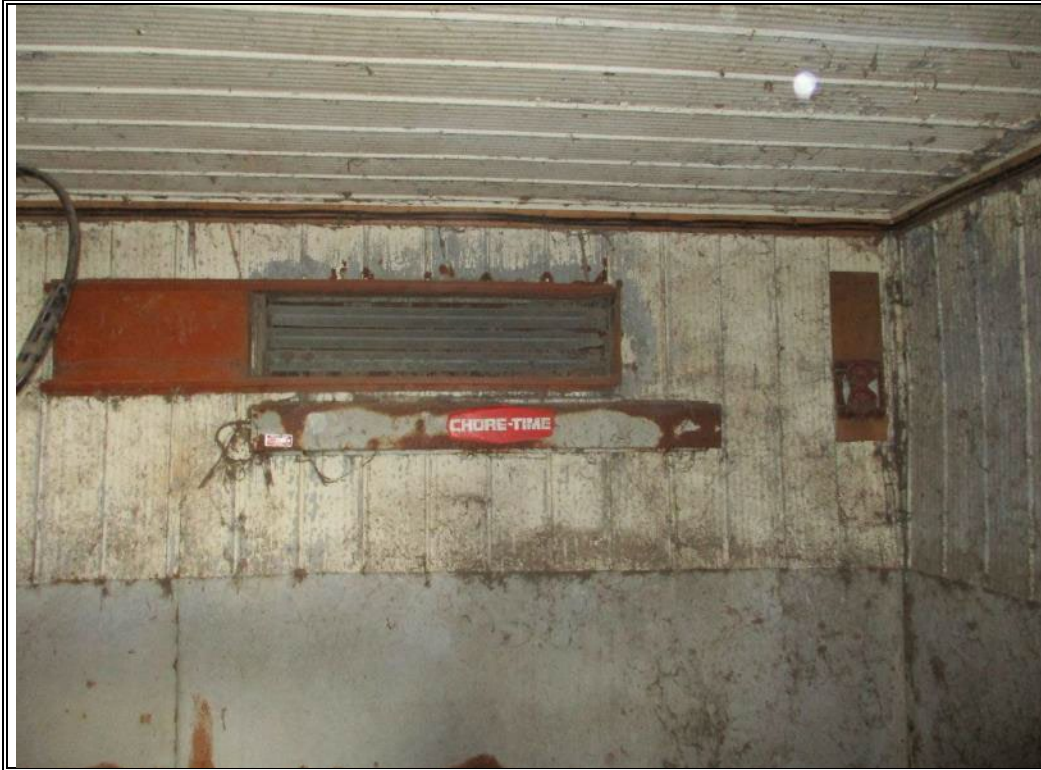
Photo Number
15

Description:
The ventilation fan shutters (Chore-Time). The ventilation systems are inoperable and abandoned.
