BURNSIDE

2023 OSIM Bridge Inspections Report

**Township of East Garafraxa
065371 Dufferin County Road 3, Unit 2
East Garafraxa, ON L9W 7J8**

**January 2024
300053343.2023**

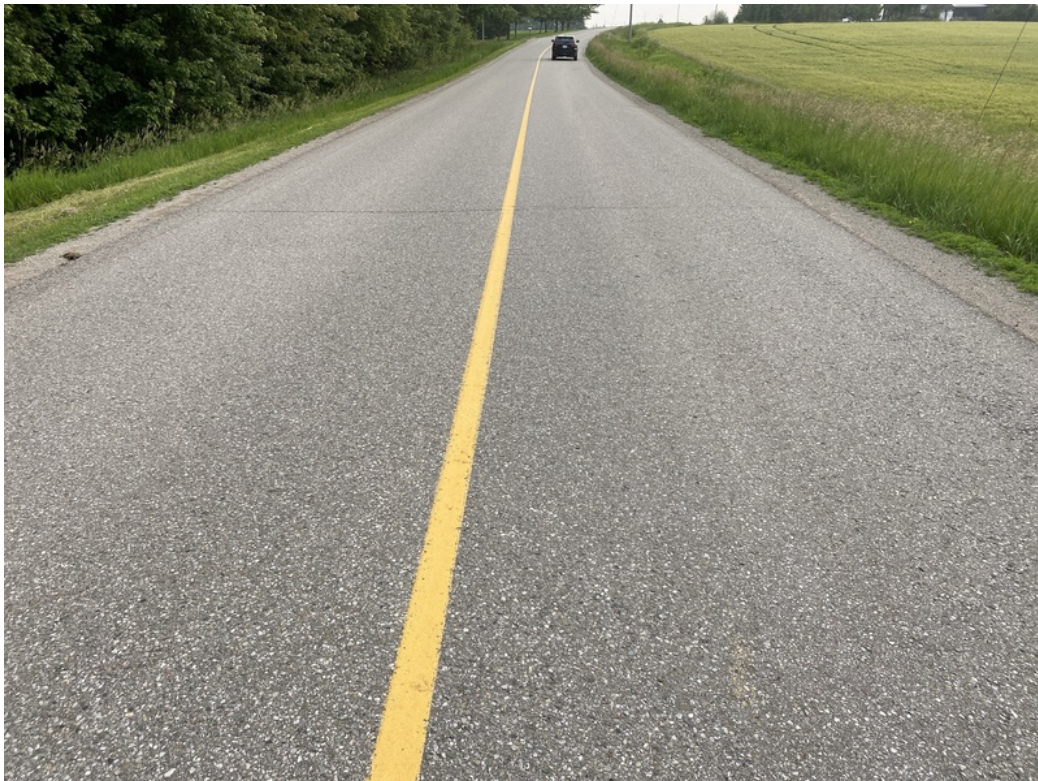
5. 1: Approach Wearing Surface (East)

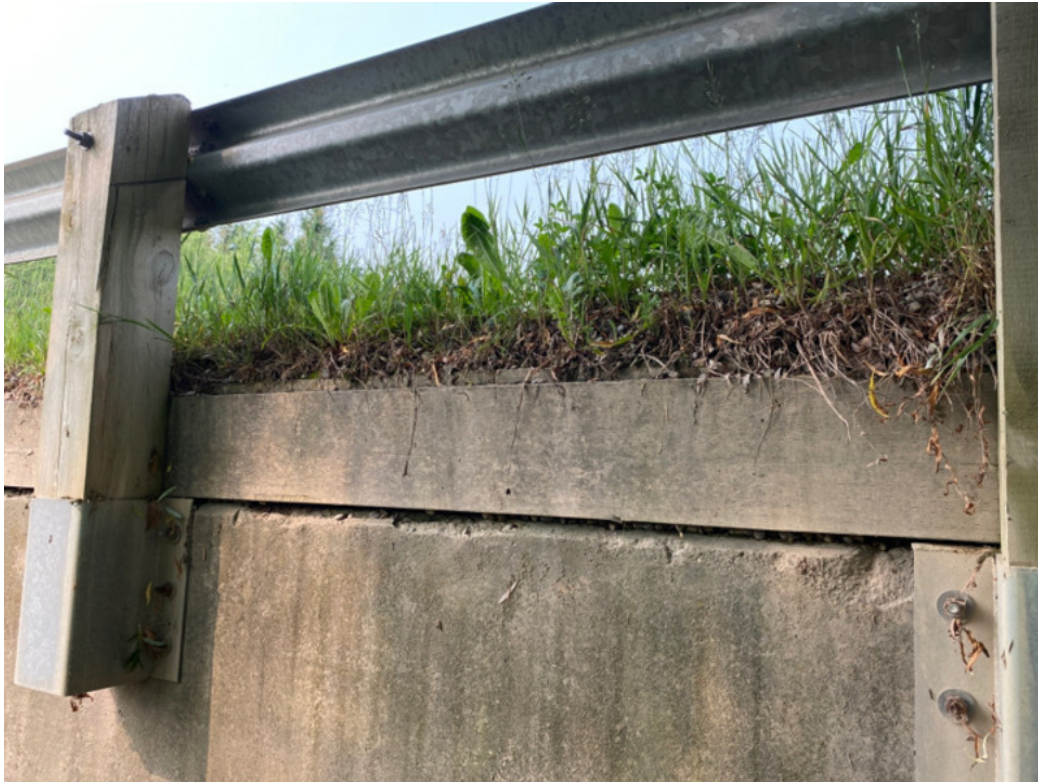
2. 2: Wingwalls (North East)

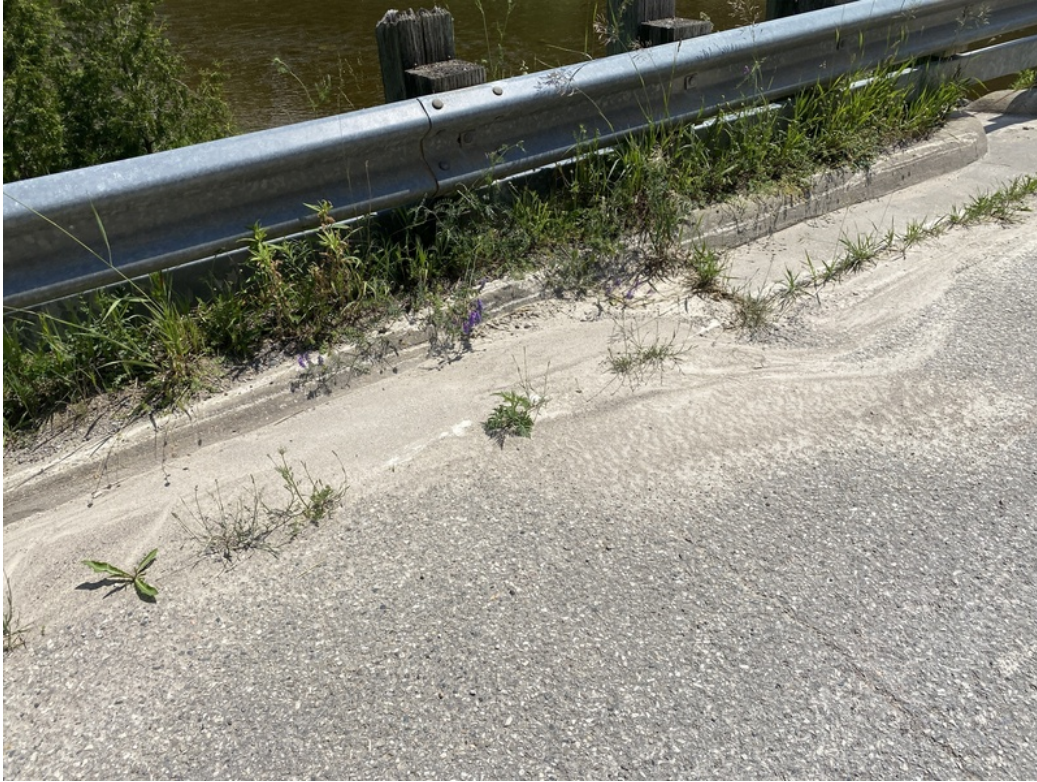
10. 6: Approach Wearing Surface (South)

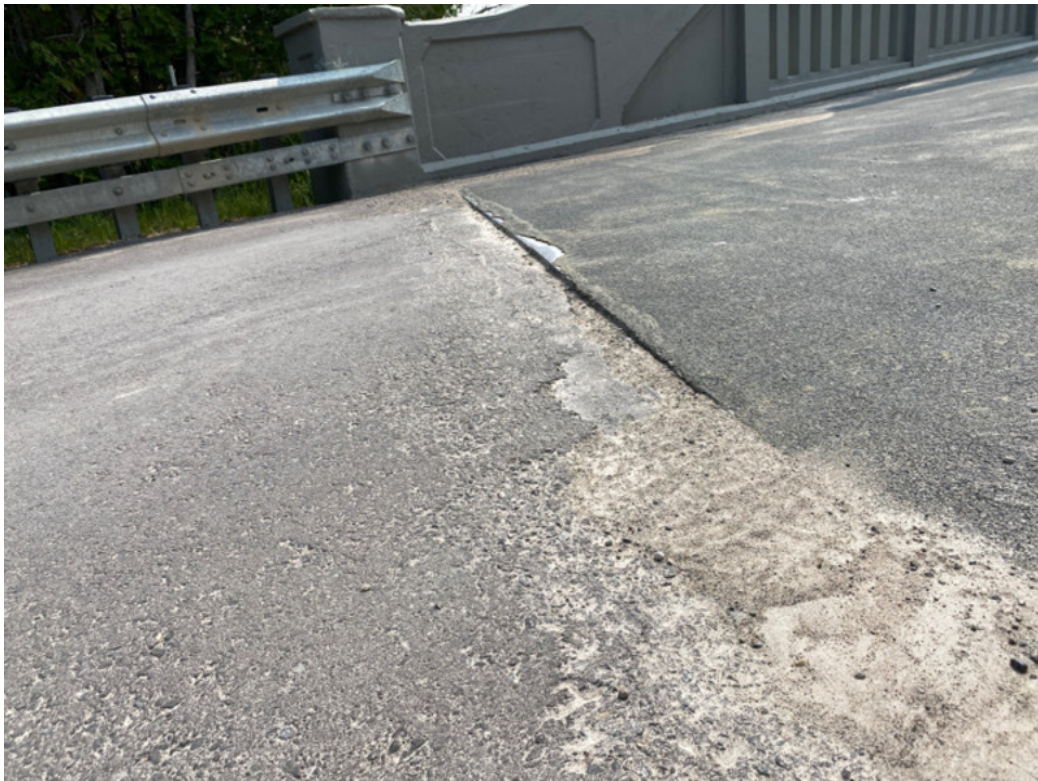
3. 7: Armouring/Retaining Device (South)

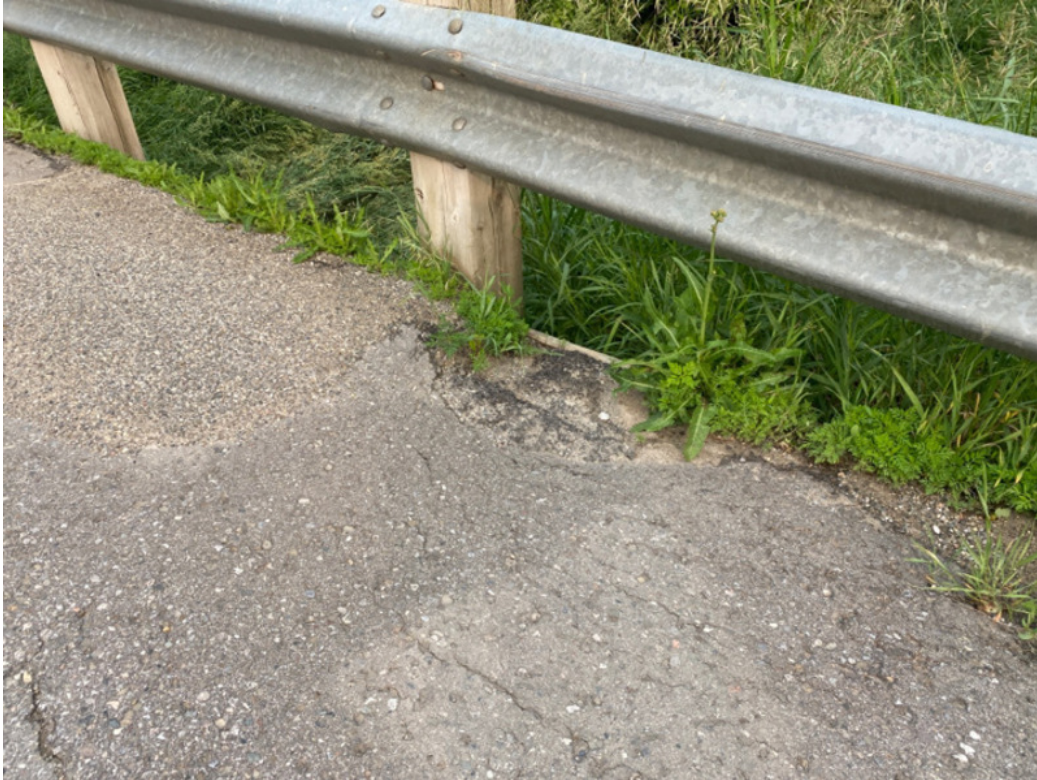
2. 31: Deck Wearing Surface (East)
