**TOWNSHIP OF EAST GARAFRAXA**  
**MARSVILLE WATER SYSTEM ASSESSMENT**

**SEPTEMBER 2025**  
**SBA File No.: M24019**

**Re:** Township of East Garafraxa, Marsville Water System Conditions Assessment Study  
Conditions Assessment Report  
SBA File No: M24019

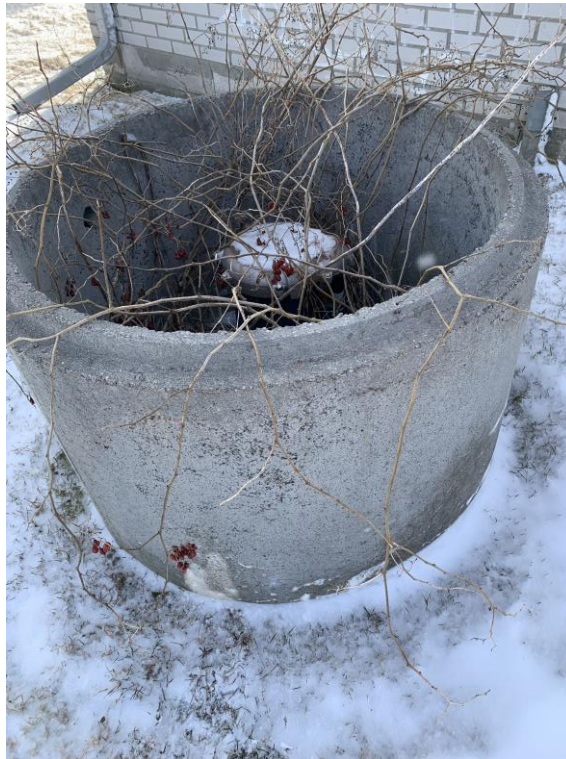
The source of water for the Marsville Subdivision DWS is ground water from a production well. The well has a 150 mm diameter casing and is drilled to a depth of 91 m (Ahmed, 2020a). It is located immediately north of the PH. It is equipped with a pitless adaptor and a submersible pump that is rated at 173 L/min (249 m<sup>3</sup>/d) with a total dynamic head (TDH) of 70 m according to the Drinking Water Works Permit No. 243-01 (Ahmed, 2020a). However, in the R.J. Burnside & Associates Limited, Water System Expansion Municipal Class Environmental Assessment (EA) Report, the pump capacity is noted to be 280 L/min at 44 m TDH (2023). Following discussions with the operator, SBA is of the opinion that these are two (2) different points on the same pump curve as the well pump has not been replaced recently. Nonetheless, the maximum permitted withdrawal under the Permit to Take Water (PTTW) (No. 8328-BQNRXE) is 365 L/min (526 m<sup>3</sup>/d) (Meek, 2020), which is a higher flow rate than the submersible pump can supply. However, it is noted that the PTTW also limits water taking to eight (8) hours per day and a maximum daily volume of 182 m<sup>3</sup>. The discharge line has a diameter of 75 mm that is connected to the well pump header in the PH (Miedema, 2024). There is a circular concrete barrier around the well to protect it from snowplows in the winter.

**Figure A.1: Production Well for the WTP**

| Item | Location | Description | Criteria | Priority | Cost Estimate |
|---|---|---|---|---|---|
| 1 | Production Well | Vegetation has grown within the concrete barrier around the existing well and is partially obstructing access. It is recommended that the vegetation is either trimmed or removed. Also, it is suggested that geotextile fabric and stone be installed around the well to help prevent future vegetative growth. | Maintenance | Medium | \$5,000.00 |

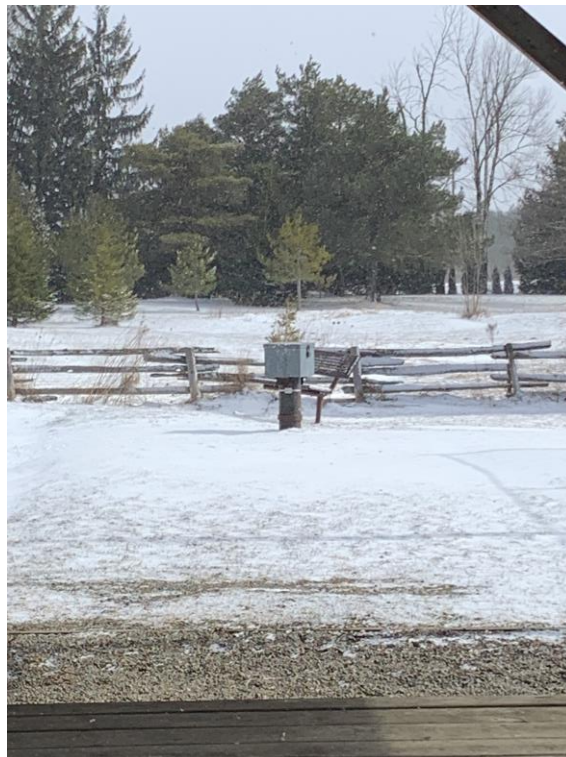
There is also another well that is currently not in use or connected to the PH. It has a 200 mm diameter steel casing and is drilled to a depth of 103 m. It is located about 10 m east of the PH and is fitted with a steel cap (Miedema, 2024). It is available for future use if required. However, the subdivision feasibility study suggests that the preferred future alternative is to develop a new well in this area and connect it to a new treatment plant rather than to use the current second well (R.J. Burnside & Associates Limited, 2023).

**Figure A.2: Second Well Near the WTP. It is not Currently Being Used, and it is Not Connected to the WTP**

| Item | Location | Description | Criteria | Priority | Cost Estimate |
|---|---|---|---|---|---|
| 2 | Future Well | The WTP currently has only one production well and therefore there is no redundancy in the raw water supply. Furthermore, the water system does not have adequate storage, hence if the production well is out of service for more than a few minutes the WTP cannot supply water. There is an additional shelf spare pump in the WTP, but the system must be put offline if the pumps are to be switched. Also, the pumps cannot be switched quickly enough to prevent disruptions to the water supply. Thus, it is recommended that the second well northeast of the WTP be retested and if possible put into production to provide redundancy with the water supply. If this well is not suitable, then an investigation and drilling of a new well should be completed in order to provide a second production well for the WTP. | Capital | High | \$250,000.00 |

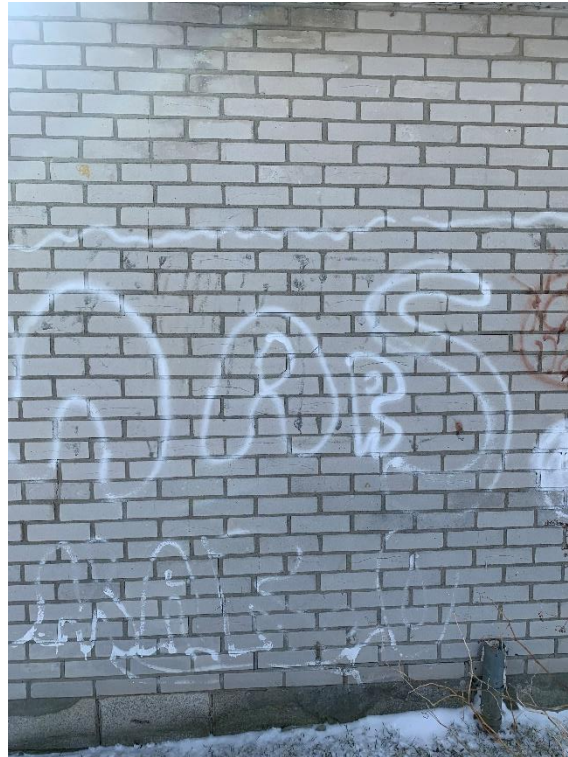
The PH building is located on the northeast end of Grand Crescent. The building itself is in relatively good condition; however, it is showing typical signs of ageing including cracks in the foundation, minor damage to exterior bricks, and minor deformation of the eavestroughs. Furthermore, the PH is small and there is no room for future expansion within the existing building. Hence, if an expansion is needed due to increased demand, a new facility will be needed.

**Figure A.3: WTP Exterior Wall Showing Ageing of Bricks and Graffiti**

| Item | Location | Description | Criteria | Priority | Cost Estimate |
|---|---|---|---|---|---|
| 3 | WTP Exterior | The WTP building is showing typical signs of ageing including cracks in the foundation, minor damage to the exterior bricks and minor deformation of eavestroughs. It is recommended the cracks are sealed, damaged bricks are replaced and damaged eavestroughs are replaced. | Maintenance | Low | \$15,000.00 |

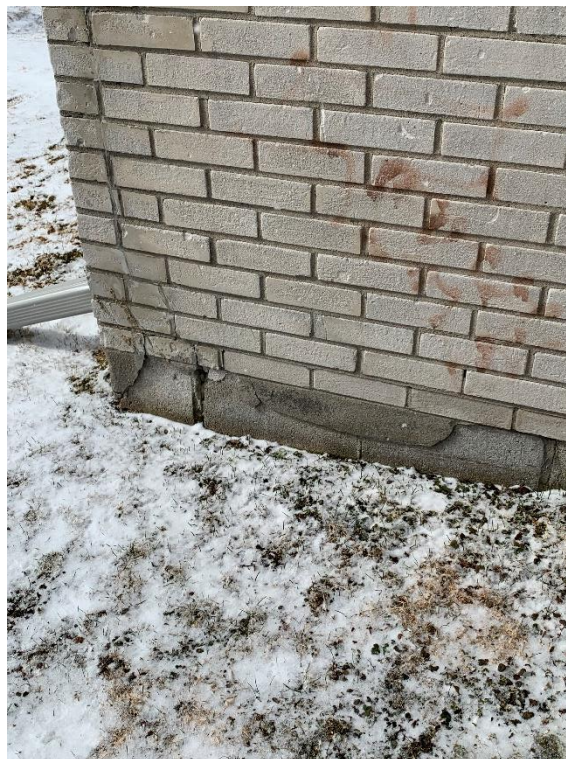
**Figure A.4: WTP Exterior Wall Showing Minor Cracks in Foundation and Damage to Bricks**

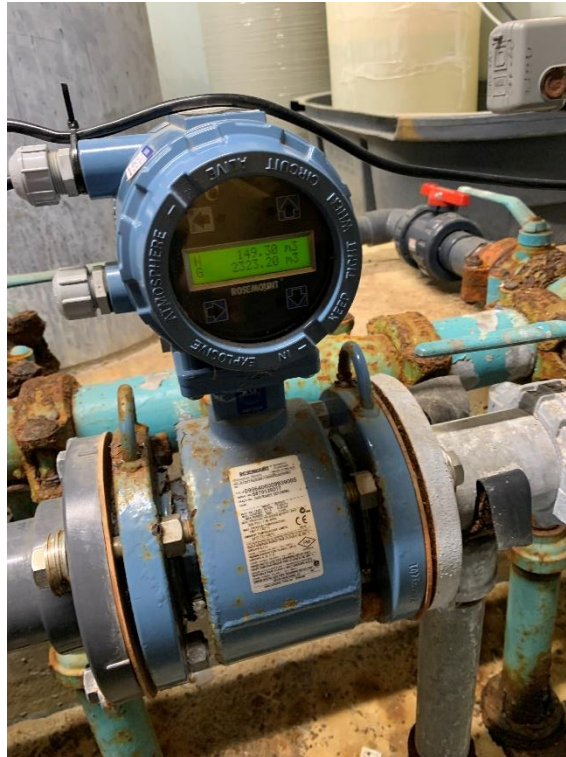
Raw water from the well enters the PH from a floor penetration near the north wall. The raw water line includes a pressure gauge, sample tap, flow control valve, backflow preventor, flow meter and injection port. Most of the raw water line is ductile iron and is noted to be the original piping. It is aged and shows signs of corrosion. However, the piping from the flow control valve to the flow meter is PVC and is in good condition. Additionally, the isolation valve downstream of the flow meter is ductile iron and is corroding, although it is still operational.

**Figure A.9: Rosemount Magnetic Flow Meter**

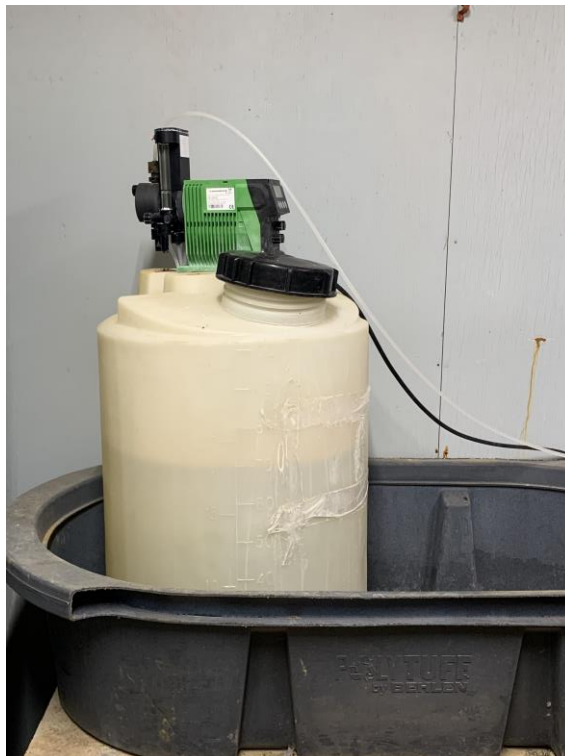
The current disinfection chemical is 12% sodium hypochlorite. The chlorine dosing system includes a 100 L sodium hypochlorite solution tank with secondary containment, a chemical metering pump, chemical discharge tubing, and an injector. The chlorination is controlled by a relay that closes when the well pump cycles (Miedema, 2024). The chemical dosing system is generally in good condition. Only one (1) metering pump was observed during the site visit. The Drinking Water Works Permit does indicate that there is a shelf spare (Ahmed, 2020a), however it is recommended that a second standby chemical metering pump be added to prevent shutdowns in the case of duty pump failure.

It is noted that since the PH is a single room building, the sodium hypochlorite is stored in the same room as the PH equipment. This is not ideal, as chemical vapours can enhance corrosion of any metallic equipment and piping. The MECP *Design Guidelines for Drinking-Water Systems* does mention that “the chemical storage area should be segregated from the main areas of the treatment plant” (2008). Although the chemicals do have adequate secondary storage and are in a corner of the building closer to the pressure tanks than the distribution header, it is recommended to have a separate room for chemical storage. This would improve safety and the longevity of equipment and piping. However, as this is a best practice and not mandatory, SBA has not included this on our costed list of recommended upgrades. Also, as previously noted, it would be difficult to expand the footprint of the PH at its existing location to include a new chemical storage room.

**Figure A.12: Sodium Hypochlorite Storage Tank and Secondary Containment Container. The Duty Chemical Metering Pump is Located on top of the Storage Tank**

1. Replace the eyewash bottles with an eyewash station to improve operator safety when working with the sodium hypochlorite.
2. Install a permanent emergency back-up generator to prevent disruptions to water supply during power outages.
3. Either connect the currently offline future well northeast of the PH or develop another well to connect to the PH to provide redundancy in raw water pumping. For the purpose of this report, we have carried the cost for future testing and connection of the existing offline well located near the PH to satisfy the MECP firm capacity recommendations.
4. Install a second chemical metering pump for dosing sodium hypochlorite to provide redundancy in chemical dosage.

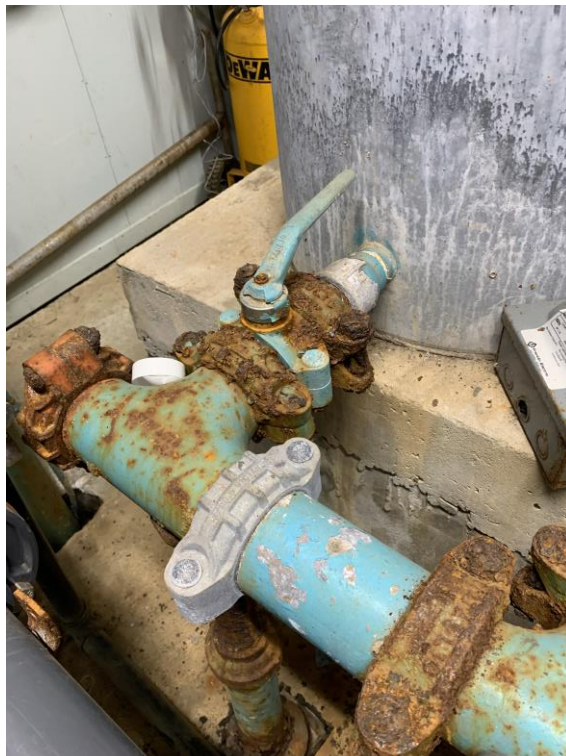
The header piping to the west that connects the two (2) older pressure tanks is galvanized iron piping, and is showing signs of ageing, namely corrosion. Several isolation butterfly valves are visibly corroding although they are still operational. Nonetheless, it is recommended that the galvanized piping and valves are replaced to ensure smooth operation and prevent future issues. The PVC piping and valves to the east that connects the newer pressure tanks are in good condition. All four of the pressure tanks are working properly and the operator did not note any concerns with their condition or operational performance.

**Figure A.14: Northwest Pressure Tank Butterfly Isolation Valve. The Valve is Significantly Corroded but Still Operational**

| Item | Location | Description | Criteria | Priority | Cost Estimate |
|---|---|---|---|---|---|
| 4 | WTP Interior | The galvanized raw water header line and piping to the two older pressure tanks are showing signs of ageing and corrosion. The associated victaulic couplings and isolation valves are also showing signs of ageing and corrosion. As well, the older pressure tanks are nearing the end of their service life and should be replaced prior to failure. It is recommended that the older galvanized piping and valves are replaced with stainless steel and the two older pressure tanks are replaced with new models. | Capital | High | \$50,000.00 |

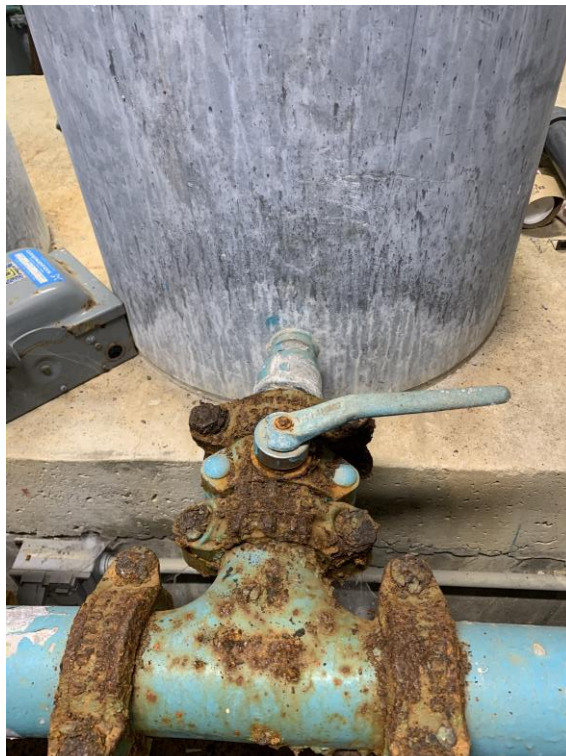
**Figure A.16: Southwest Pressure Tank Butterfly Isolation Valve. The Valve is Significantly Corroded but Still Operational**

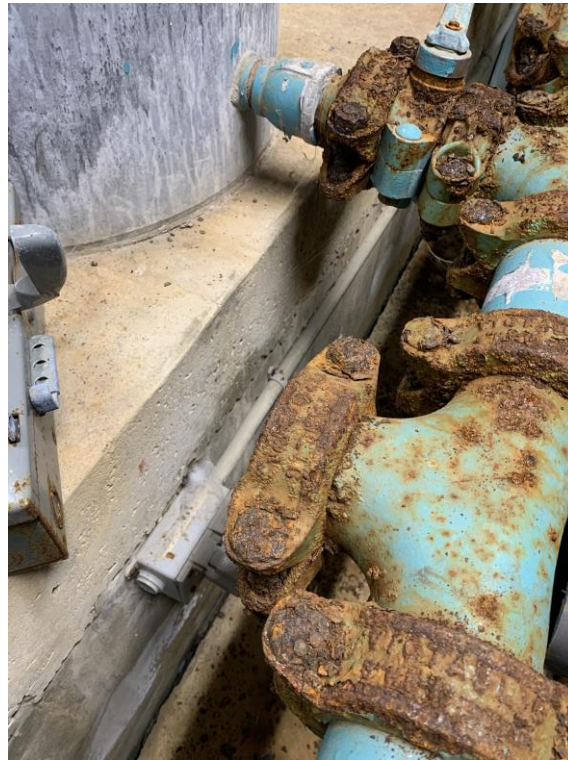
**Figure A.17: Header Piping to the Two West (Older) Pressure Tanks. The Piping Shows Significant Corrosion**
