BUILDING CONDITION ASSESSMENT

MEETING HALL & COMMUNITY CENTRE

191282 13TH LINE
EAST GARAFRAXA, ONTARIO

December 15, 2023

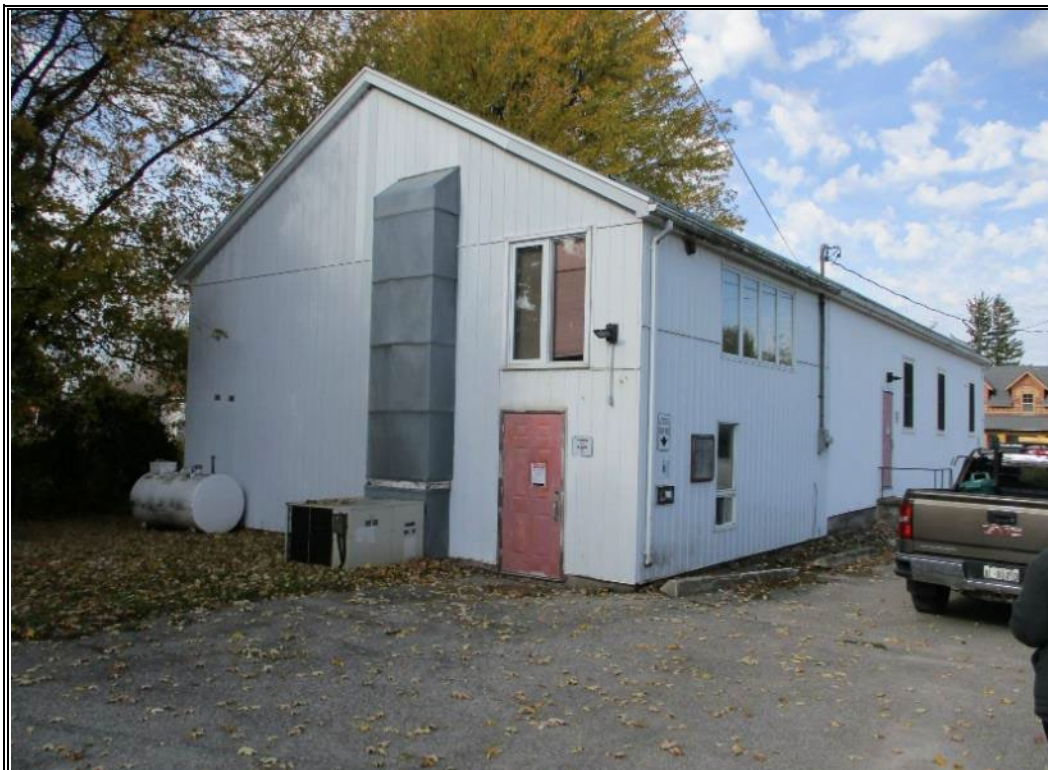
East and south elevations of the community hall.

It was reported that the air conditioner has not been working for multiple years.

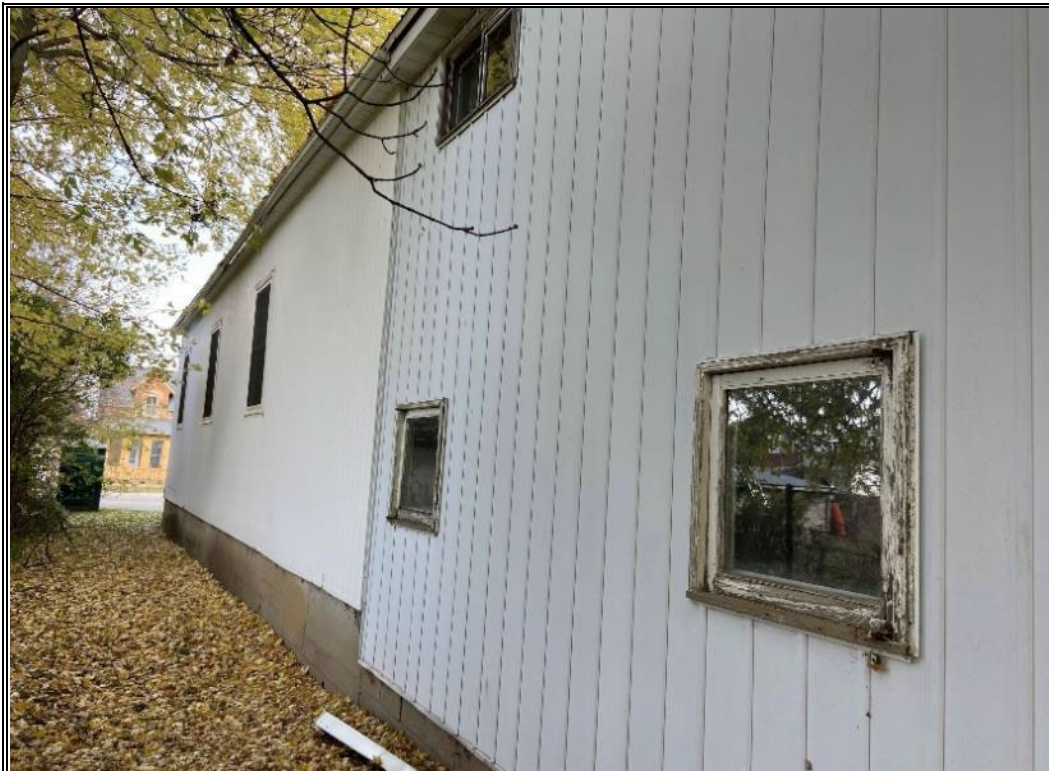
West (rear) elevation of the community hall.

The foundation walls are concrete block and cast in place concrete.

Windows are aged, and wood framing is in poor condition.

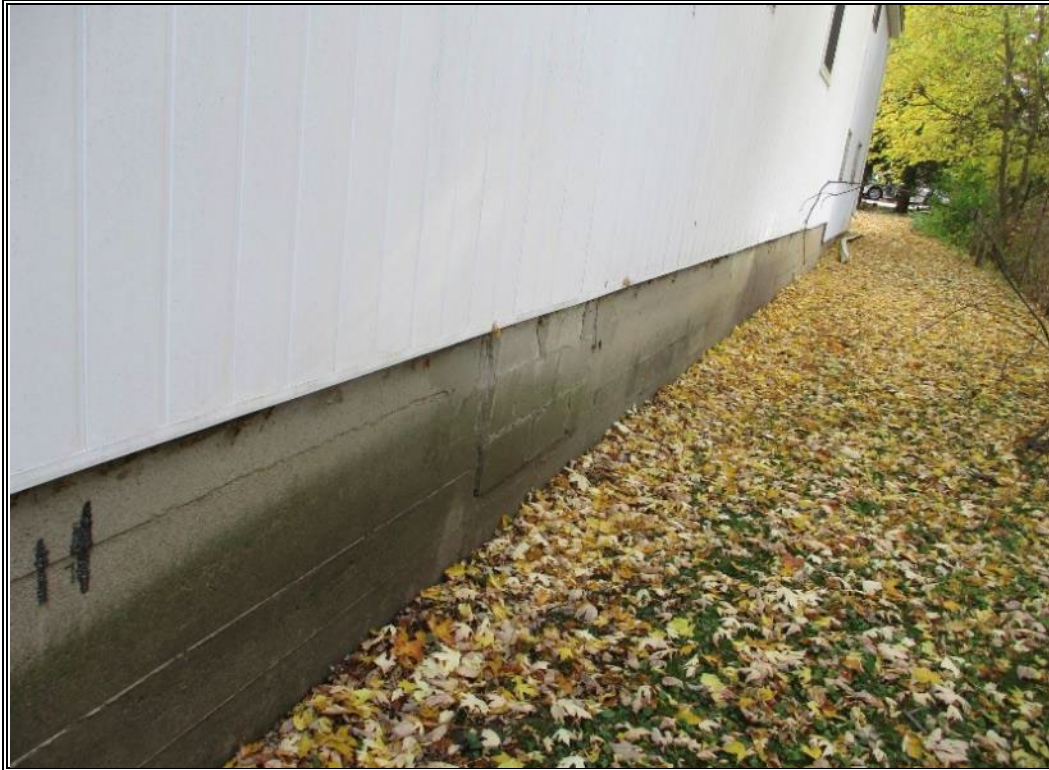
A foundation wall opening is closed with concrete block.

The exposed foundation walls are stained.

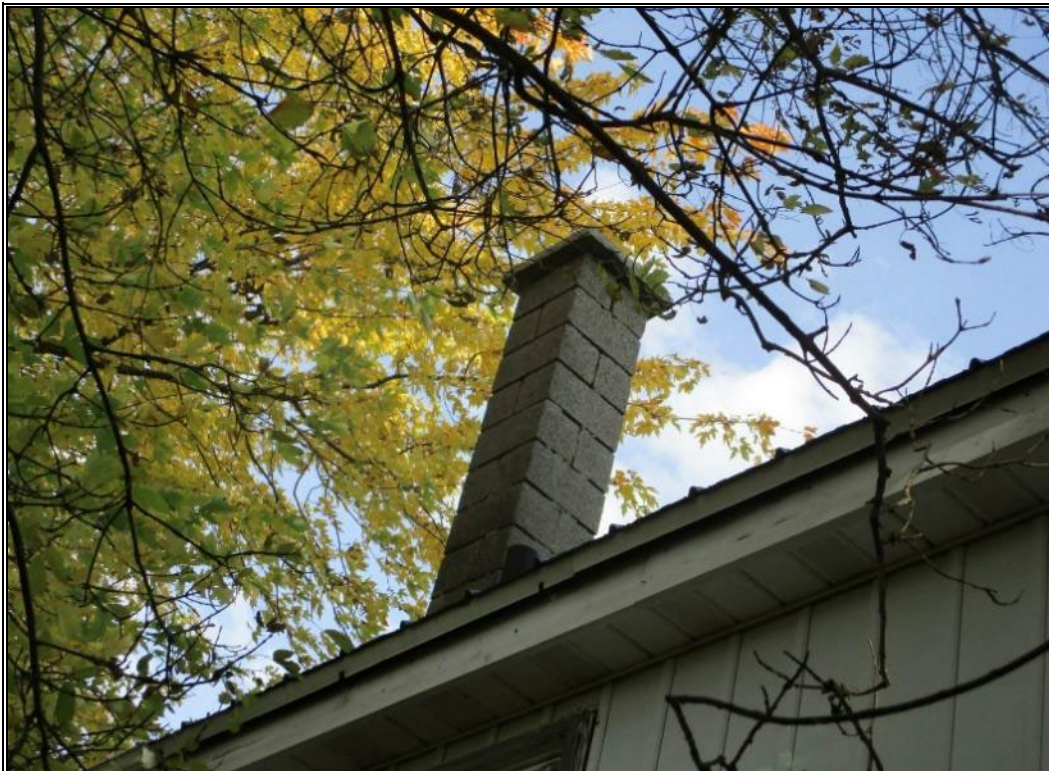
The chimney is brick.

The mortar between the bricks appears to be deteriorated.

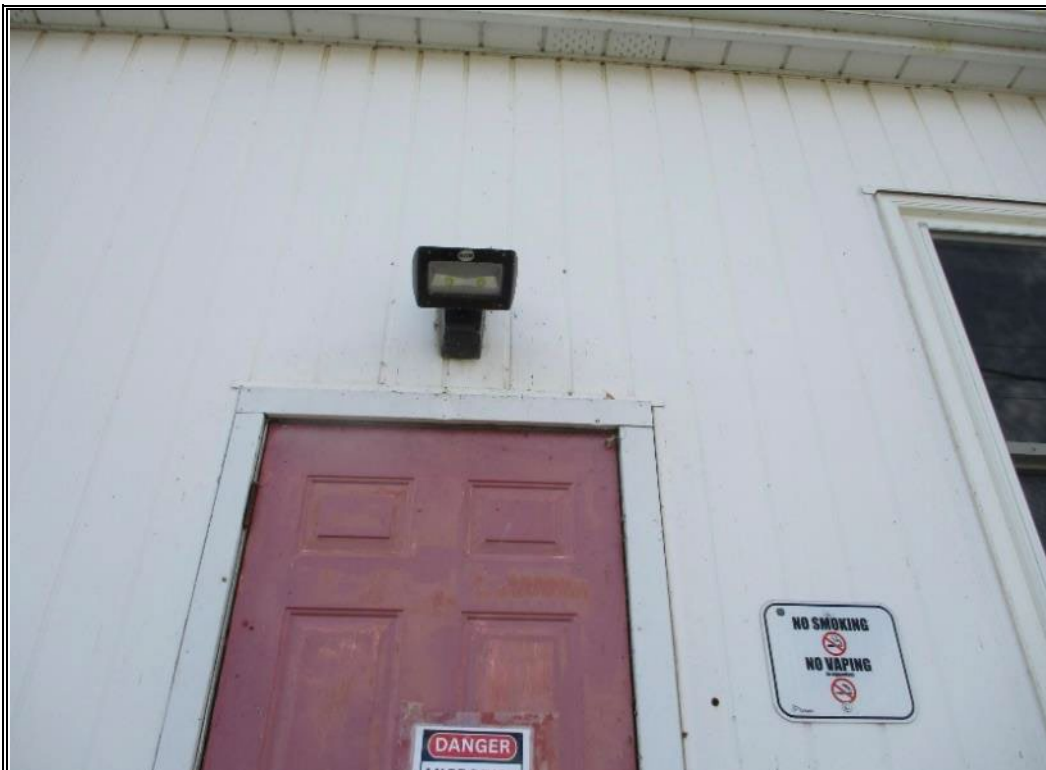
The side entrance has exterior LED lighting.

Paint coatings of service doors are aged/deteriorated.

Door hardware is rusted.

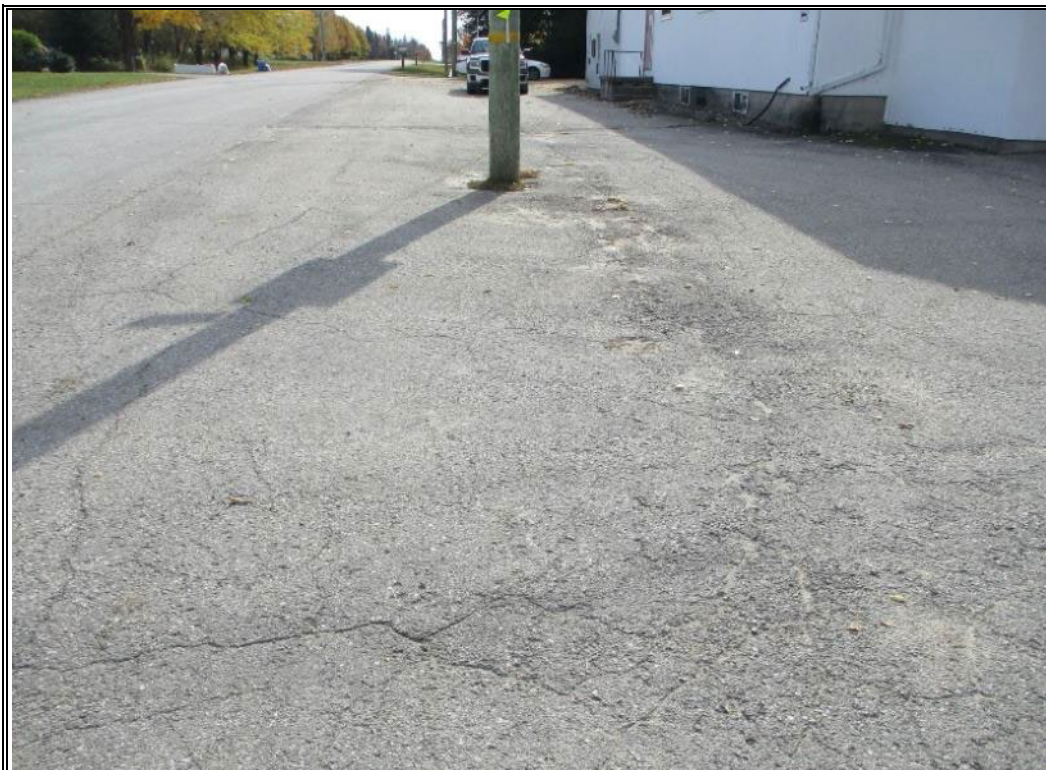
Asphalt pavement.

The asphalt driveway and parking area is aged and in poor condition with deterioration in the form of cracking, alligatoring, raveling and moss/grass growing at some locations.

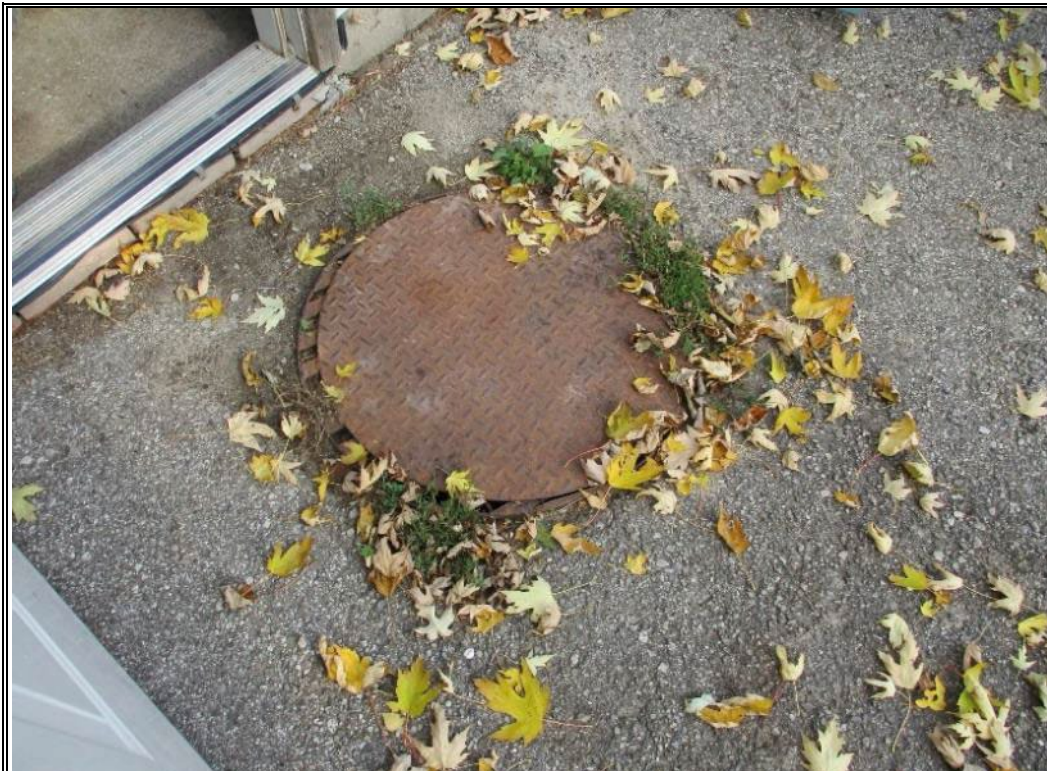
A drain that collects stormwater and releases it to the soil. The drain has a cover, and vegetation is growing in the gaps.

The bricks under the doorway are deteriorated and allow water to pass inside the hall.

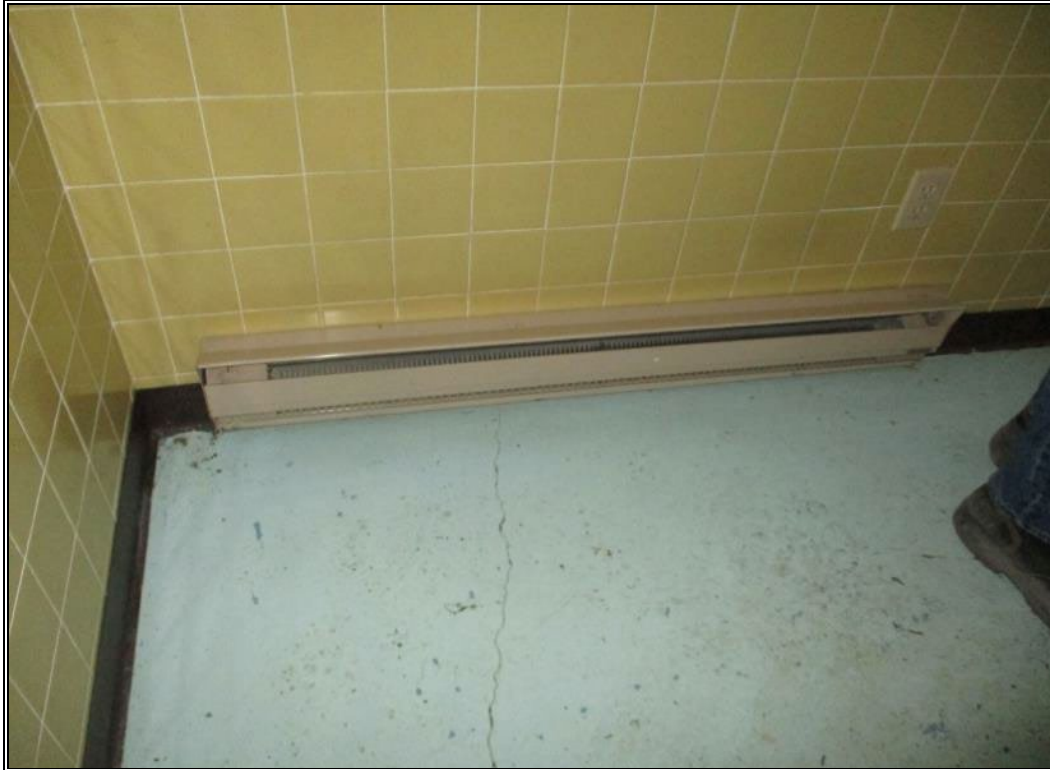
Supplemental electric baseboard heating is provided.

The concrete floors are cracked.

Paint coatings are deteriorated.

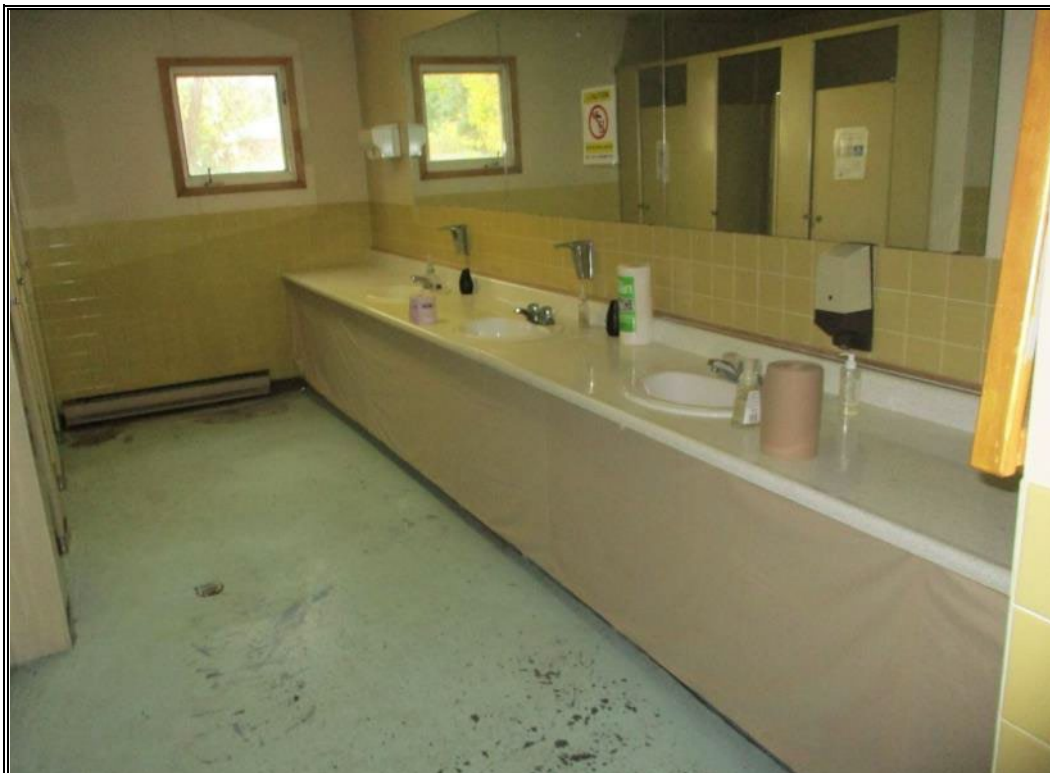
The washrooms finishes are composed of typical ceramic tile walls, painted gypsum walls and ceilings, toilets and stalls, sinks, mirrors, faucets, and countertops and painted concrete floors.

Paint coatings are deteriorated.

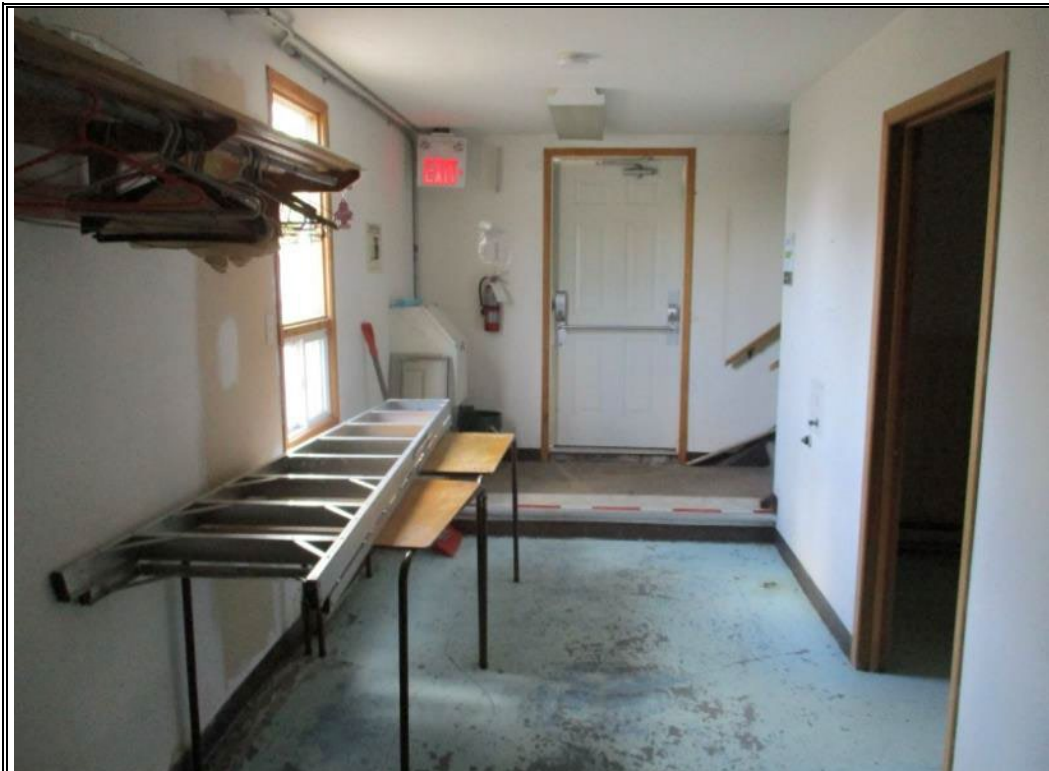
Description:
There is exit
signage and a fire
extinguisher at the
entrance.

The floor is
concrete, and the
walls are painted
drywall.

The paint on the
floor is damaged.
The walls have
inconsistent paint.

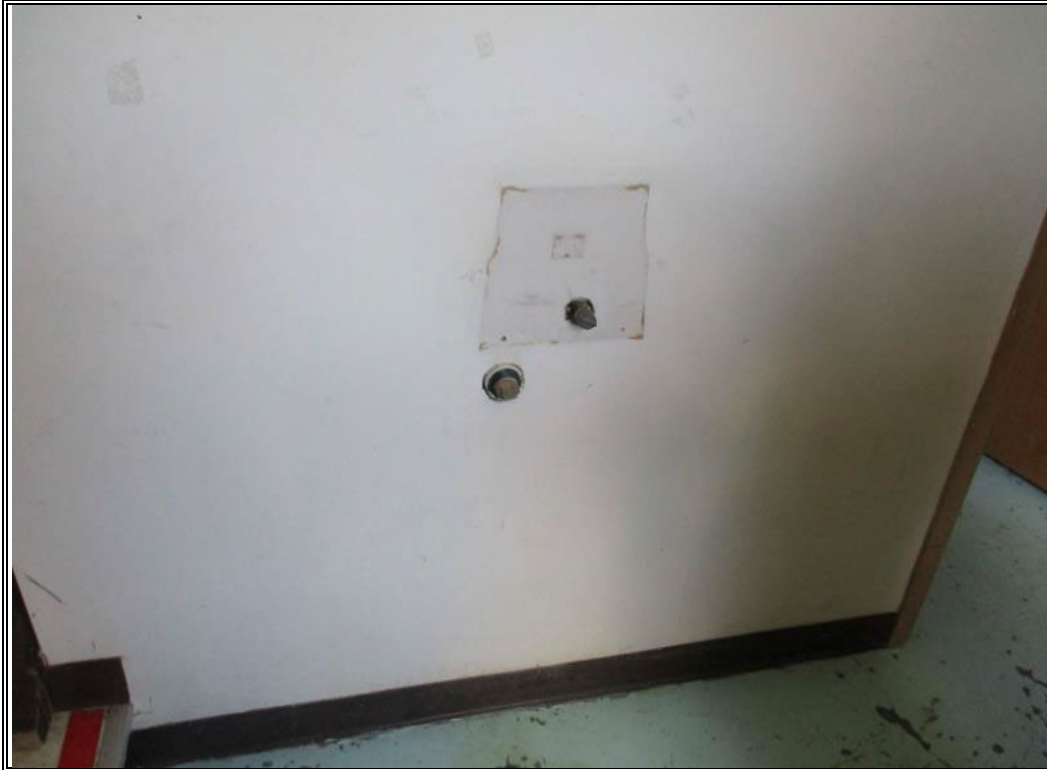
There is an abandoned plumbing connection.

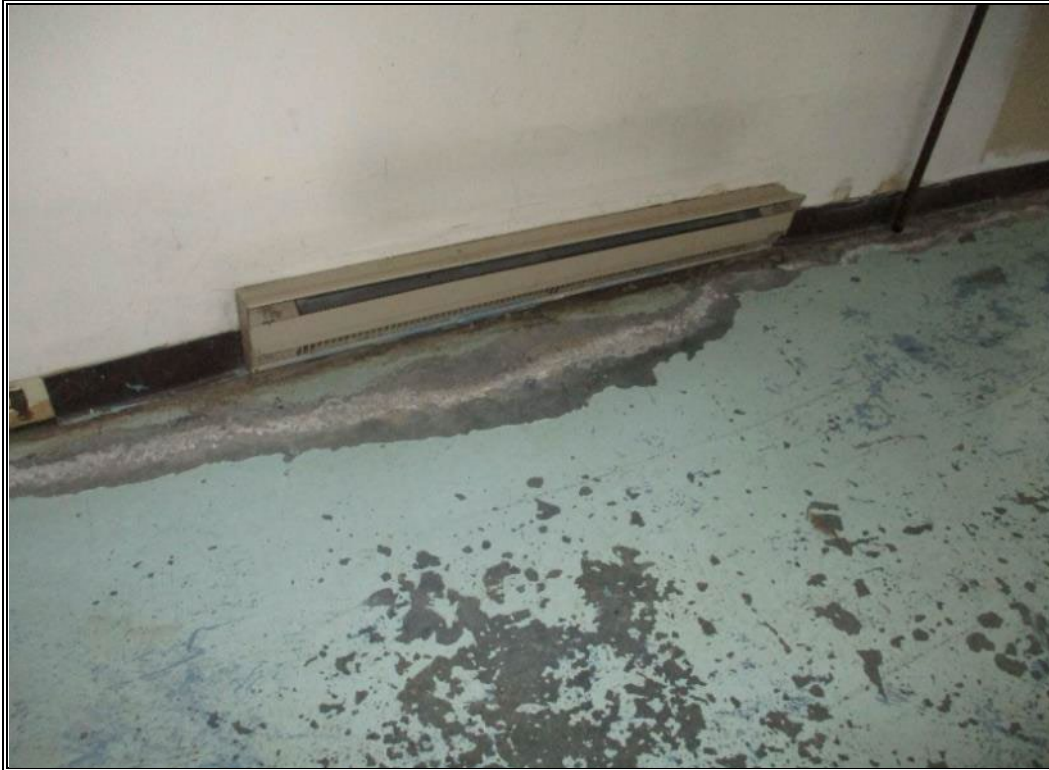
The entrance has electric baseboard heating.

The floor finish is deteriorated.

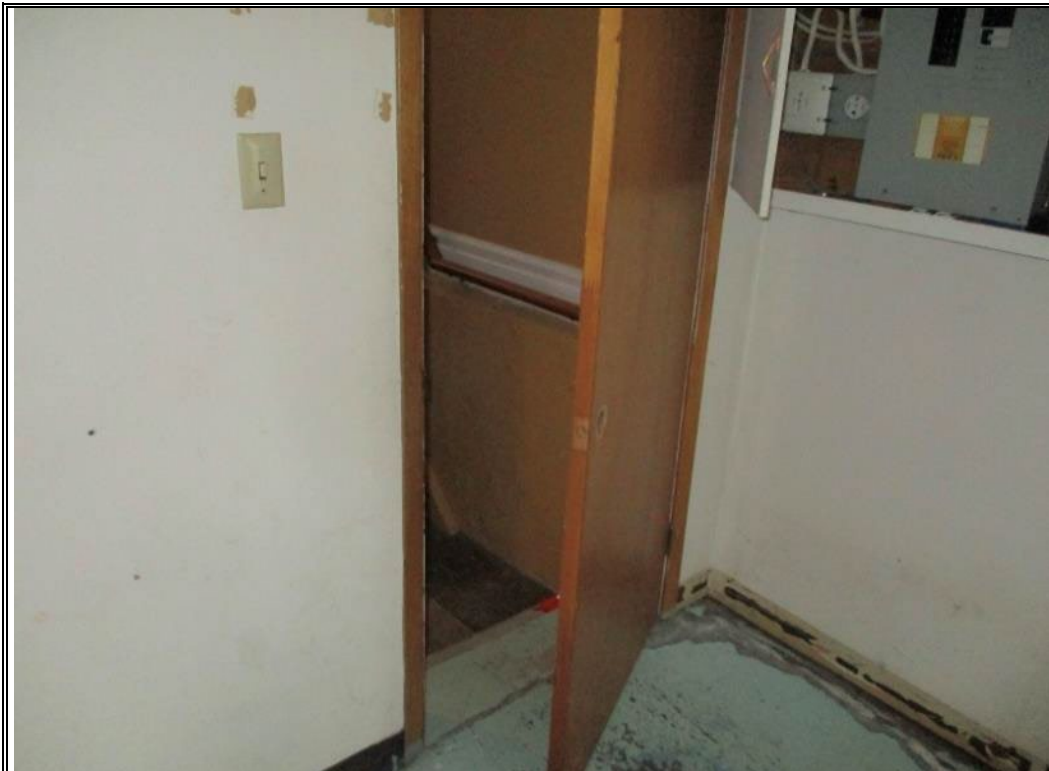
Wood door to corridor.

The door is missing handle fixtures.

The paint finishes are damaged/deteriorated.

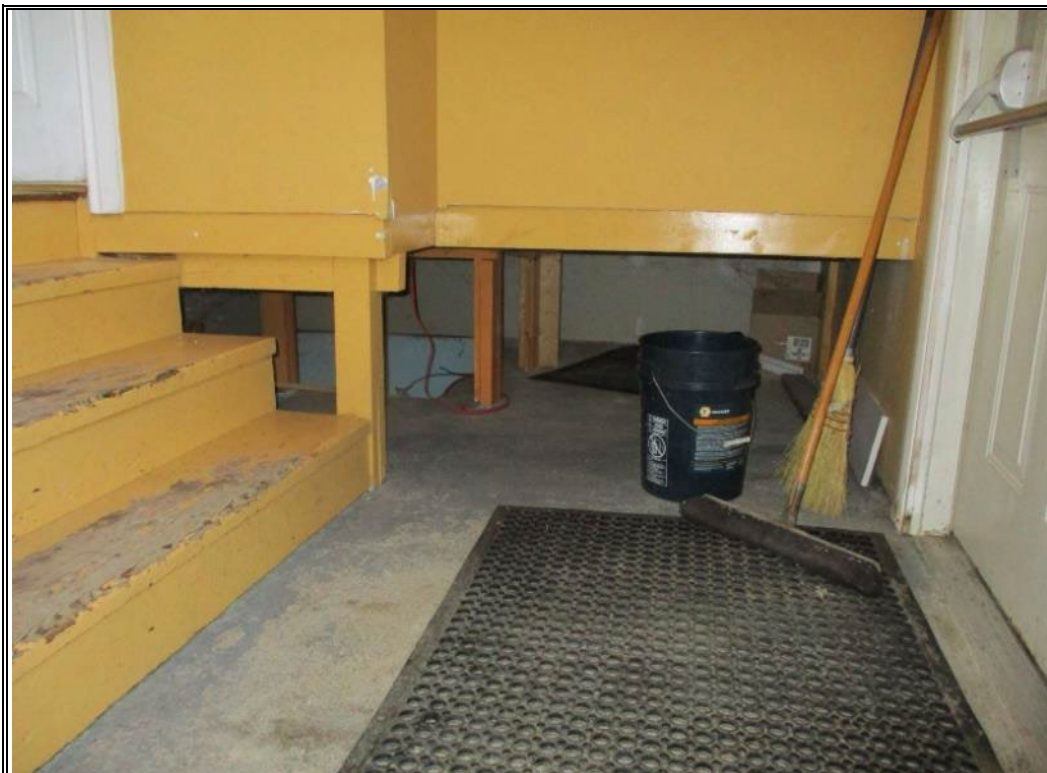
A portion of the main level corresponding to the serving room is elevated on wood framing. There appear to be abandoned stairs to the basement below. The serving room appears to be retrofit work.

The paint on the wood stairs and the concrete floor is deteriorated.

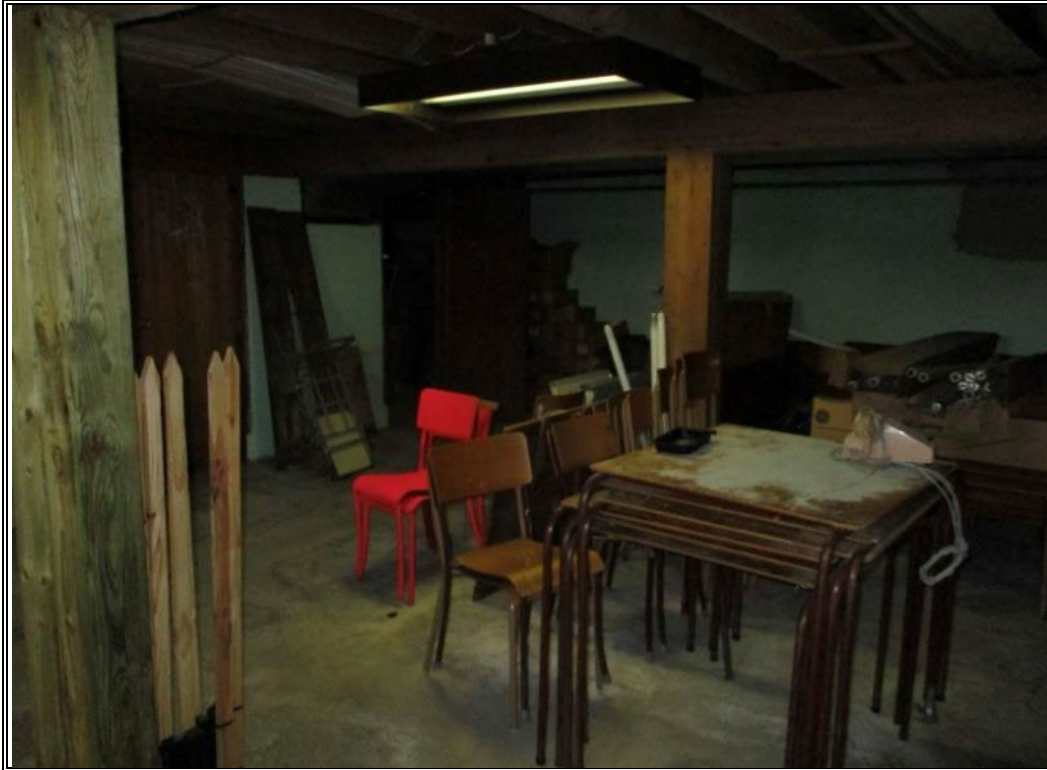
Basement. The columns, beams, and joists are wood.

The basement is used primarily for storage. Basement finishes are in poor condition.

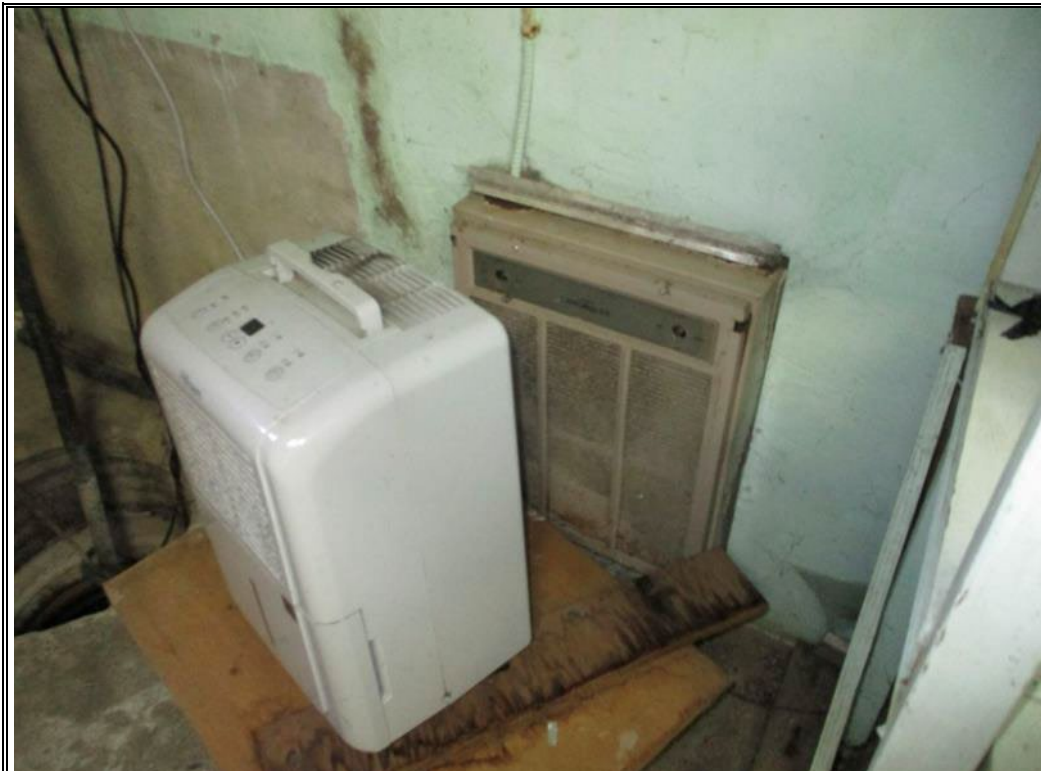
The basement has supplemental electric heating.

There is localized water penetration staining on the walls.

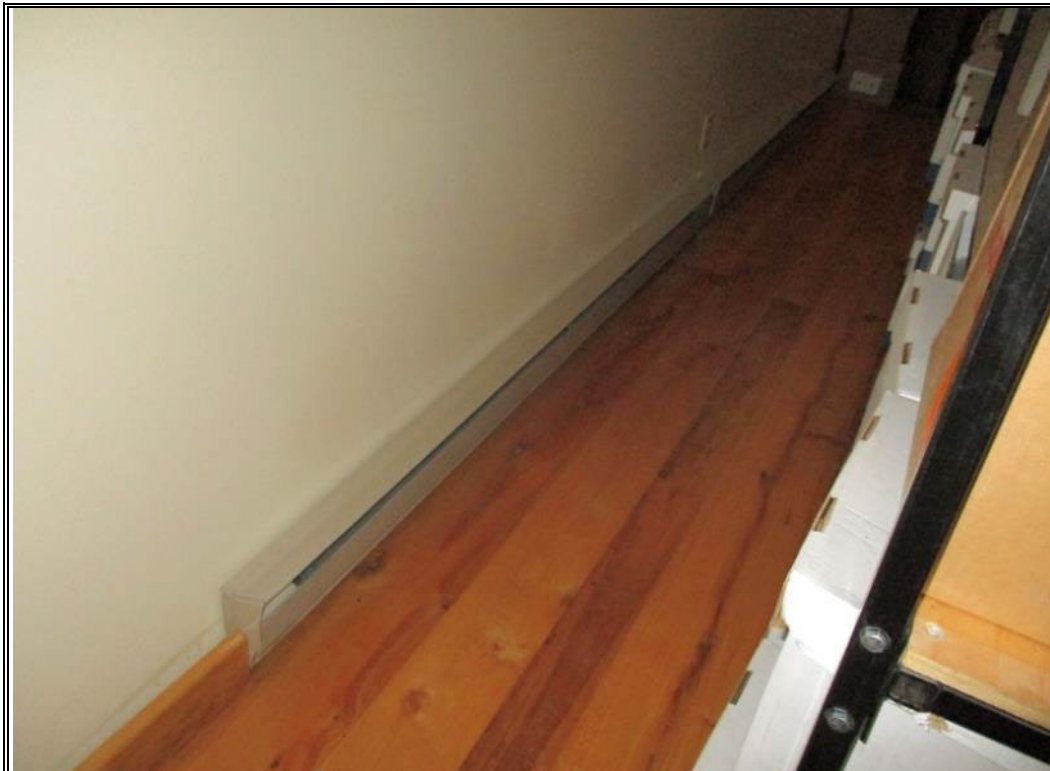
Supplemental electric baseboard heating and heating from the oil furnace is provided.

There is hardwood flooring that is in poor condition.

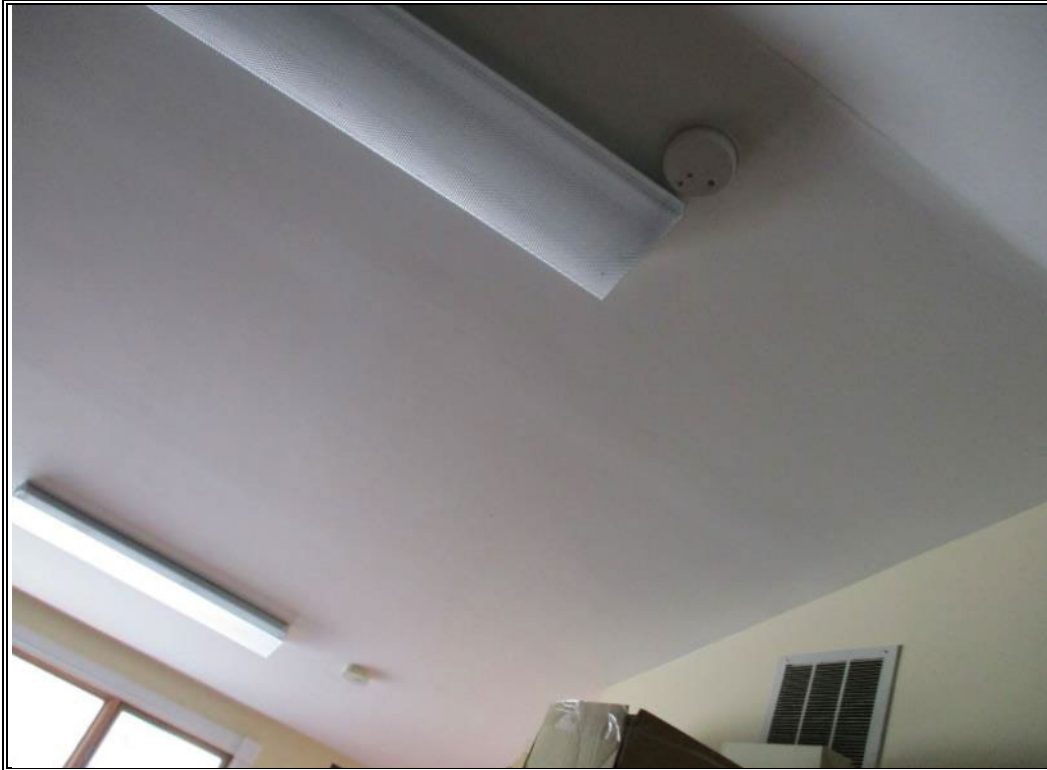
The office has a smoke/carbon monoxide detector.
