BURNSIDE

2023 OSIM Bridge Inspections Report

**Township of East Garafraxa
065371 Dufferin County Road 3, Unit 2
East Garafraxa, ON L9W 7J8**

**January 2024
300053343.2023**

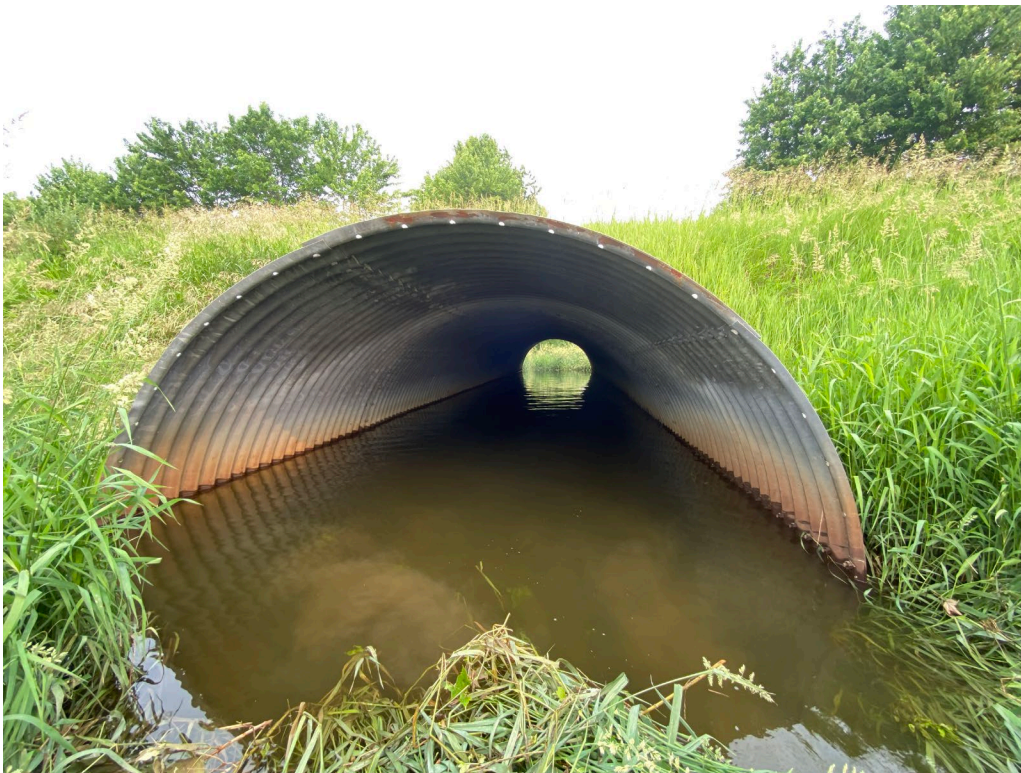
1.1 Structure No. 0001

<u>Structure Name:</u>	Culvert 0001	2023 BCI =60.30
<u>Road Name:</u>	20th Side Rd	
<u>Location:</u>	Concession 10, Lots 20 & 21 (East Garafraxa, in Dufferin County)	
<u>Structure Type:</u>	CSP Ellipse Culvert(s)	
<u>Number of Spans:</u>	1	<u>Span Lengths:</u> 3.9 m
<u>Overall Structure Width:</u>	21.2 m	<u>Roadway Width:</u> 7 m
<u>Year of Construction:</u>	1976	<u>Current Load Limit:</u>

Recommendation:	Structure replacement recommended within 10 years.
------------------------	---

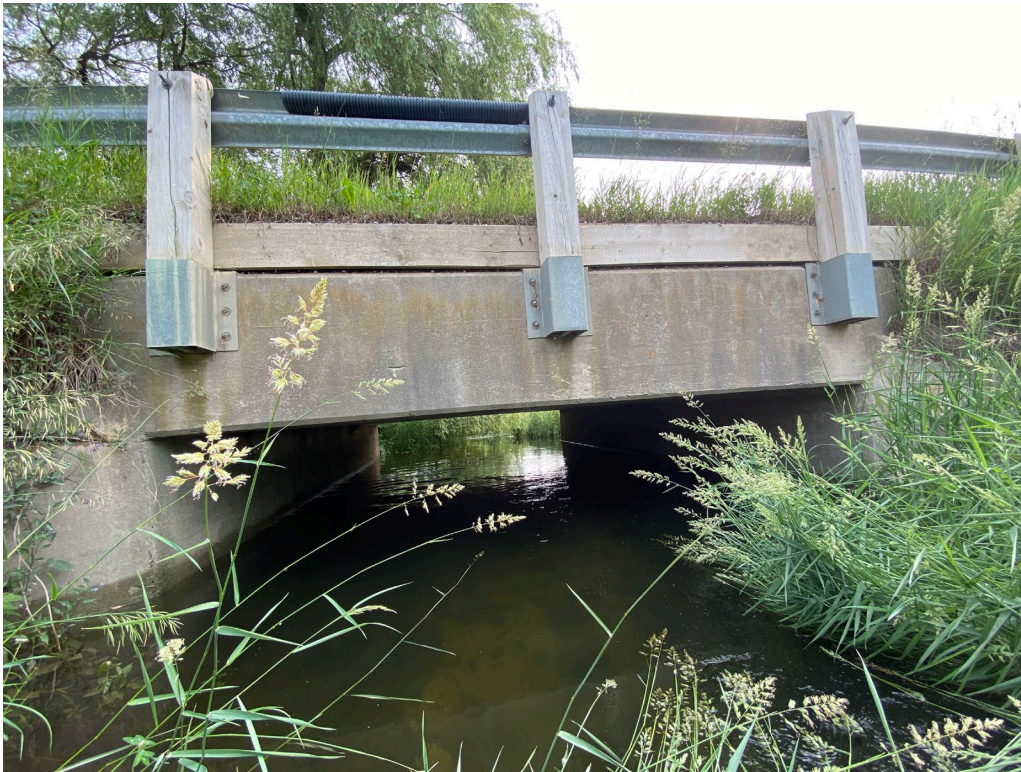
1.2 Structure No. 0002

<u>Structure Name:</u>	Structure 0002	2023 BCI =73.71
<u>Road Name:</u>	10th Line	
<u>Location:</u>	Concession 10 & 11, Lot 16 East Garafraxa	
<u>Structure Type:</u>	Cast-In-Place Conc. Rigid Frame	
<u>Number of Spans:</u>	1	<u>Span Lengths:</u> 4.3 m
<u>Overall Structure Width:</u>	7.5 m	<u>Roadway Width:</u> 6 m
<u>Year of Construction:</u>	1950	<u>Current Load Limit:</u>

Recommendation:	No Capital Works is estimated to be required within the next 10 years.
------------------------	---

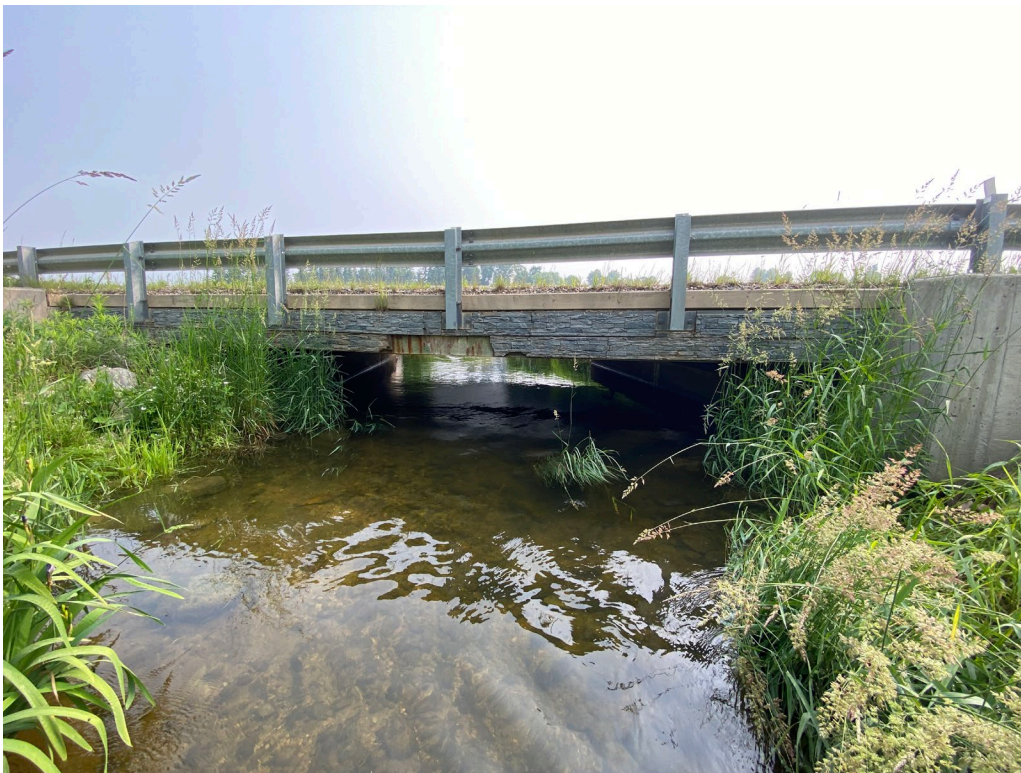
1.3 Structure No. 0003

<u>Structure Name:</u>	Bridge 0003	2023 BCI =97.62
<u>Road Name:</u>	10th Line	
<u>Location:</u>	Concession 10, Lots 20 & 21 (East Garafraxa, in Dufferin County)	
<u>Structure Type:</u>	Other - Prefabricated Fibreglass Bridge	
<u>Number of Spans:</u>	1	<u>Span Lengths:</u> 8.5 m
<u>Overall Structure Width:</u>	7.5 m	<u>Roadway Width:</u> 7 m
<u>Year of Construction:</u>	2015	<u>Current Load Limit:</u>

Recommendation:	Minor Rehabilitation is recommended within 3 years.
------------------------	--

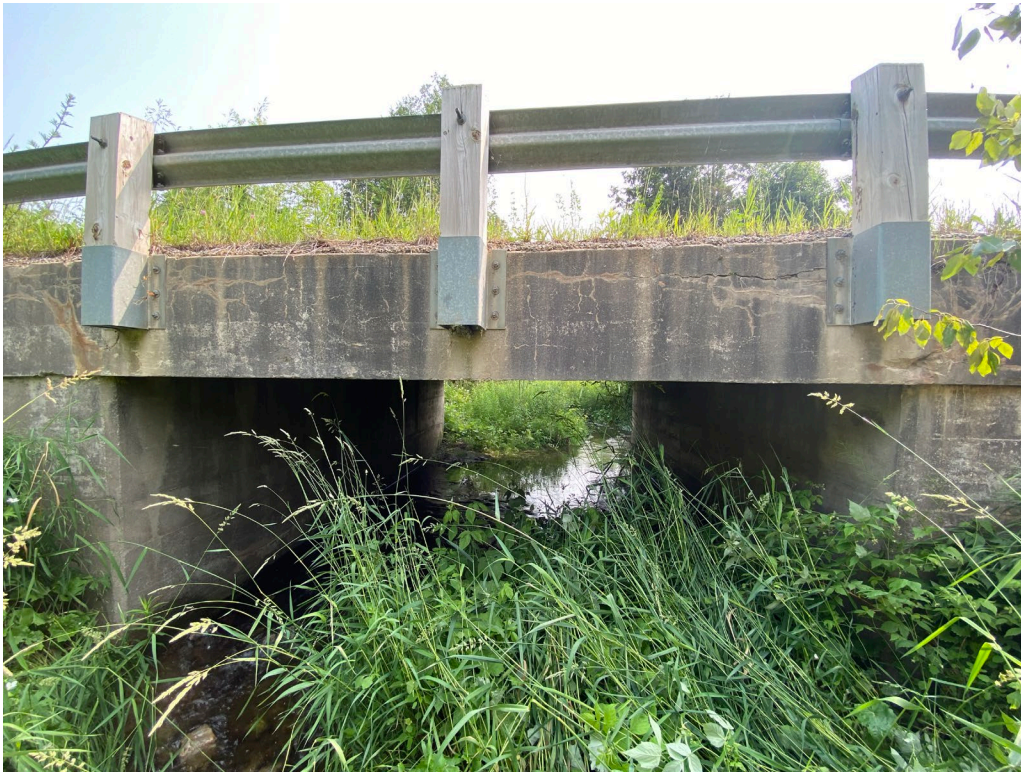
1.4 Structure No. 0004

<u>Structure Name:</u>	Culvert 0004	2023 BCI =73.63
<u>Road Name:</u>	11th Line	
<u>Location:</u>	Concession 11 & 12, Lot 16 East Garafraxa	
<u>Structure Type:</u>	Cast-In-Place Conc. Rigid Frame	
<u>Number of Spans:</u>	1	<u>Span Lengths:</u> 4.4 m
<u>Overall Structure Width:</u>	7.3 m	<u>Roadway Width:</u> 7 m
<u>Year of Construction:</u>	1945	<u>Current Load Limit:</u>

Recommendation:	No Capital Works is estimated to be required within the next 10 years.
------------------------	---

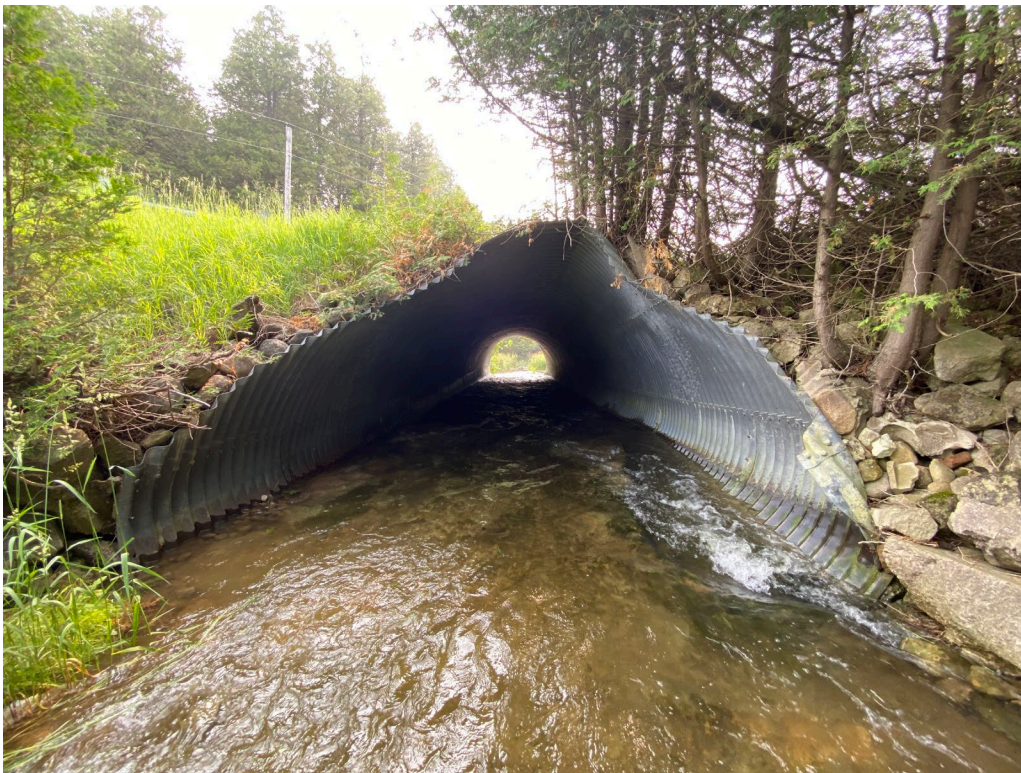
1.5 Structure No. 0005

<u>Structure Name:</u>	Culvert 0005	2023 BCI =44.10
<u>Road Name:</u>	10th Line	
<u>Location:</u>	Concession 10 & 11, Lot 14 (East Garafraxa, in Dufferin County)	
<u>Structure Type:</u>	CSP Multi-Plate Ellipse Culvert(s)	
<u>Number of Spans:</u>	1	<u>Span Lengths:</u> 4.6 m
<u>Overall Structure Width:</u>	28.1 m	<u>Roadway Width:</u> 6.5 m
<u>Year of Construction:</u>	1972	<u>Current Load Limit:</u>

Recommendation:	Structure replacement is recommended within 2 years.
------------------------	---

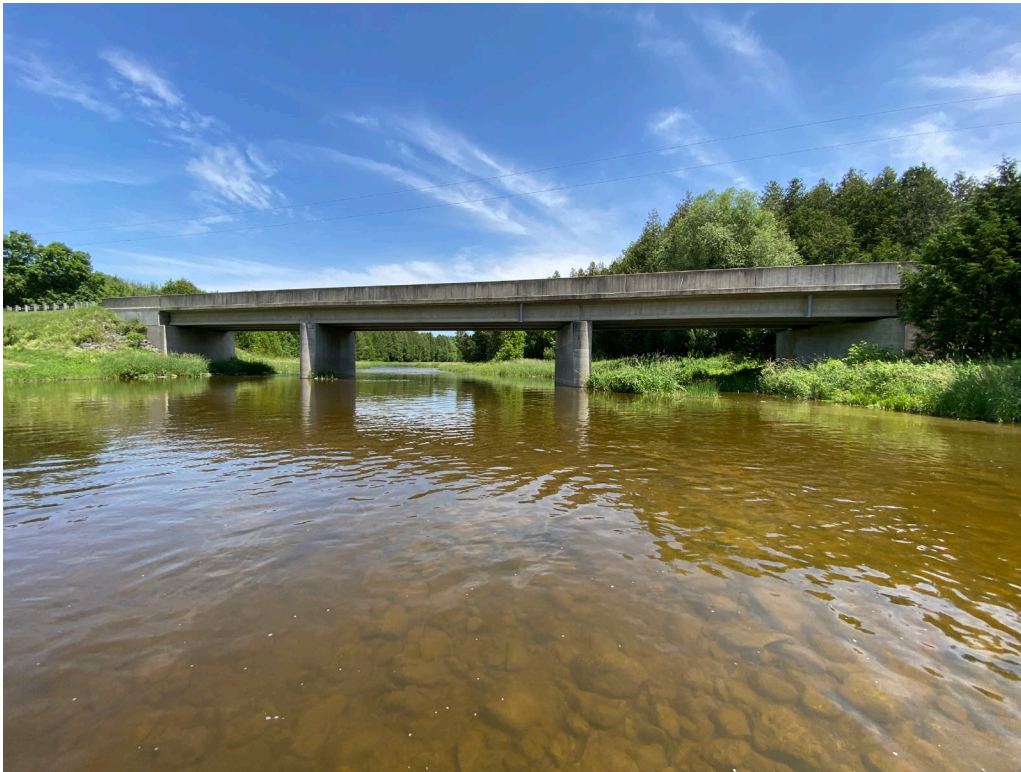
1.6 Structure No. 0006

<u>Structure Name:</u>	Bridge 0006	2023 BCI =74.65
<u>Road Name:</u>	11th Line	
<u>Location:</u>	Concession 11 & 12, Lot 15 East Garafraxa	
<u>Structure Type:</u>	Precast Concrete I-Girder	
<u>Number of Spans:</u>	3	<u>Span Lengths:</u> 15.8, 22.0,15.8 m
<u>Overall Structure Width:</u>	9.3 m	<u>Roadway Width:</u> 7 m
<u>Year of Construction:</u>	1987	<u>Current Load Limit:</u>

Recommendation:	No Capital Works estimated to be required within 10 years. Future structure rehabilitation should be considered.
------------------------	---

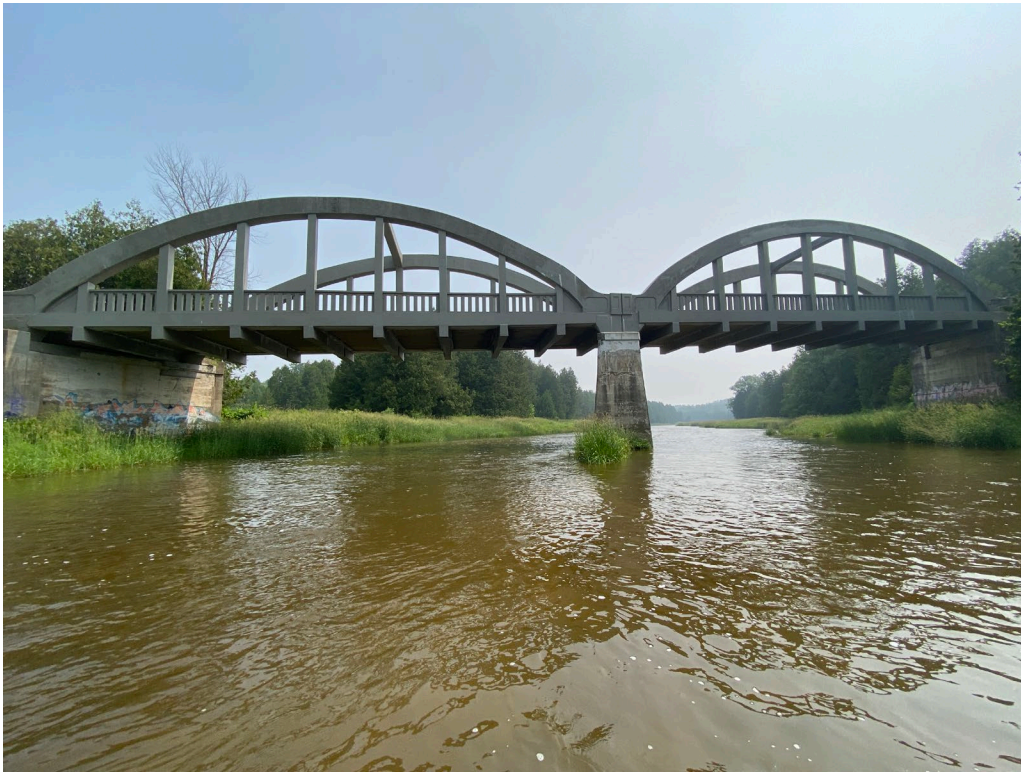
1.7 Structure No. 0007

<u>Structure Name:</u>	Bridge 0007	2023 BCI =80.92
<u>Road Name:</u>	12th Line	
<u>Location:</u>	780 m South of County Road 5	
<u>Structure Type:</u>	Bowstring Arch (Concrete)	
<u>Number of Spans:</u>	2	<u>Span Lengths:</u> 26, 26 m
<u>Overall Structure Width:</u>	6.706 m	<u>Roadway Width:</u> 8 m
<u>Year of Construction:</u>	1926	<u>Current Load Limit:</u>

Recommendation:	Forgo rehabilitation and replace structure in future (replacement timeline estimated to exceed 10 years).
------------------------	--

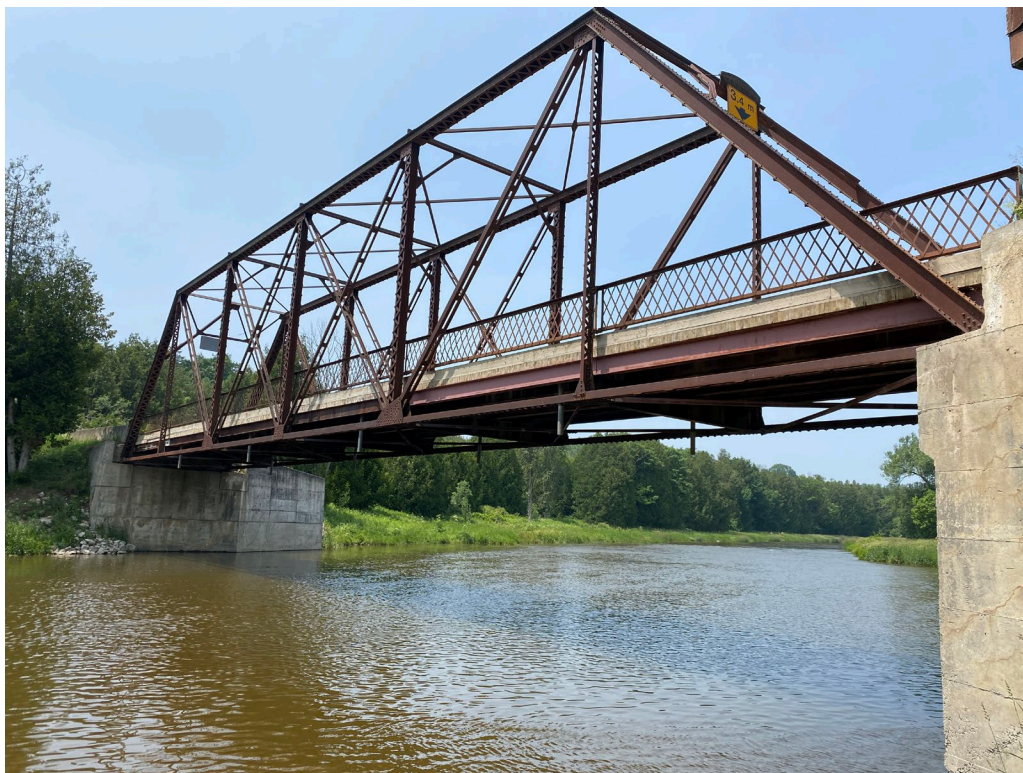
1.8 Structure No. 0008

<u>Structure Name:</u>	Bridge 0008	2023 BCI =51.49
<u>Road Name:</u>	13th Line	
<u>Location:</u>	13th Line, Concession 13 & 14, Lot 14, Approx. 0.8 km South of Sideroad 15	
<u>Structure Type:</u>	Steel Truss (Timber Deck)	
<u>Number of Spans:</u>	1	<u>Span Lengths:</u> 36.5 m
<u>Overall Structure Width:</u>	4.27 m	<u>Roadway Width:</u> 3.9 m
<u>Year of Construction:</u>	1913	<u>Current Load Limit:</u> 12/16/25 tonnes

Recommendation:	Forgo rehabilitation and replace structure within 5 years.
------------------------	---

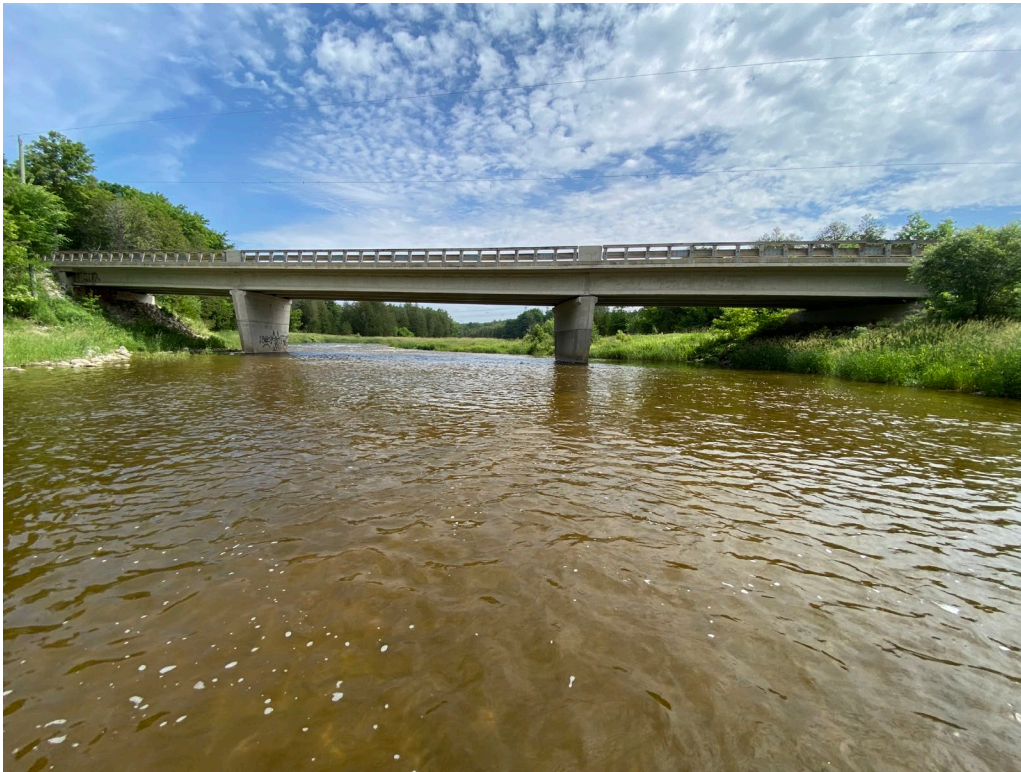
1.9 Structure No. 0009

<u>Structure Name:</u>	Bridge 0009	2023 BCI =90.99
<u>Road Name:</u>	10th Line	
<u>Location:</u>	Concession 10 & 11, Lot 13	
<u>Structure Type:</u>	Precast Concrete I-Girder	
<u>Number of Spans:</u>	3	<u>Span Lengths:</u> 17.9,27,17.9 m
<u>Overall Structure Width:</u>	9.8 m	<u>Roadway Width:</u> 8 m
<u>Year of Construction:</u>	2008	<u>Current Load Limit:</u>

Recommendation:	No Capital Works estimated to be required within 10 years. Future structure rehabilitation should be considered.
------------------------	---

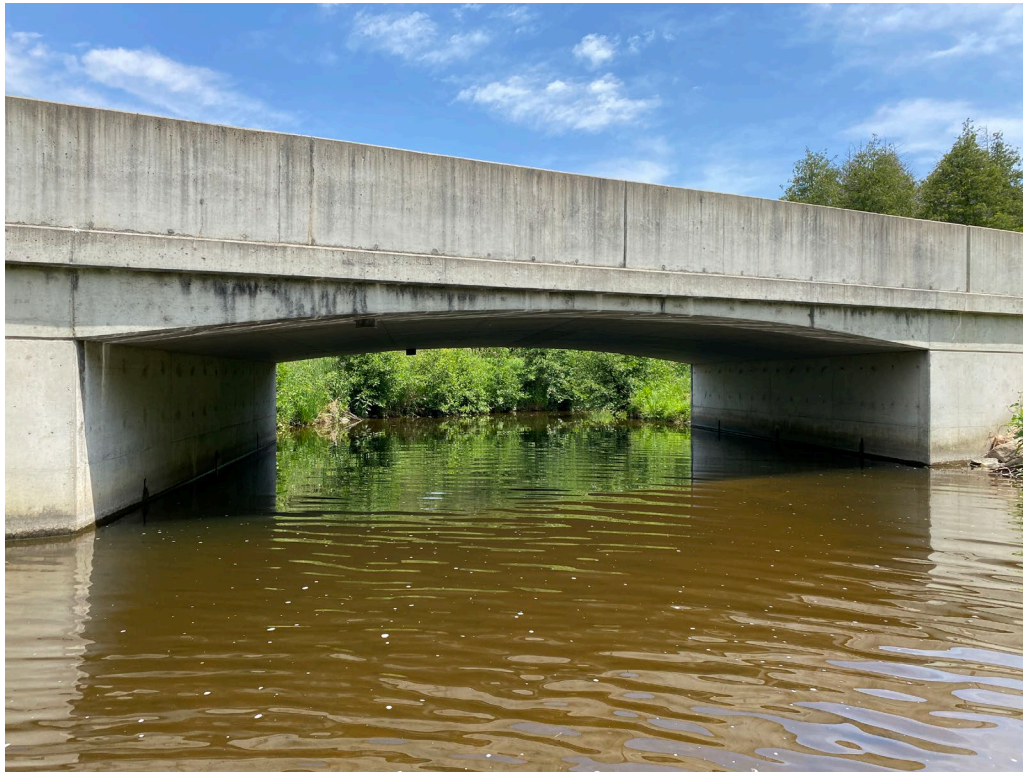
1.10 Structure No. 0010

<u>Structure Name:</u>	Bridge 0010	2023 BCI =87.55
<u>Road Name:</u>	11th Line	
<u>Location:</u>	Concession 11 & 12, Lot 12 (East Garafraxa, Dufferin County)	
<u>Structure Type:</u>	Cast-In-Place Conc. Rigid Frame	
<u>Number of Spans:</u>	1	<u>Span Lengths:</u> 11 m
<u>Overall Structure Width:</u>	9.5 m	<u>Roadway Width:</u> 8 m
<u>Year of Construction:</u>	2003	<u>Current Load Limit:</u>

Recommendation:	No Capital Works estimated to be required within 10 years. Future structure rehabilitation should be considered.
------------------------	---

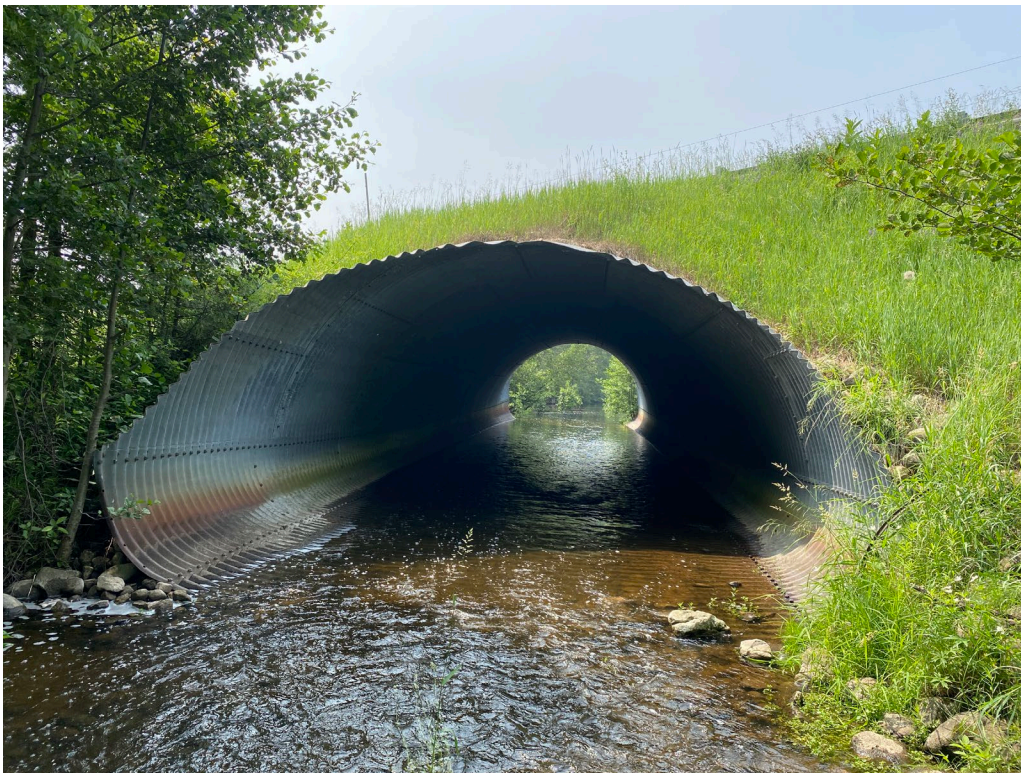
1.11 Structure No. 0011

<u>Structure Name:</u>	Culvert 0011	2023 BCI =68.89
<u>Road Name:</u>	20th Line	
<u>Location:</u>	Concession 12 & 13 Lot 12 (East Garafraxa, in Dufferin County)	
<u>Structure Type:</u>	CSP Multi-Plate Ellipse Culvert(s)	
<u>Number of Spans:</u>	1	<u>Span Lengths:</u> 6.3 m
<u>Overall Structure Width:</u>	23.5 m	<u>Roadway Width:</u> 6 m
<u>Year of Construction:</u>	1969	<u>Current Load Limit:</u>

Recommendation:	No Capital Works is estimated to be required within the next 10 years.
------------------------	---

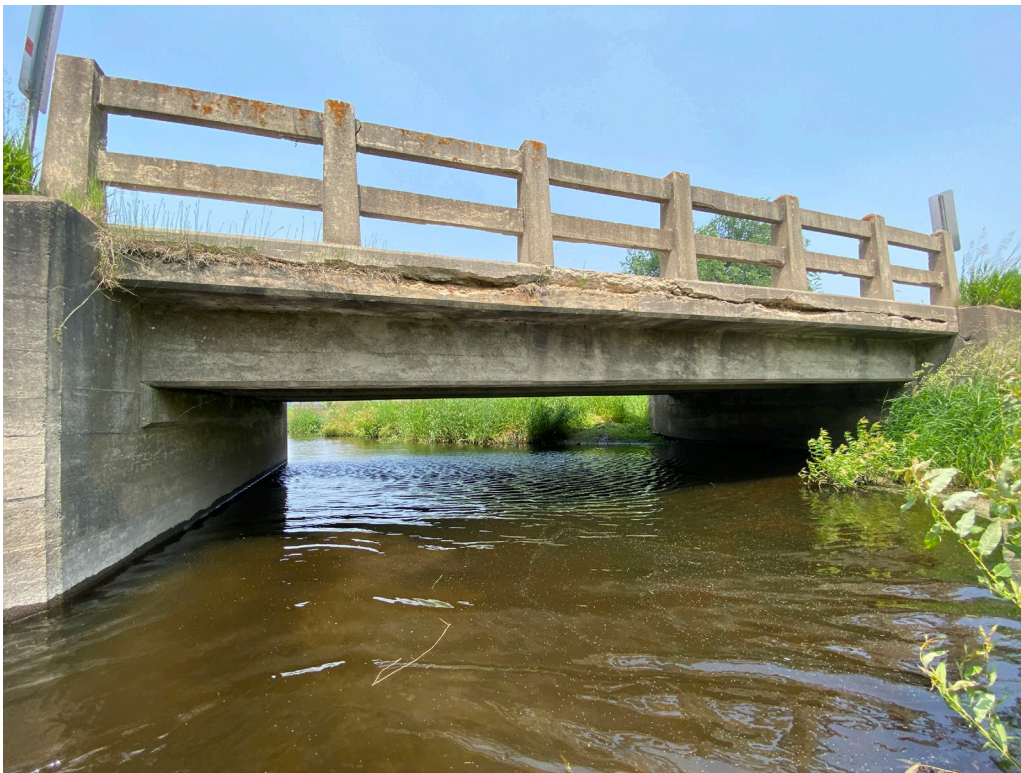
1.12 Structure No. 0014

<u>Structure Name:</u>	Bridge 0014	2023 BCI =70.44
<u>Road Name:</u>	10th Side Road	
<u>Location:</u>	Concession 13, Lots 10 & 11 (East Garafraxa, Dufferin County)	
<u>Structure Type:</u>	Cast-In-Place Concrete T-Beam	
<u>Number of Spans:</u>	1	<u>Span Lengths:</u> 9.1 m
<u>Overall Structure Width:</u>	6.5 m	<u>Roadway Width:</u> 6 m
<u>Year of Construction:</u>	1930	<u>Current Load Limit:</u>

Recommendation: Major Rehabilitation is recommended within 4 years.

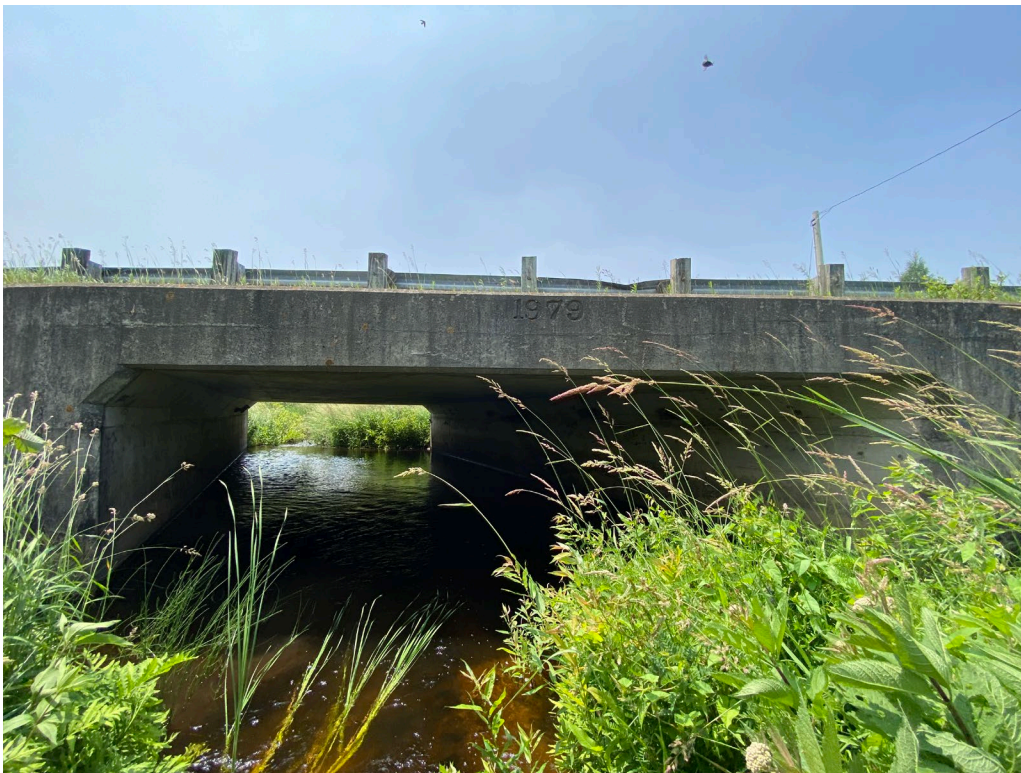
1.13 Structure No. 0015

<u>Structure Name:</u>	Culvert 0015	2023 BCI =74.78
<u>Road Name:</u>	13th Line	
<u>Location:</u>	Concession 13 & 14, Lot 10 (East Garafraxa, in Dufferin County)	
<u>Structure Type:</u>	Cast-In-Place Conc. Box Culvert	
<u>Number of Spans:</u>	1	<u>Span Lengths:</u> 7 m
<u>Overall Structure Width:</u>	14.6 m	<u>Roadway Width:</u> 7 m
<u>Year of Construction:</u>	1979	<u>Current Load Limit:</u>

Recommendation:	No Capital Works is estimated to be required within the next 10 years.
------------------------	---

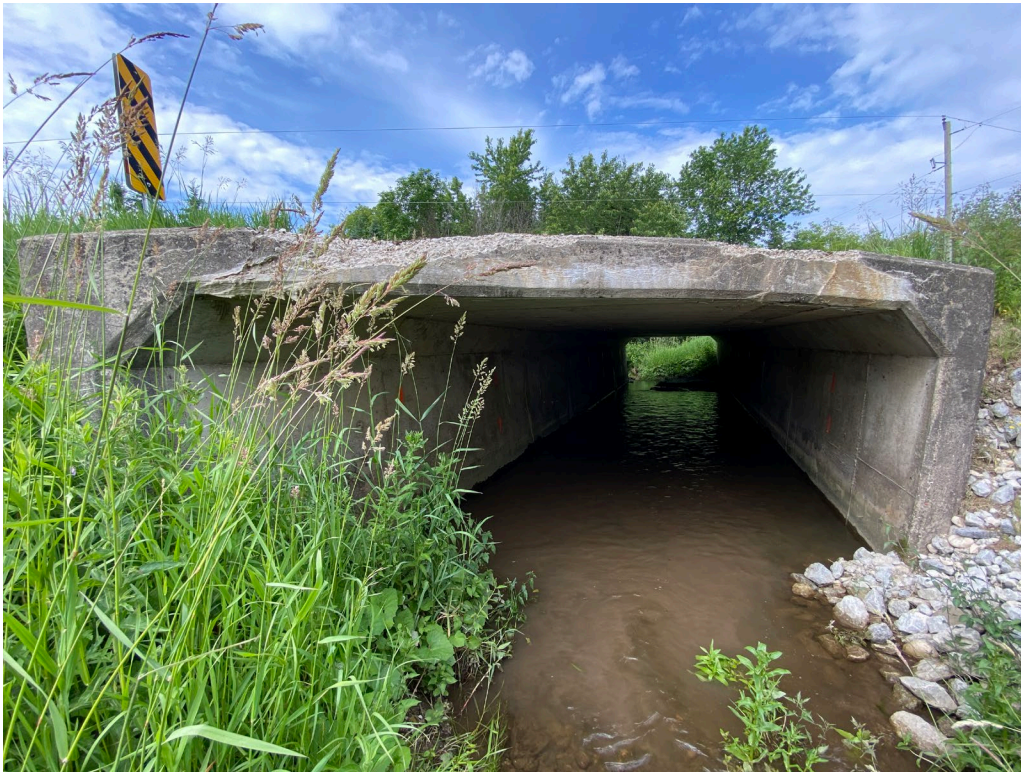
1.14 Structure No. 0016

<u>Structure Name:</u>	Culvert 0016	2023 BCI =56.74
<u>Road Name:</u>	East-West Garafraxa Townline	
<u>Location:</u>	Lot 10 (East Garafraxa, in Dufferin County)	
<u>Structure Type:</u>	Cast-In-Place Conc. Box Culvert	
<u>Number of Spans:</u>	1	<u>Span Lengths:</u> 3.6 m
<u>Overall Structure Width:</u>	17.7 m	<u>Roadway Width:</u> 6 m
<u>Year of Construction:</u>	1960	<u>Current Load Limit:</u>

Recommendation:	Structure replacement is recommended within 8 years.
------------------------	---

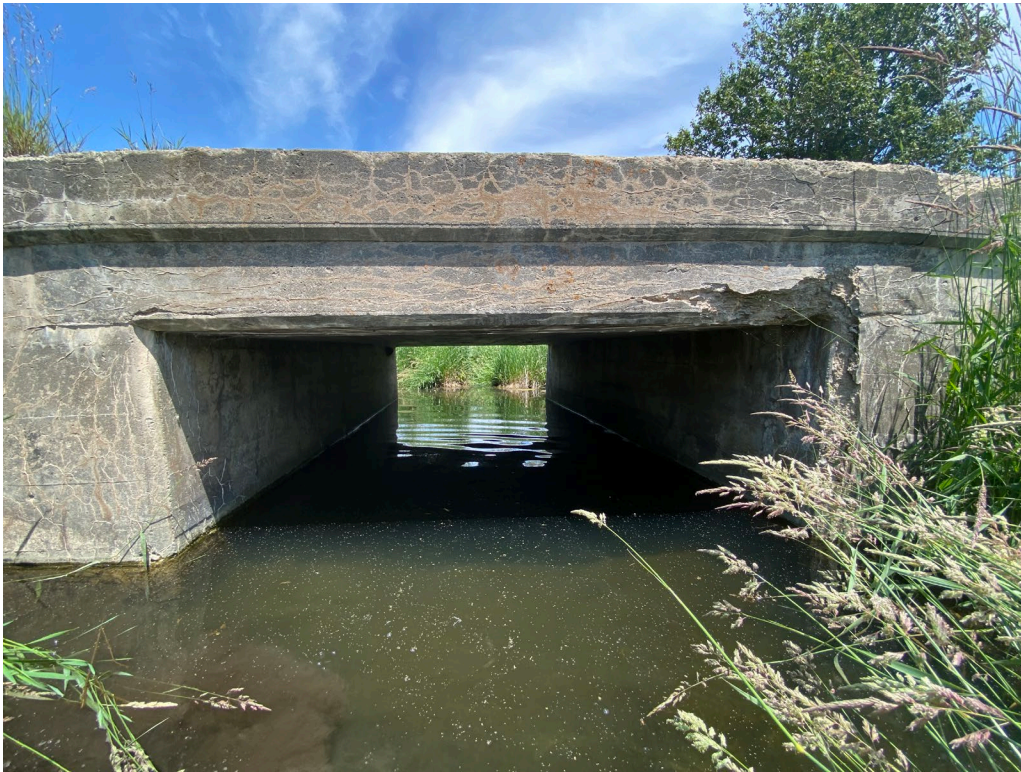
Structure Name: Culvert 0017
Road Name: 13th Line
Location: Lot 10 (East Garafraxa, in Dufferin County)
Structure Type: Cast-In-Place Conc. Box Culvert
Number of Spans: 1 Span Lengths: 2.7 m
Overall Structure Width: 5.9 m Roadway Width: 5 m
Year of Construction: 1940 Current Load Limit:

2023 BCI =62.5

Recommendation:	No Capital Works is estimated to be required within the next 10 years.
------------------------	---

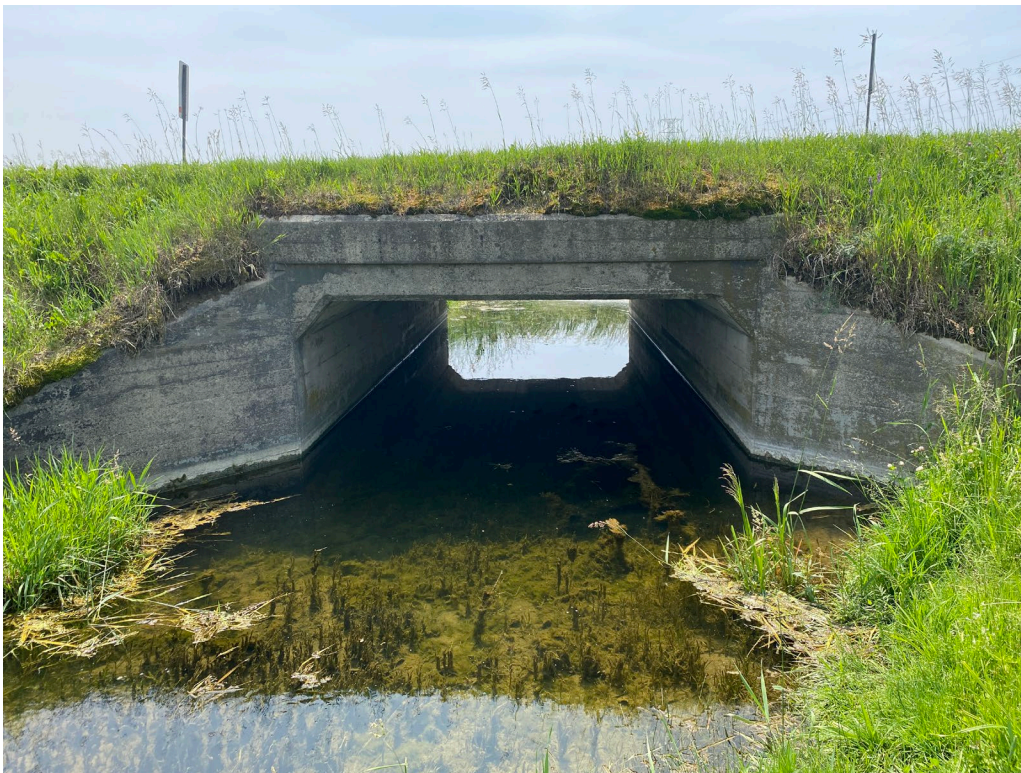
1.16 Structure No. 0019

<u>Structure Name:</u>	Culvert 0019	2023 BCI =74.64
<u>Road Name:</u>	16th Line	
<u>Location:</u>	Concession 16 & 17, Lot 7 (East Garafraxa, in Dufferin County)	
<u>Structure Type:</u>	Cast-In-Place Conc. Box Culvert	
<u>Number of Spans:</u>	1	<u>Span Lengths:</u> 3.5 m
<u>Overall Structure Width:</u>	8 m	<u>Roadway Width:</u> 6 m
<u>Year of Construction:</u>	1960	<u>Current Load Limit:</u>

Recommendation:	No Capital Works is estimated to be required within the next 10 years.
------------------------	---

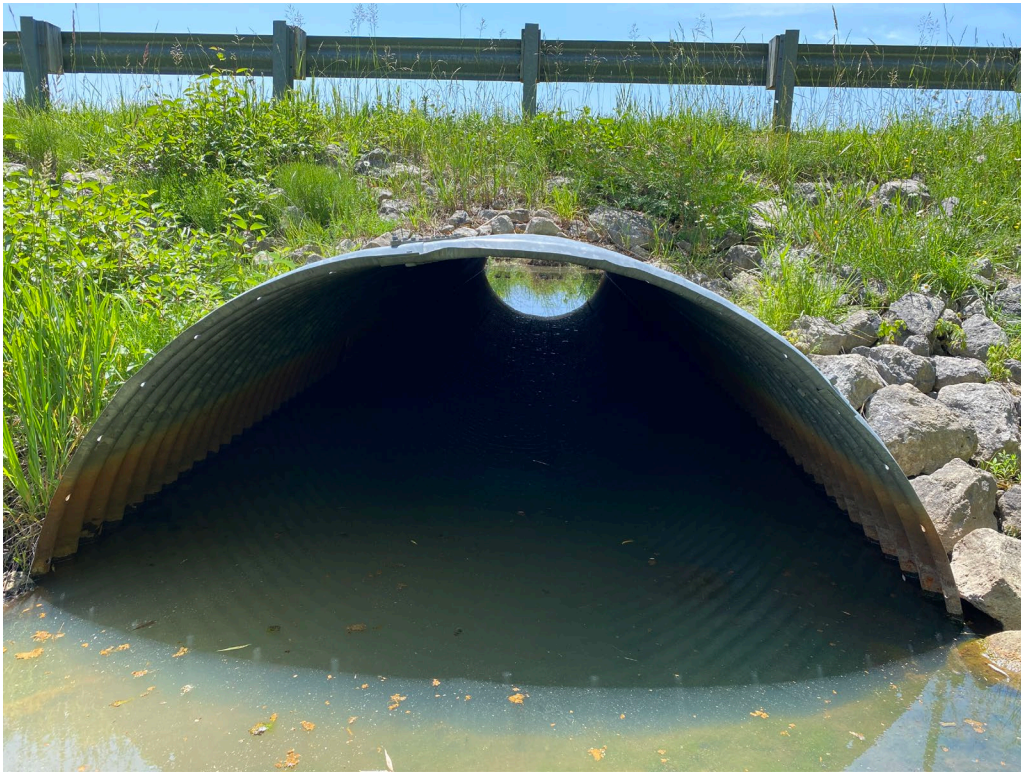
1.17 Structure No. 0021

<u>Structure Name:</u>	Culvert 0021	2023 BCI =73.89
<u>Road Name:</u>	12th Line	
<u>Location:</u>	Concession 12 & 13, Lot 5 (East Garafraxa, Dufferin County)	
<u>Structure Type:</u>	CSP Multi-Plate Ellipse Culvert(s)	
<u>Number of Spans:</u>	1	<u>Span Lengths:</u> 3.1 m
<u>Overall Structure Width:</u>	11.7 m	<u>Roadway Width:</u> 7 m
<u>Year of Construction:</u>	2007	<u>Current Load Limit:</u>

Recommendation:	No Capital Works is estimated to be required within the next 10 years.
------------------------	---

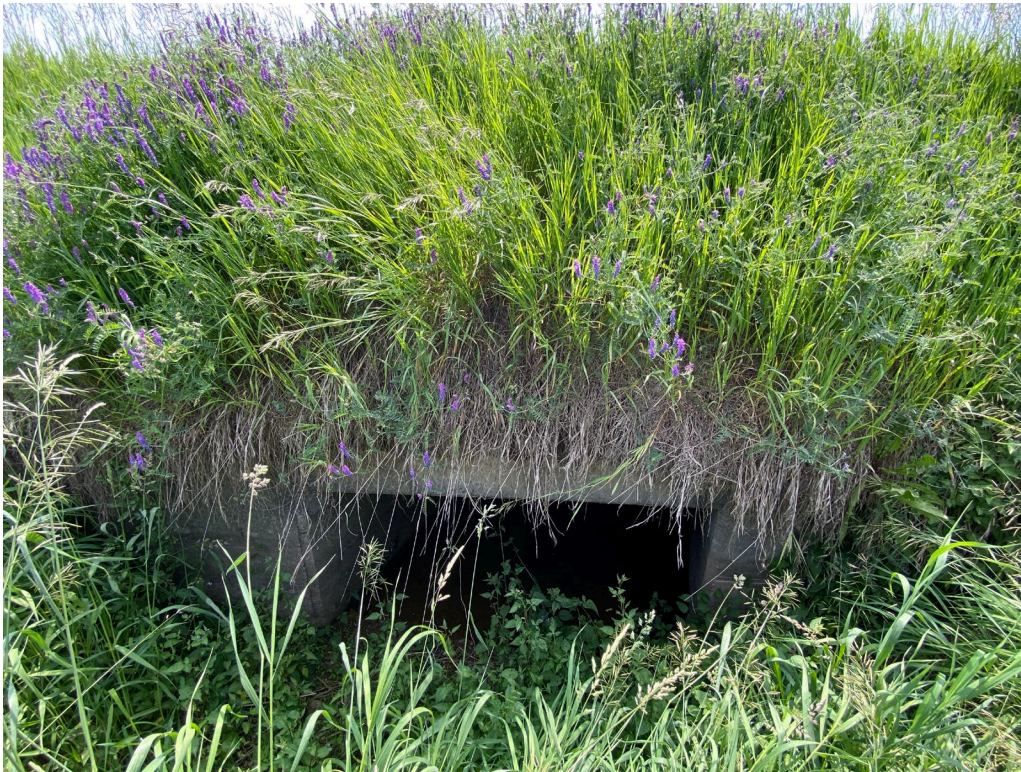
1.18 Structure No. 0022

<u>Structure Name:</u>	Culvert 0022	2023 BCI =74.47
<u>Road Name:</u>	East Garafraxa - Caledon Townline	
<u>Location:</u>	18th Line, 1.4 km north of East Garafraxa	
<u>Structure Type:</u>	Cast-In-Place Conc. Box Culvert	
<u>Number of Spans:</u>	1	<u>Span Lengths:</u> 1.9 m
<u>Overall Structure Width:</u>	9 m	<u>Roadway Width:</u> 7 m
<u>Year of Construction:</u>	1940	<u>Current Load Limit:</u>

Recommendation:	No Capital Works is estimated to be required within the next 10 years.
------------------------	---

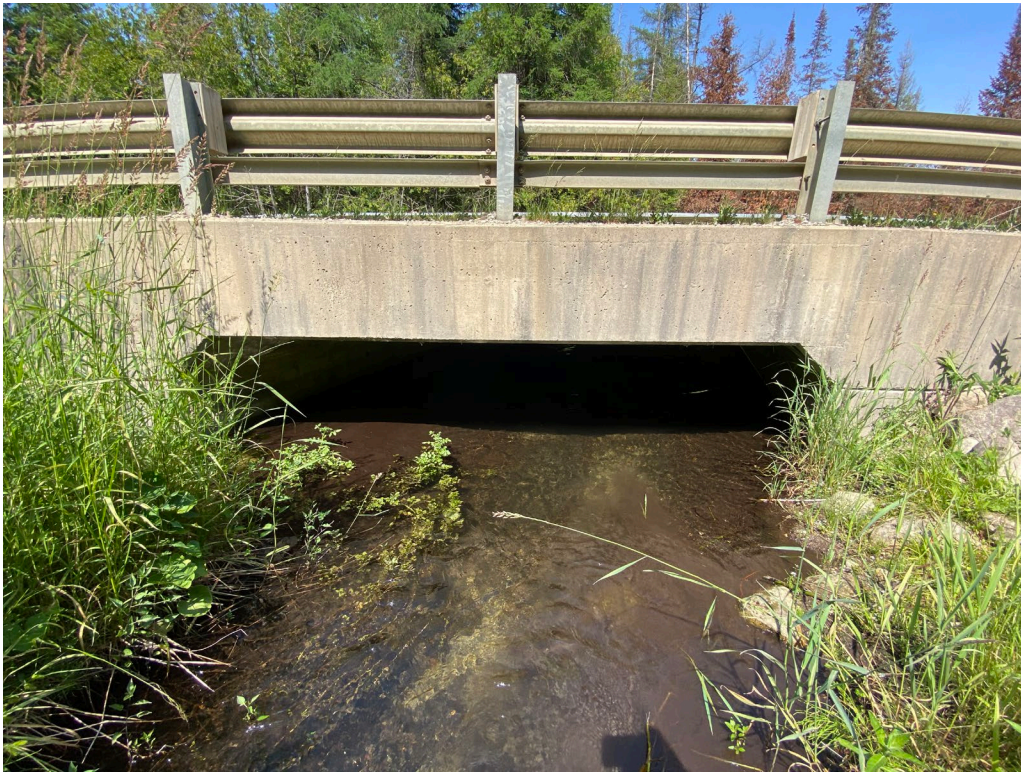
1.19 Structure No. 0023

<u>Structure Name:</u>	Culvert 0023	2023 BCI =91.09
<u>Road Name:</u>	19th Line	
<u>Location:</u>	Concession 19 & A, Lot 2 (East Garafraxa, Dufferin County)	
<u>Structure Type:</u>	Cast-In-Place Conc. Box Culvert	
<u>Number of Spans:</u>	1	<u>Span Lengths:</u> 4 m
<u>Overall Structure Width:</u>	9.7 m	<u>Roadway Width:</u> 7 m
<u>Year of Construction:</u>	2007	<u>Current Load Limit:</u>

Recommendation:	No Capital Works is estimated to be required within the next 10 years.
------------------------	---

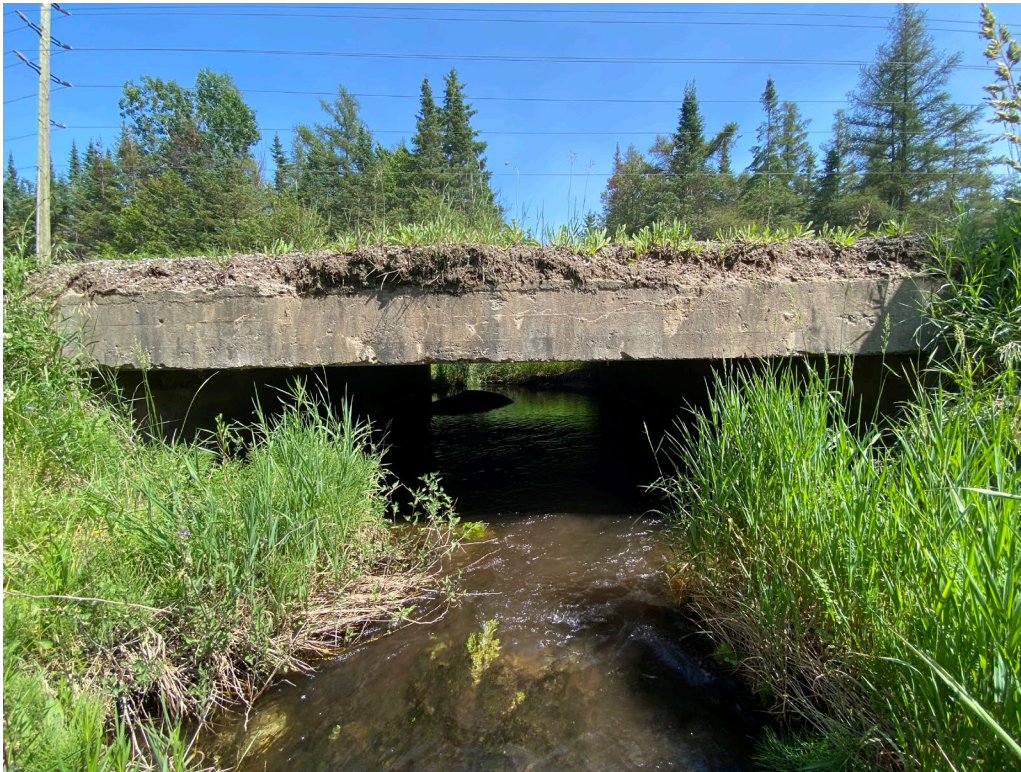
1.20 Structure No. 0024

Culvert 0024 is generally in fair condition but is demonstrating signs of severe concrete deterioration. Based on the structure type, low clearance, and narrow driving platform width, a rehabilitation is not recommended, and replacement of the structure should be considered as the BCI approaches 40.

Recommendation:	Forgo rehabilitation and replace structure in future (replacement timeline estimated to exceed 10 years).
------------------------	--

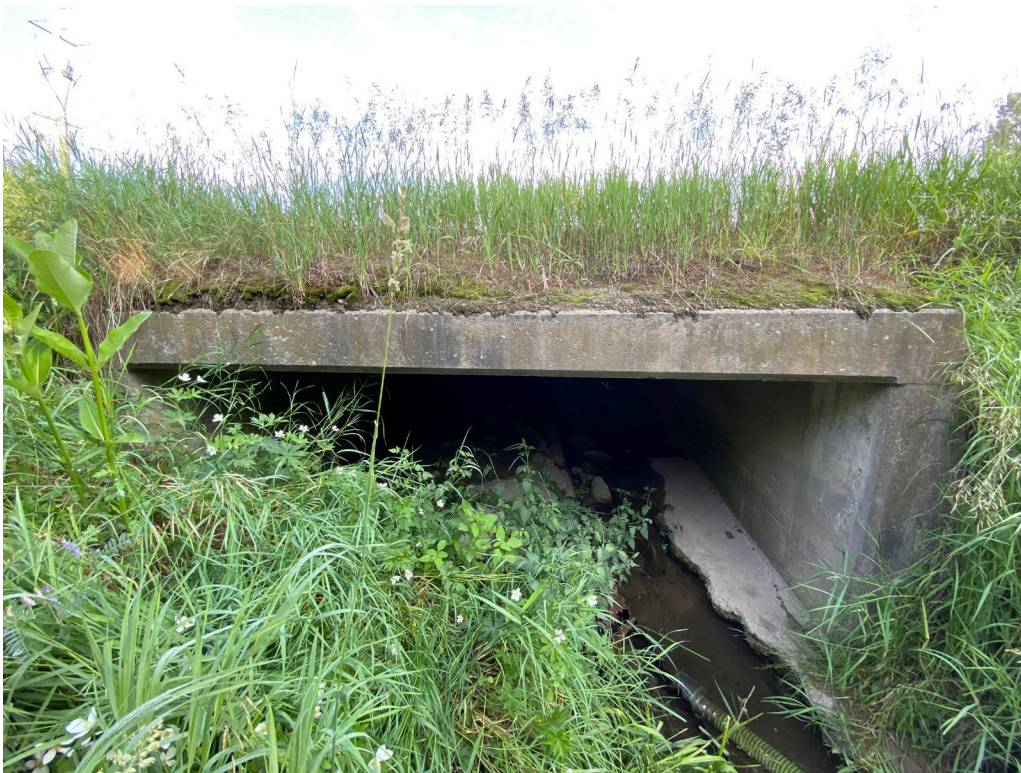
1.21 Structure No. 0026

Culvert 0026, which has been previously extended, is generally in fair to good condition overall; however, the original portion of the deck is demonstrating signs of severe concrete deterioration, moisture penetration and severe delamination with exposed corroded reinforcing on the deck. Replacement timeline is based on the condition of the original structure.

Recommendation:	Major Rehabilitation is recommended within 5 years.
------------------------	--

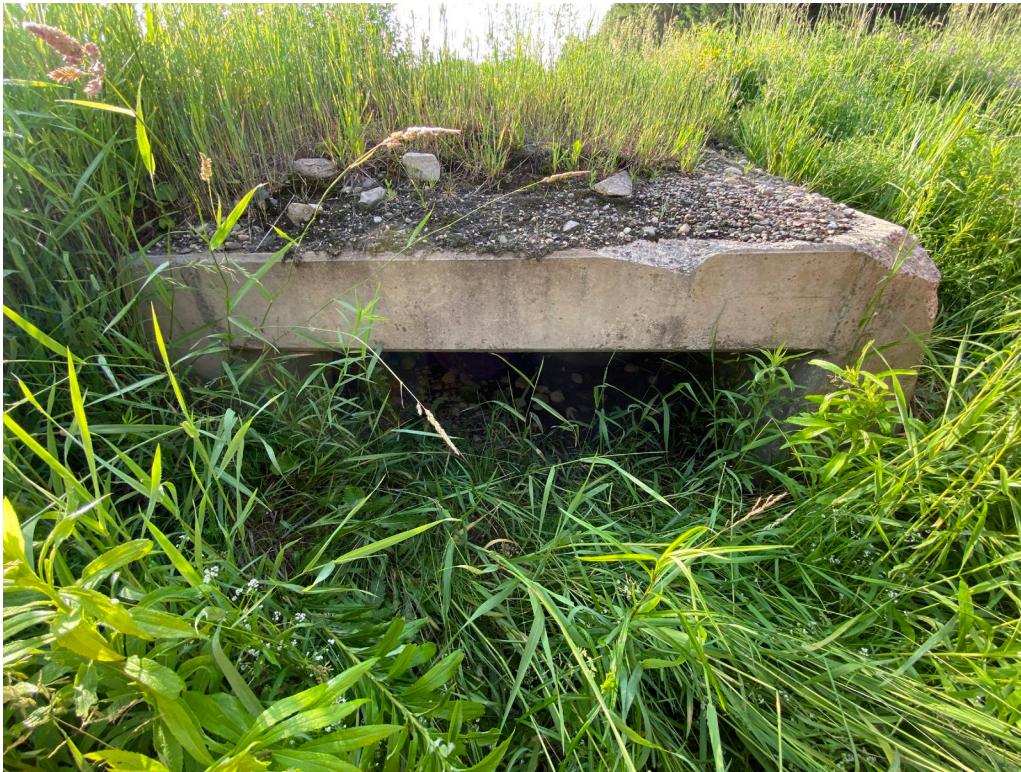
1.22 Structure No. 0027

Culvert 0027 is generally in good condition with only minor defects noted. Based on the structure type and span, a rehabilitation is not recommended, and replacement of the structure should be considered as the BCI approaches 40.

Maintenance Need	Element and Comments	Estimated Cost
Hazard Signs	Install hazard warning signs at structure	\$1,000.00
Maintenance Needs Total		\$1,000.00

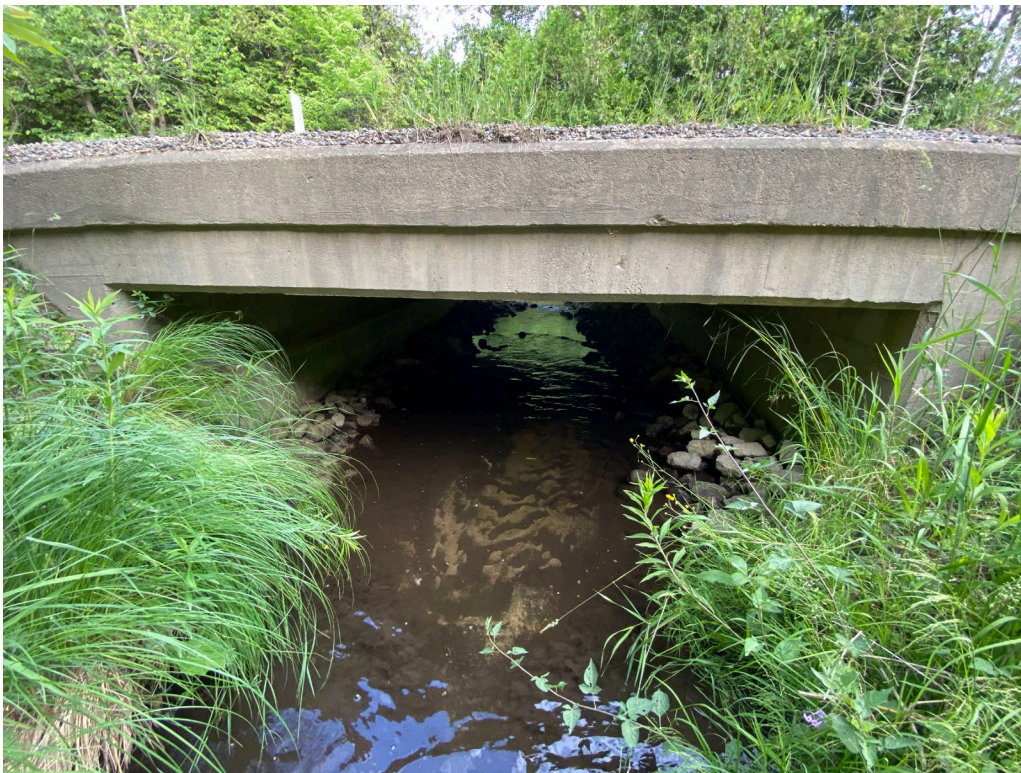
1.23 Structure No. 0029

Culvert 0029 is generally in good to fair condition but is demonstrating signs of concrete deterioration throughout the barrel. Time to replacement has been identified based on the condition of the barrel.

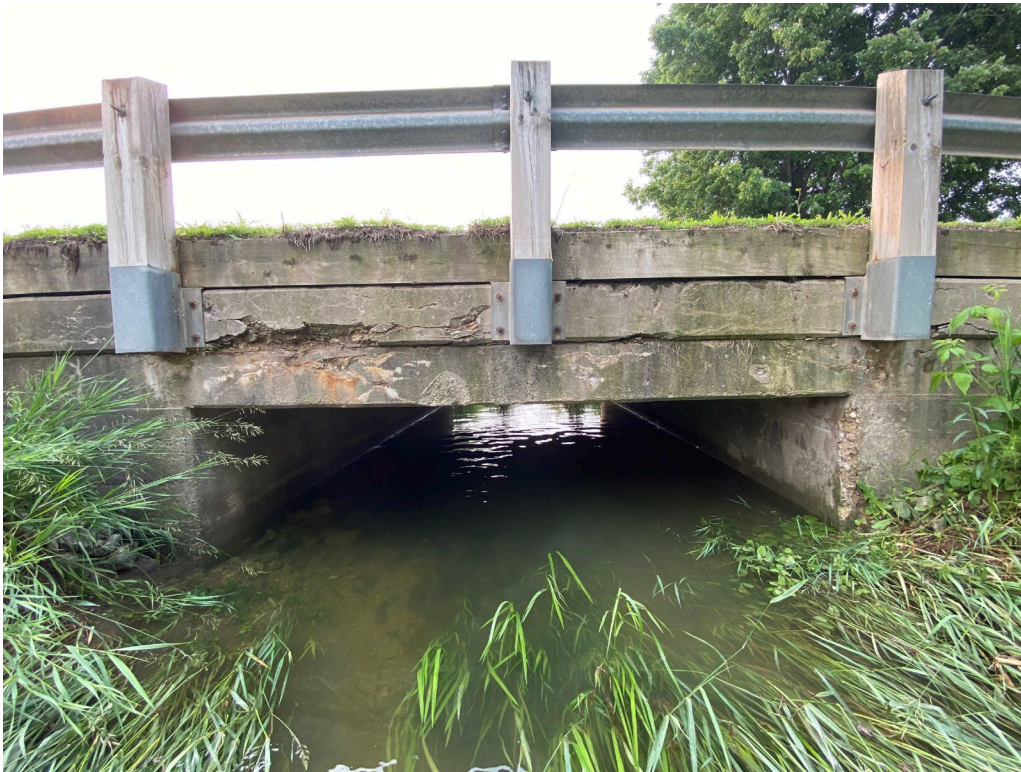
1.24 Structure No. 0031

Culvert 0031 is generally in fair to good condition but is showing signs of severe concrete deterioration, specifically to the wingwalls, fascia and soffit.
