BURNSIDE

2023 OSIM Bridge Inspections Report

**Township of East Garafraxa
065371 Dufferin County Road 3, Unit 2
East Garafraxa, ON L9W 7J8**

**January 2024
300053343.2023**

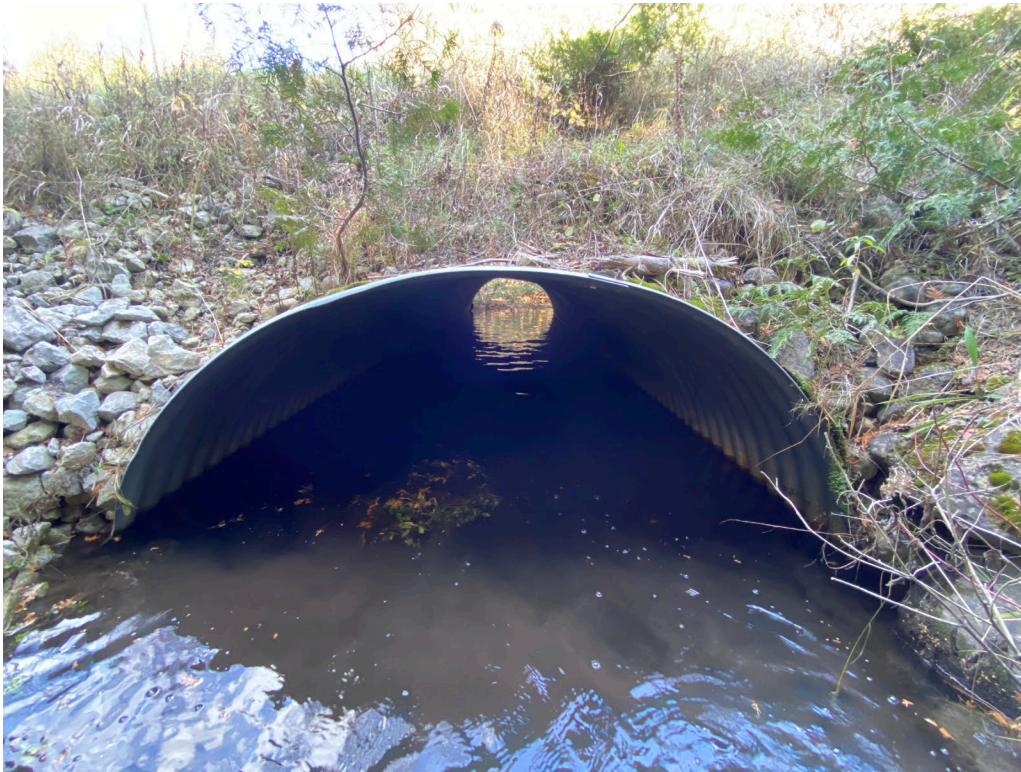
1.25 Structure No. 41

Structure 41 is generally in good condition with only minor defects noted.

Maintenance Need	Element and Comments	Estimated Cost
Erosion Control	Place rock protection NW	\$500.00
Hazard Signs	Install hazard warning signs at structure	\$1,000.00
Maintenance Needs Total		\$1,500.00

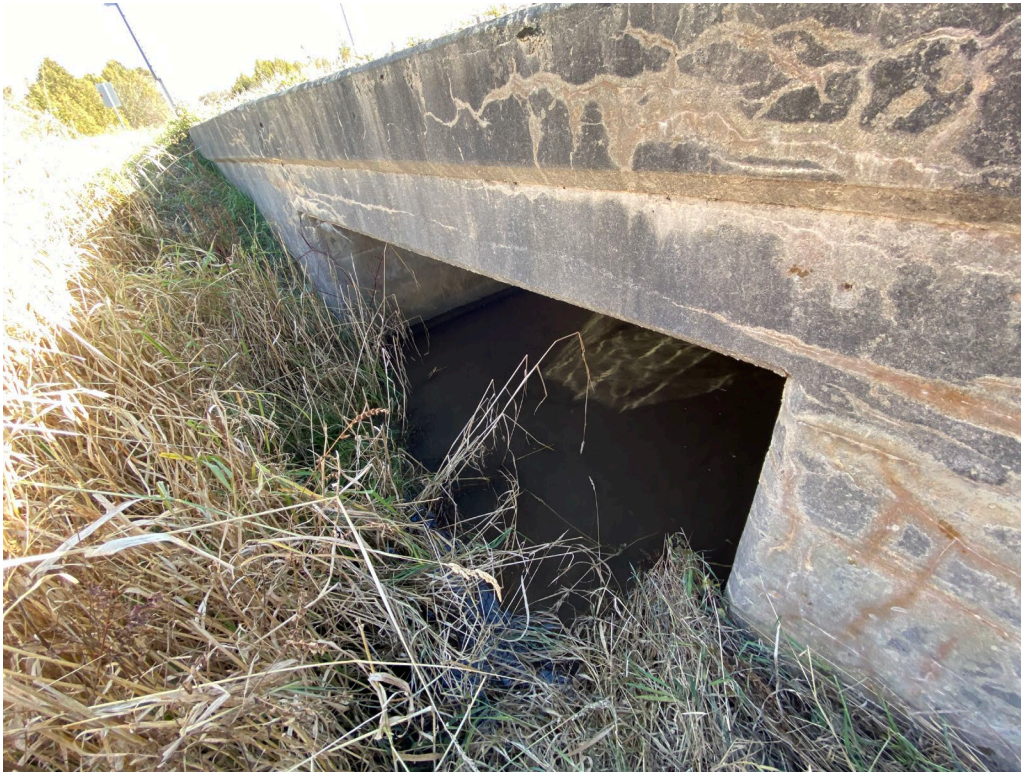
1.26 Structure No. 42
2023 BCI =69.39

Structure 42 is generally in good condition with only minor defects noted.

Maintenance Need	Element and Comments	Estimated Cost
Hazard Signs	Replace NE and reinstate NW ands SE hazard warning signs	\$500.00
Maintenance Needs Total		\$500.00

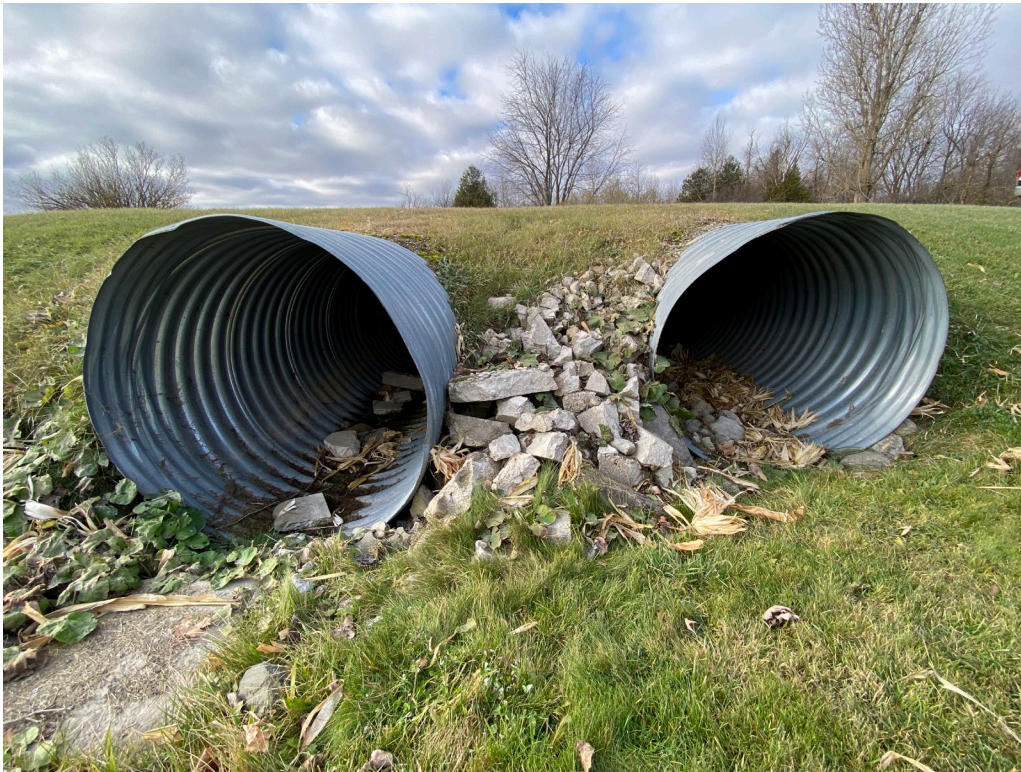
1.27 Structure No. 43

Structure 43 is generally in good condition with only minor defects noted.

Maintenance Need	Element and Comments	Estimated Cost
Erosion Control	Place rock protection on west embankments and in stream at outlet	\$2,000.00
Hazard Signs	Install hazard warning signs at structure	\$1,000.00
Maintenance Needs Total		\$3,000.00

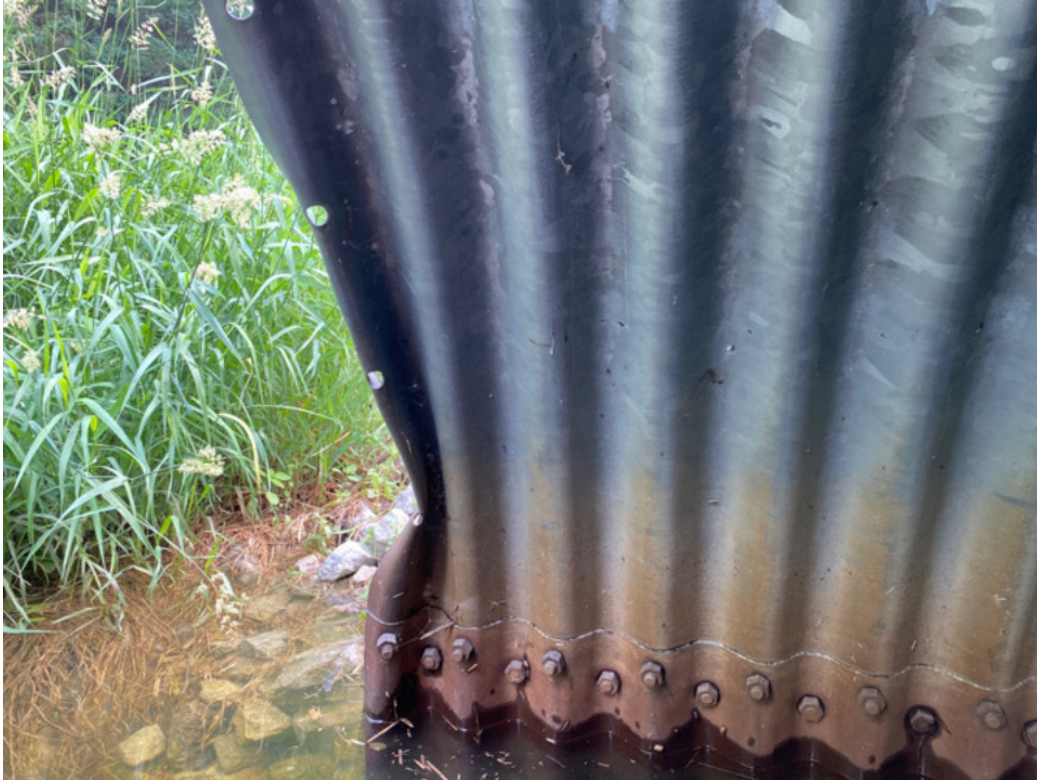
1. 1: Barrels (North East)

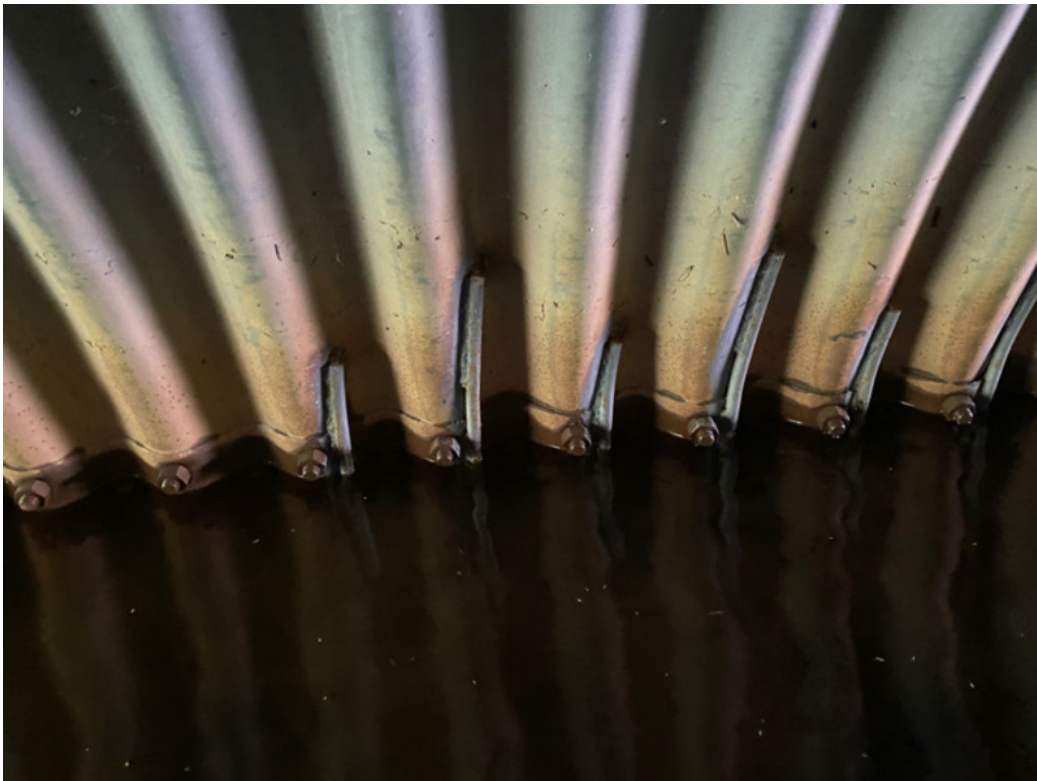
2. 1: Barrels (East)

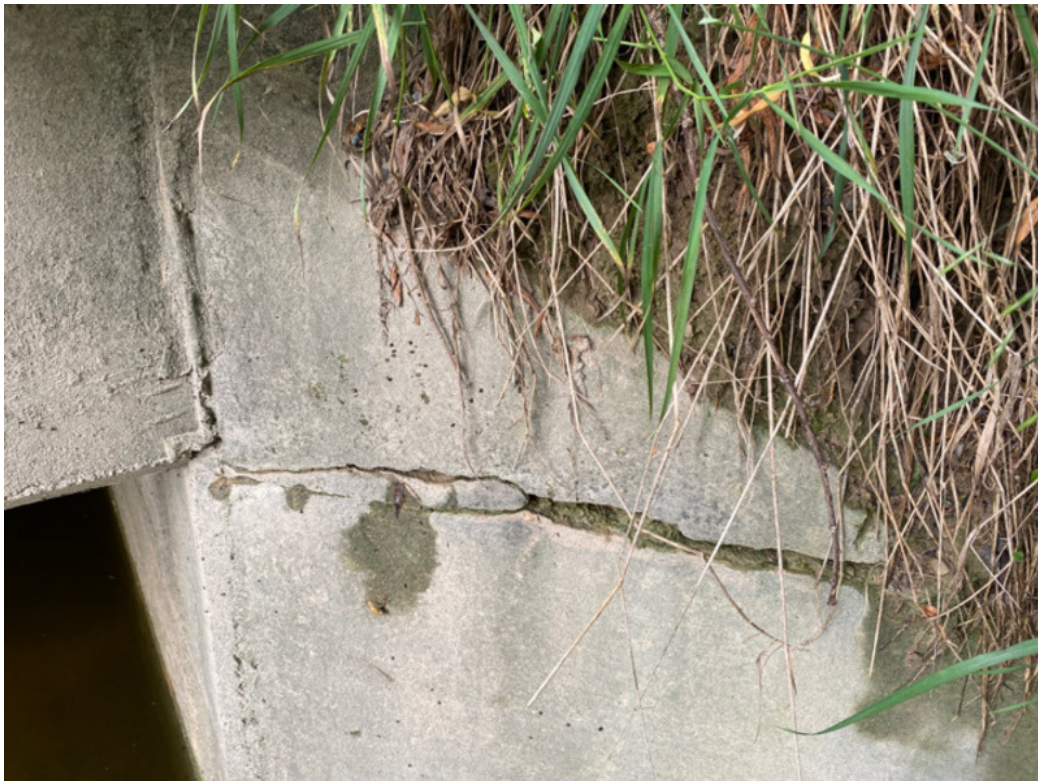
2. 2: Wingwalls (North East)

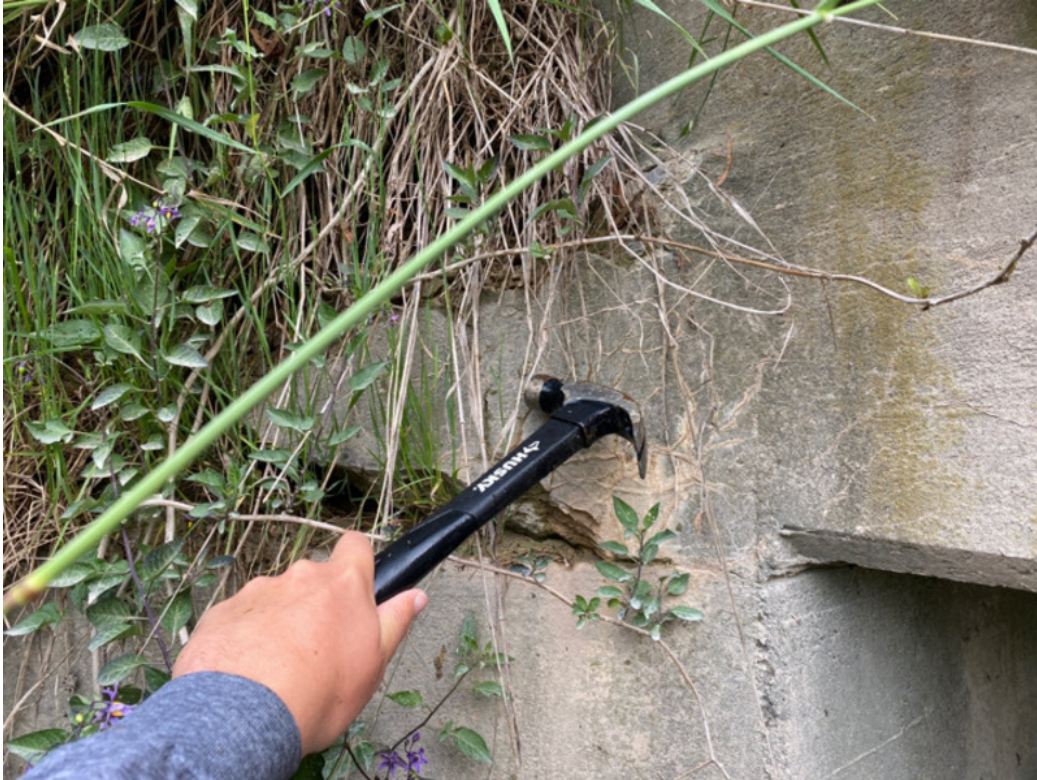
3. 2: Wingwalls (North West)

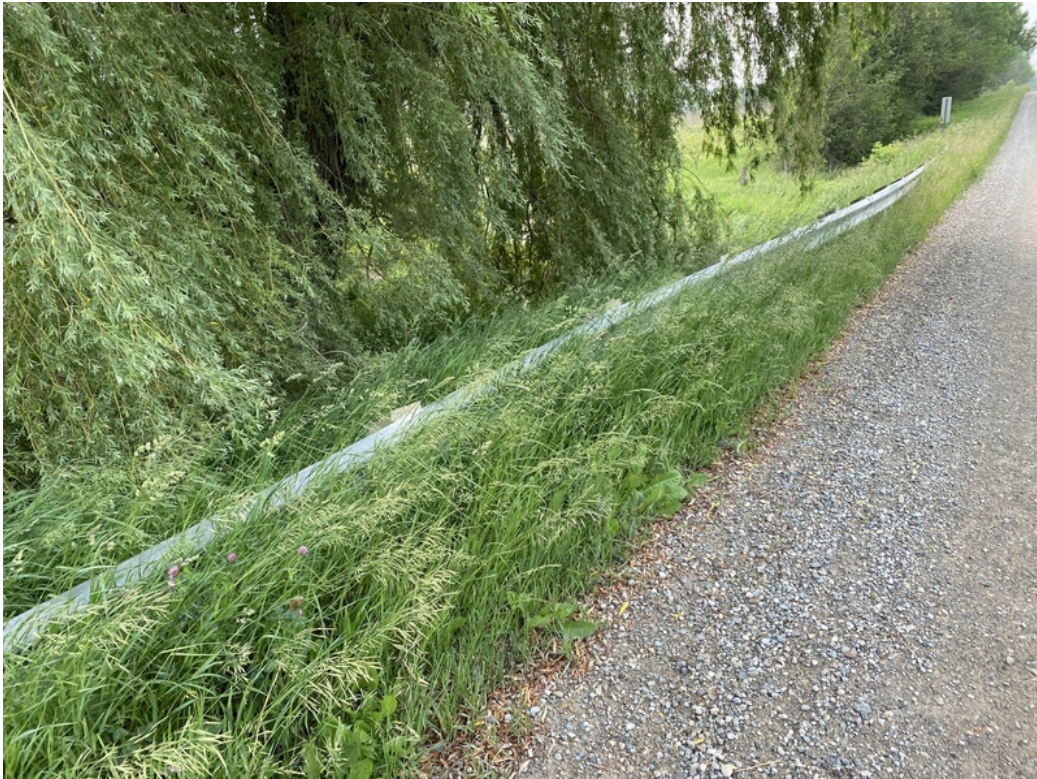
5. 2: Railing System (East)

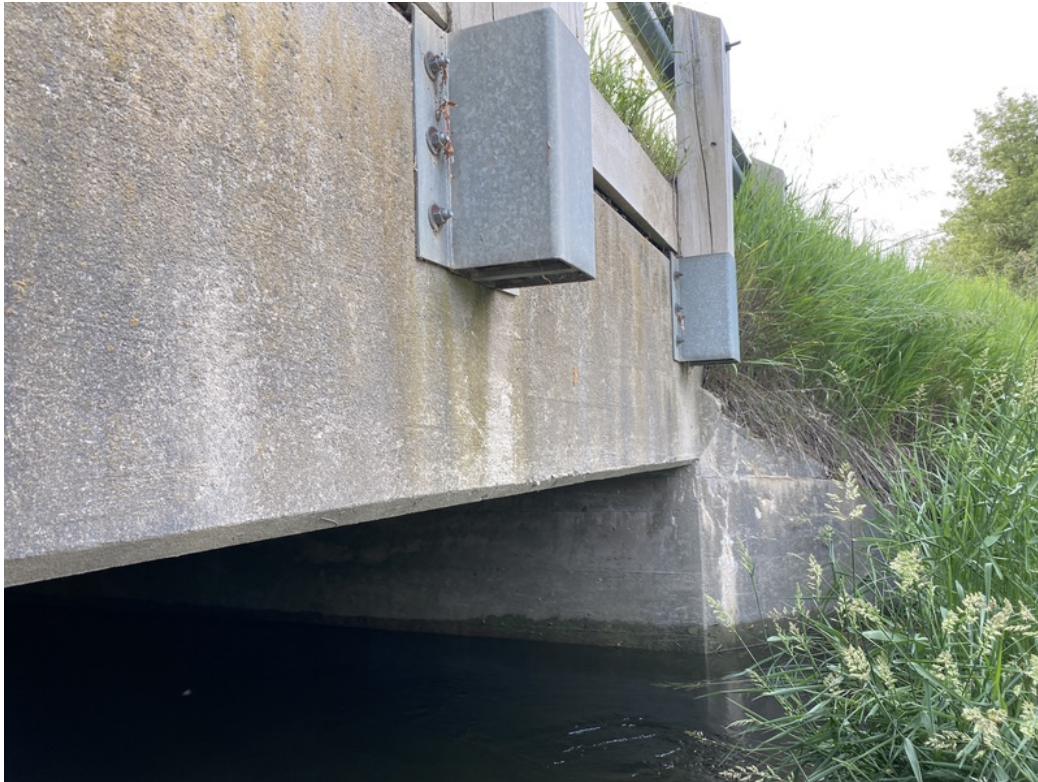
7. 2: Soffit - Thin Slab - Ext (West)

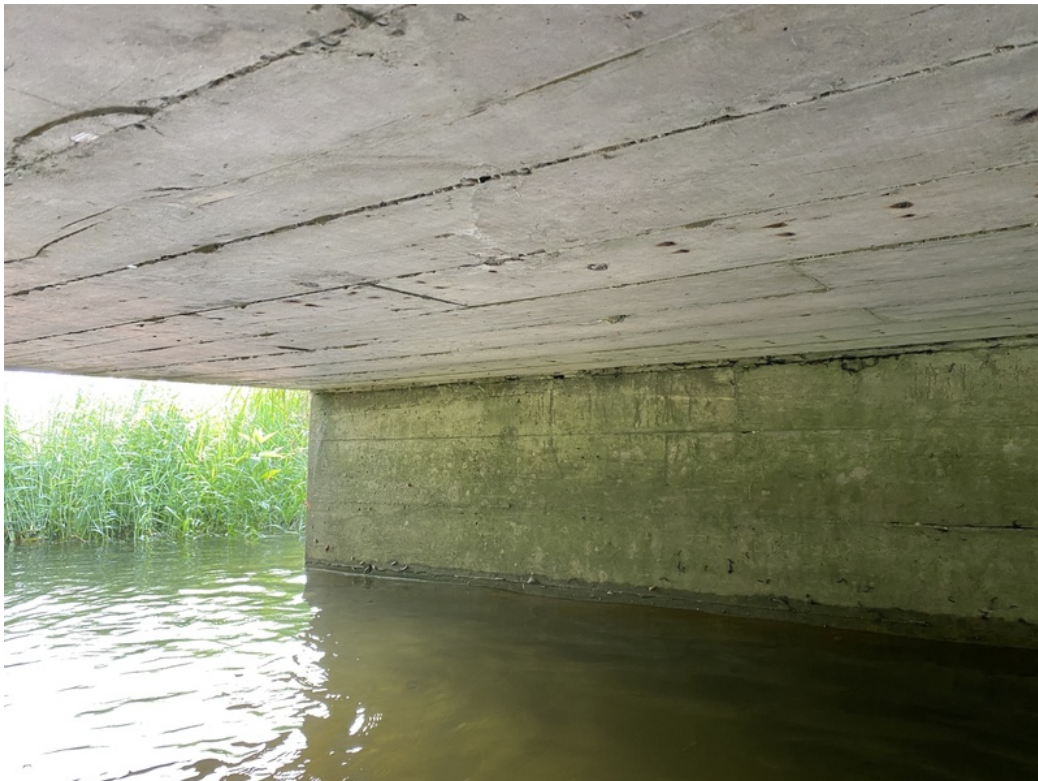
8. 2: Soffit - Thin Slab - Int (South West)

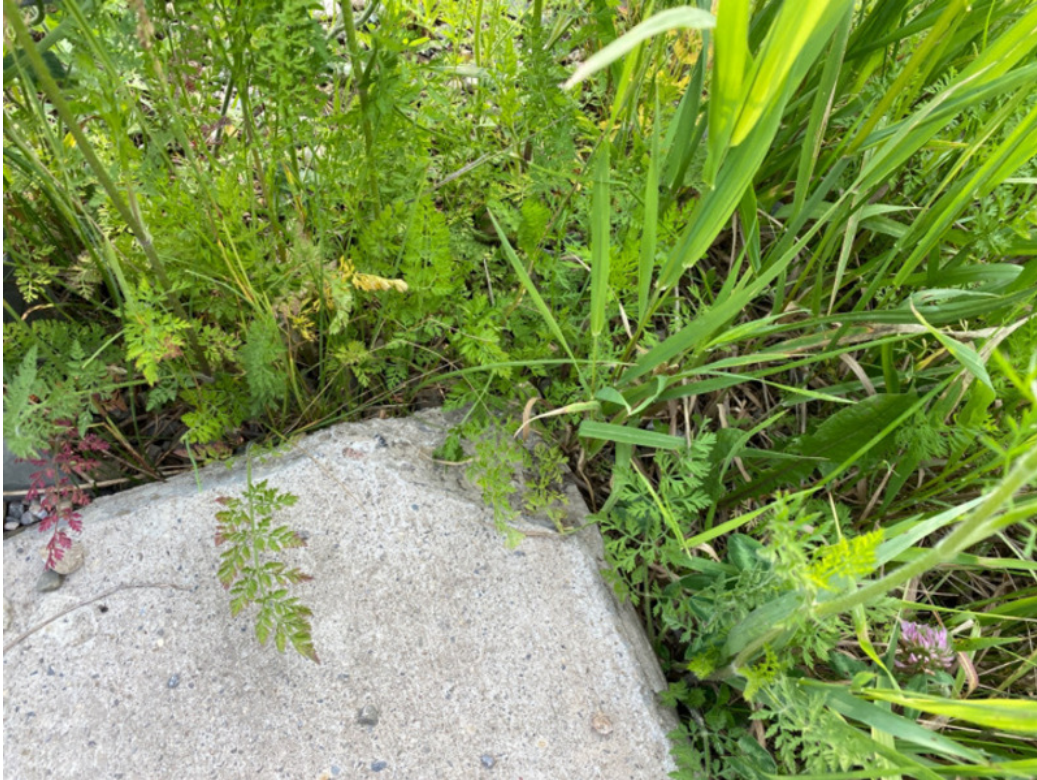
1. 3: Wingwalls (South West)

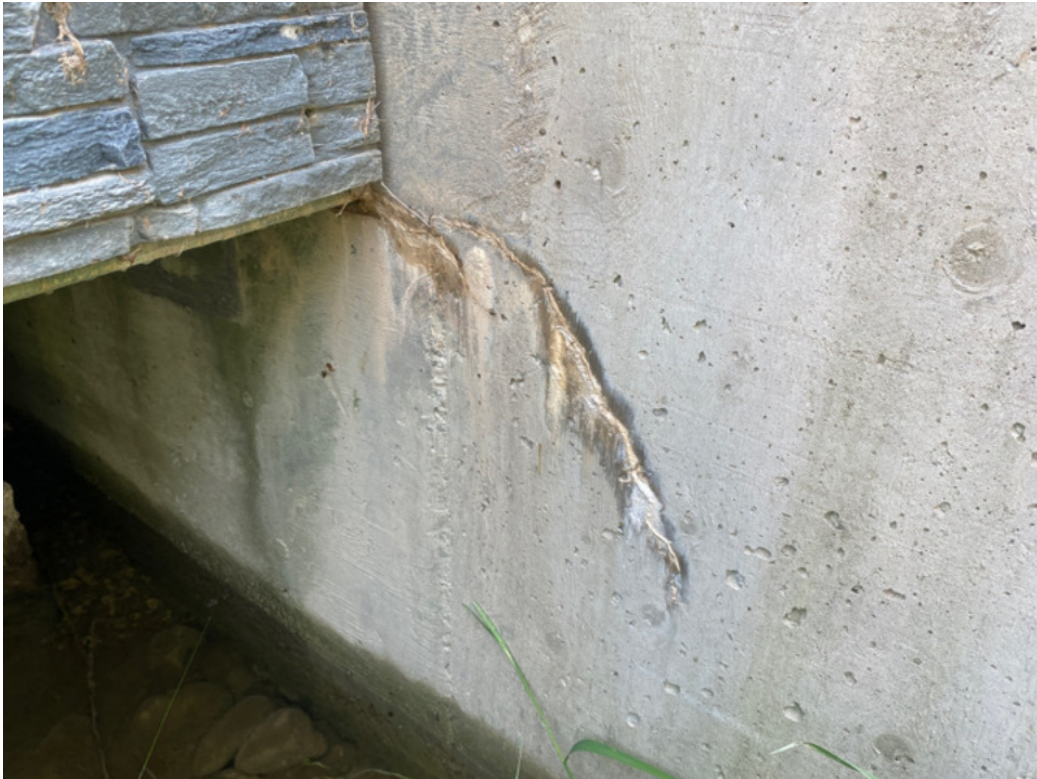
2. 3: Wingwalls (South West)

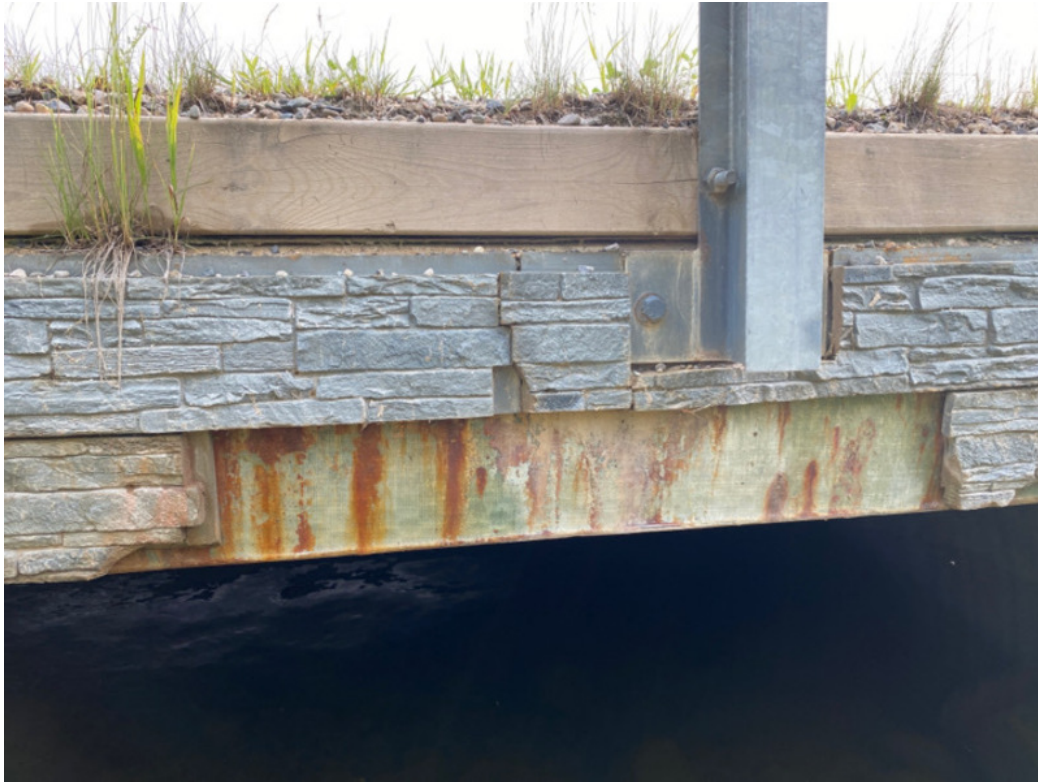
3. 3: Soffit - Thin Slab - Ext (West)

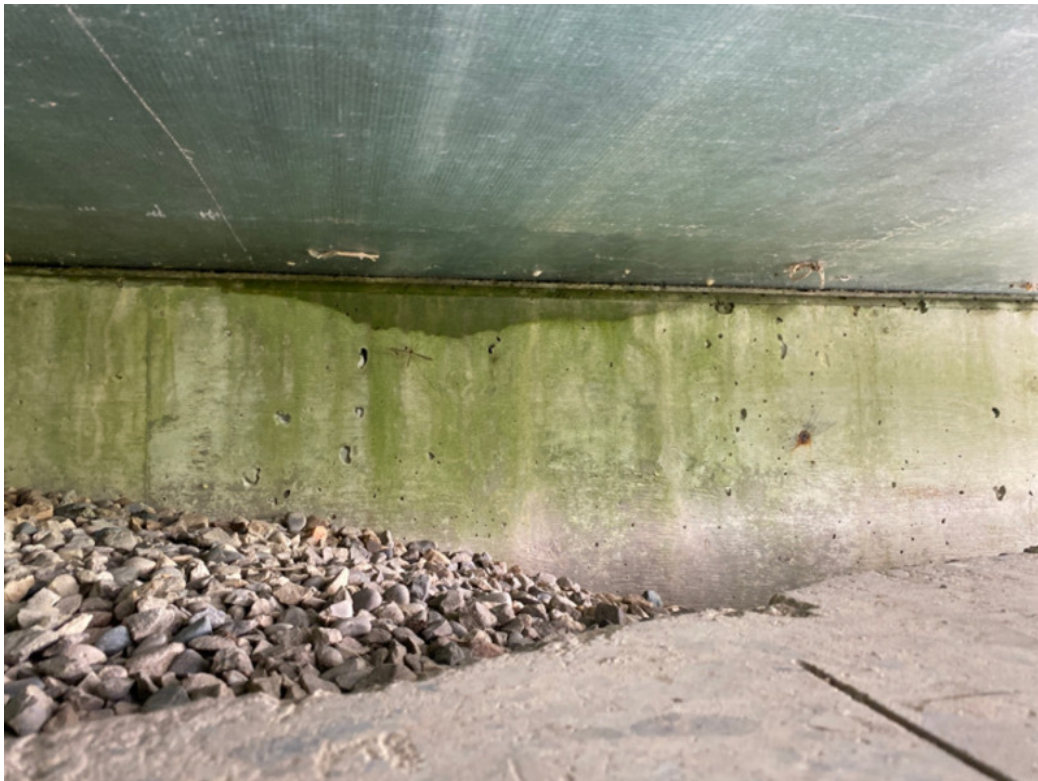
4. 3: Abutment Walls (North)

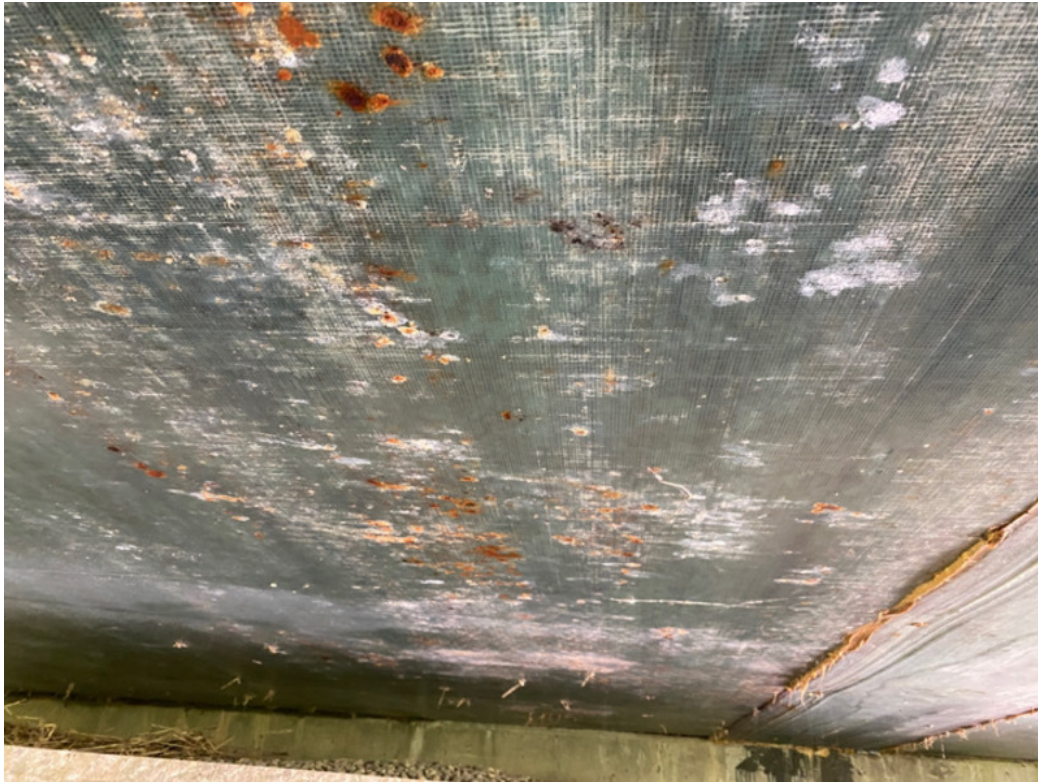
5. 3: Soffit - Thin Slab - Int (South)

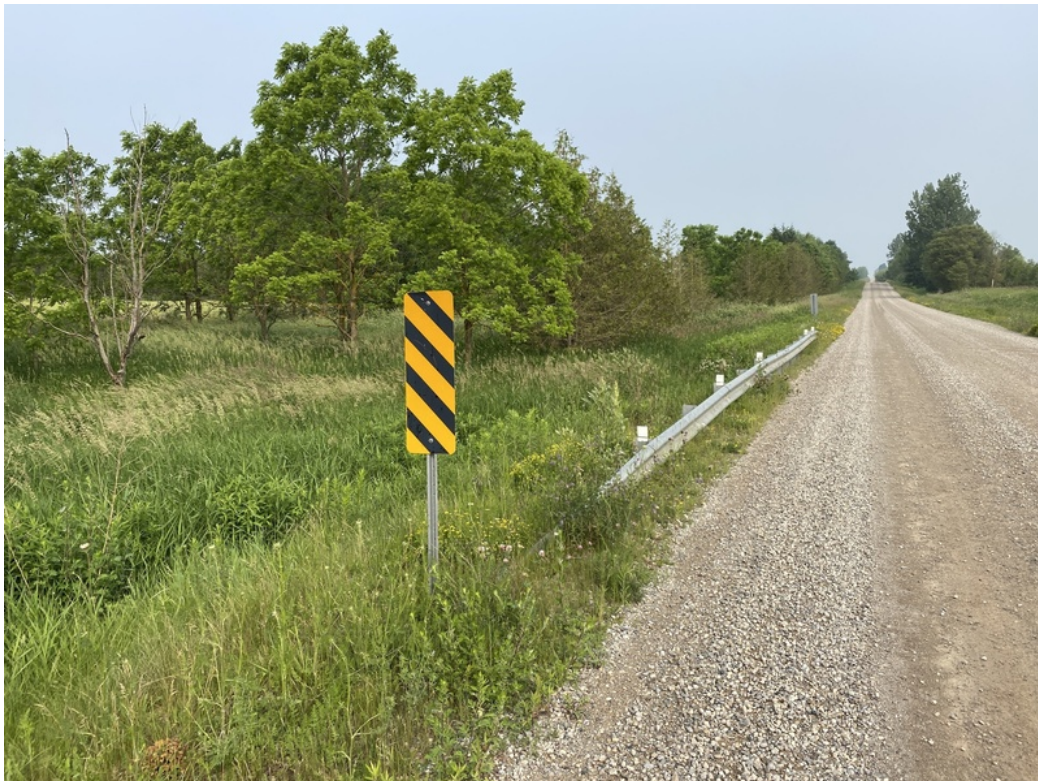
6. 3: Railing System (South West)

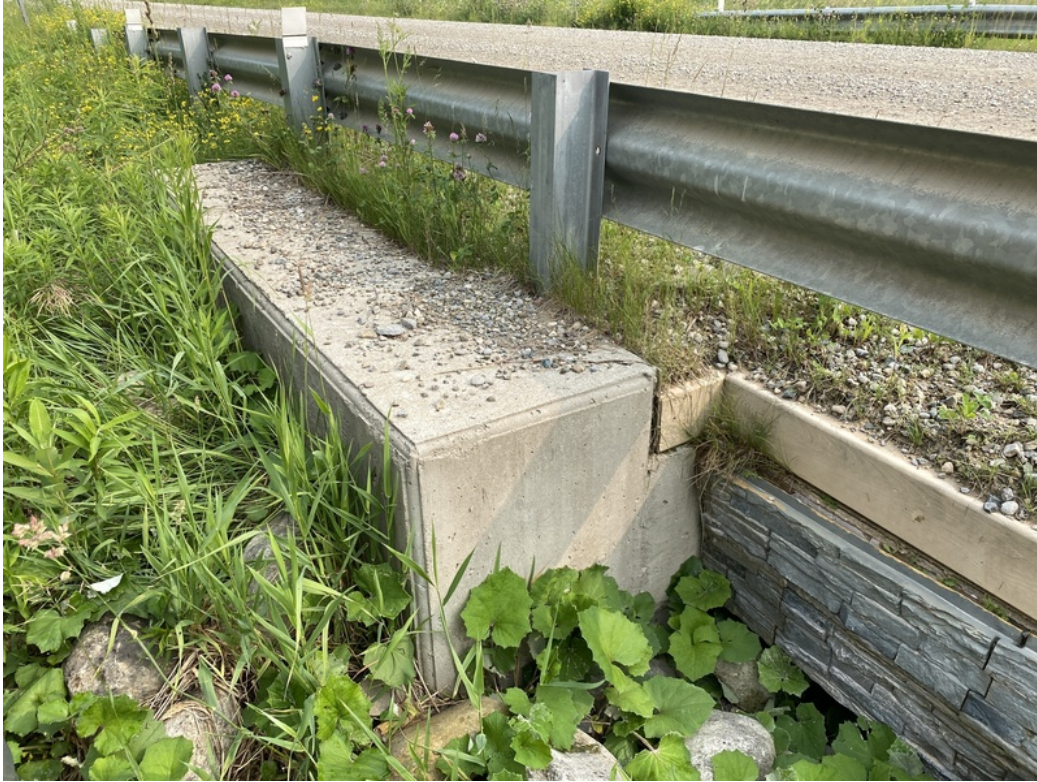
9. 3: Wingwalls (North West)

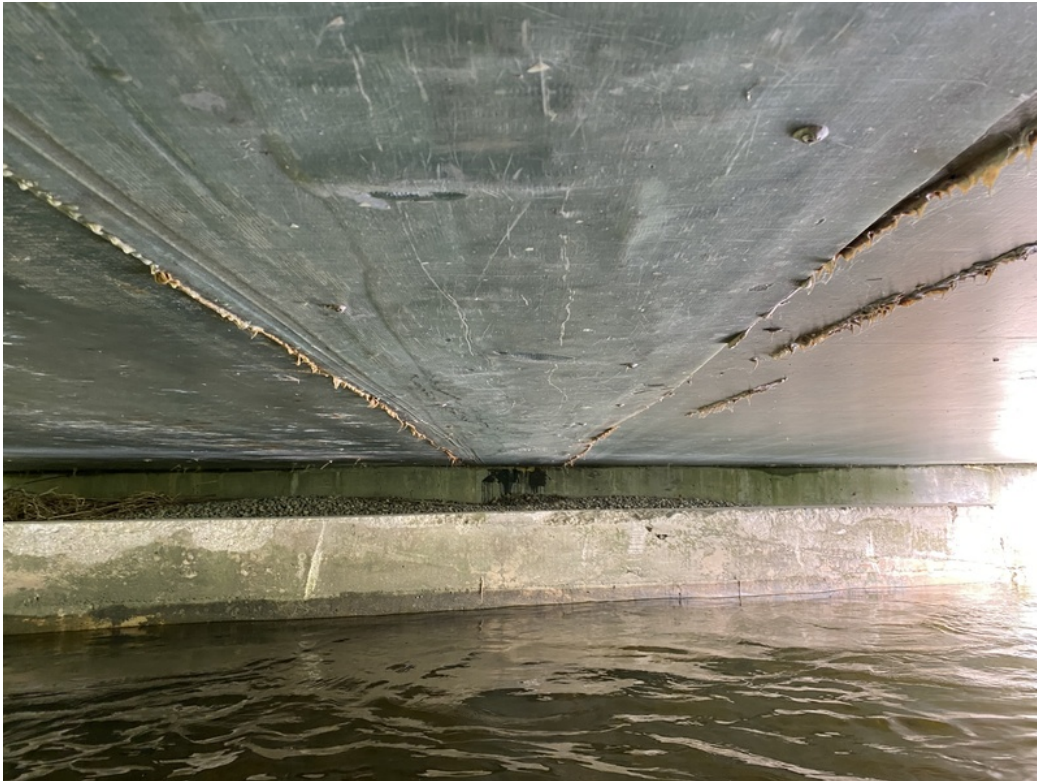
11. 3: Soffit - Thin Slab - Int (South)

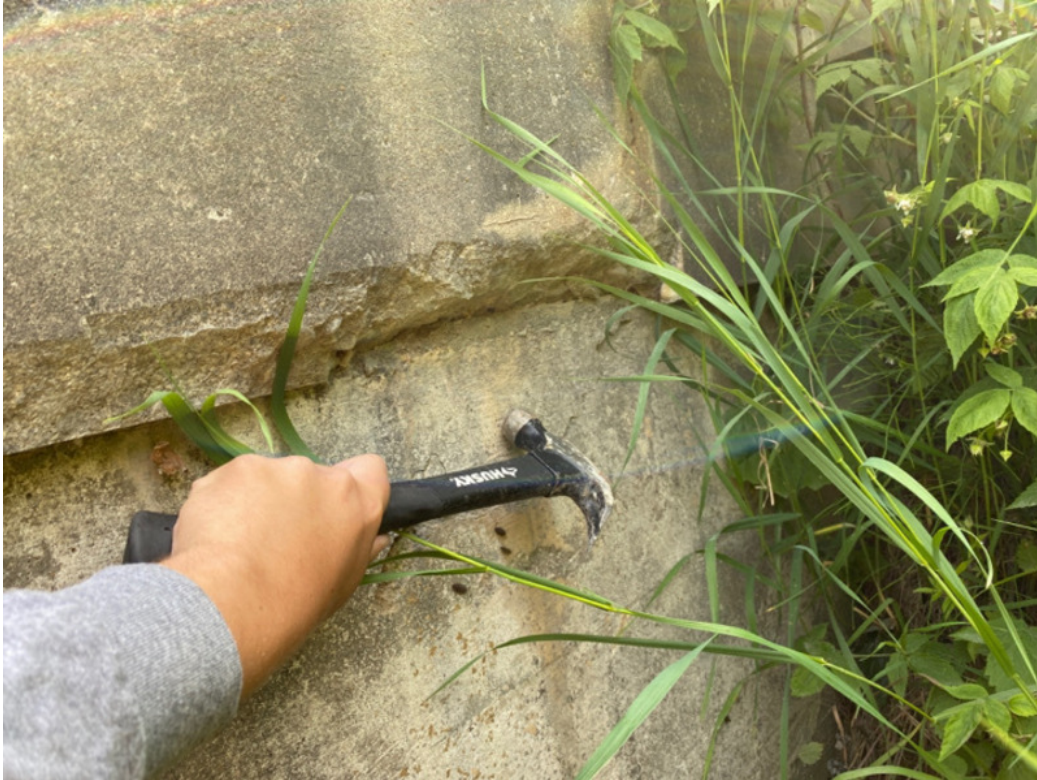
1. 4: Wingwalls (South West)

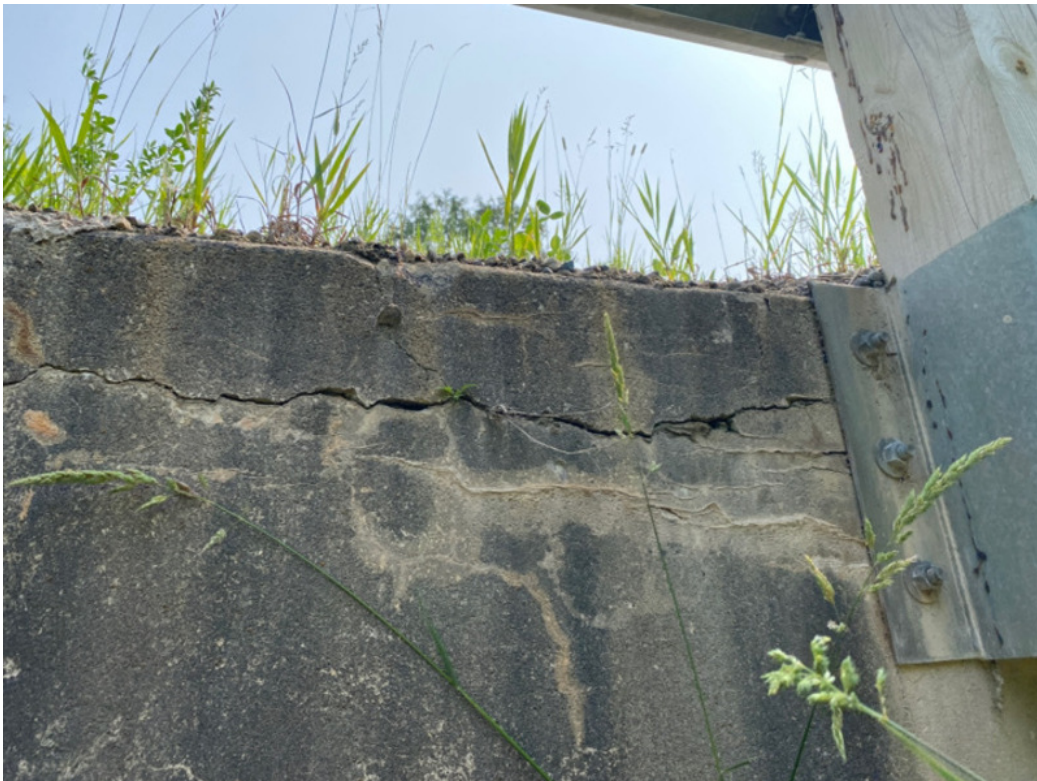
2. 4: Soffit - Thin Slab - Ext (West)

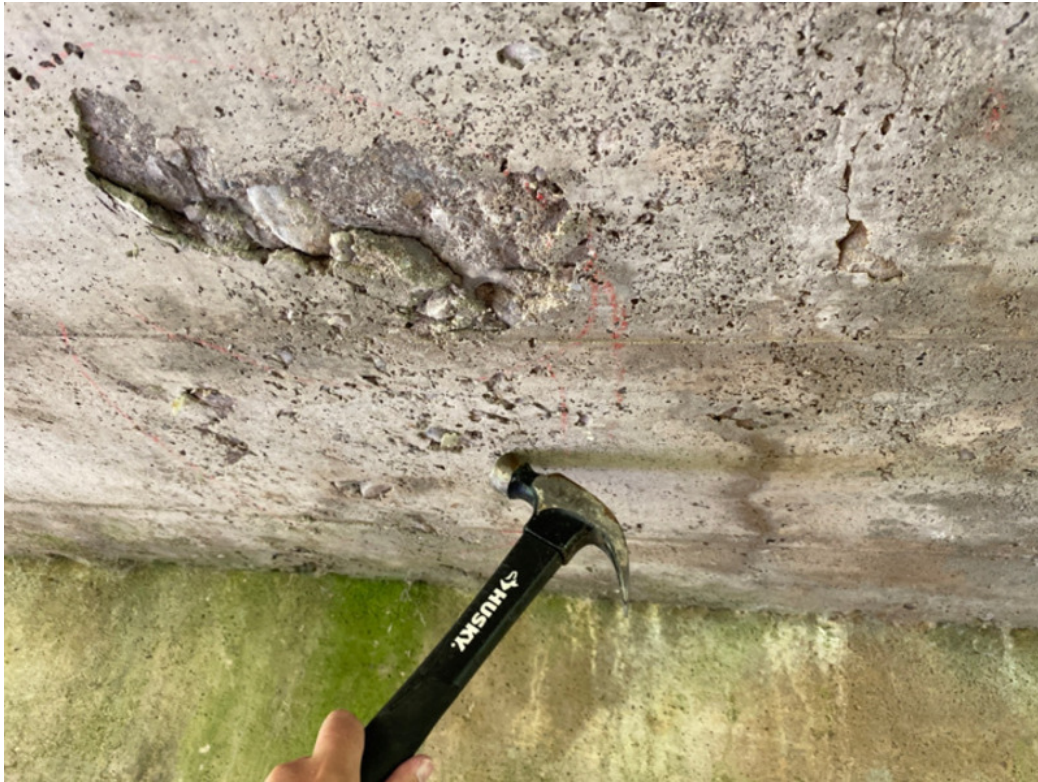
3. 4: Soffit - Thin Slab - Int (South)

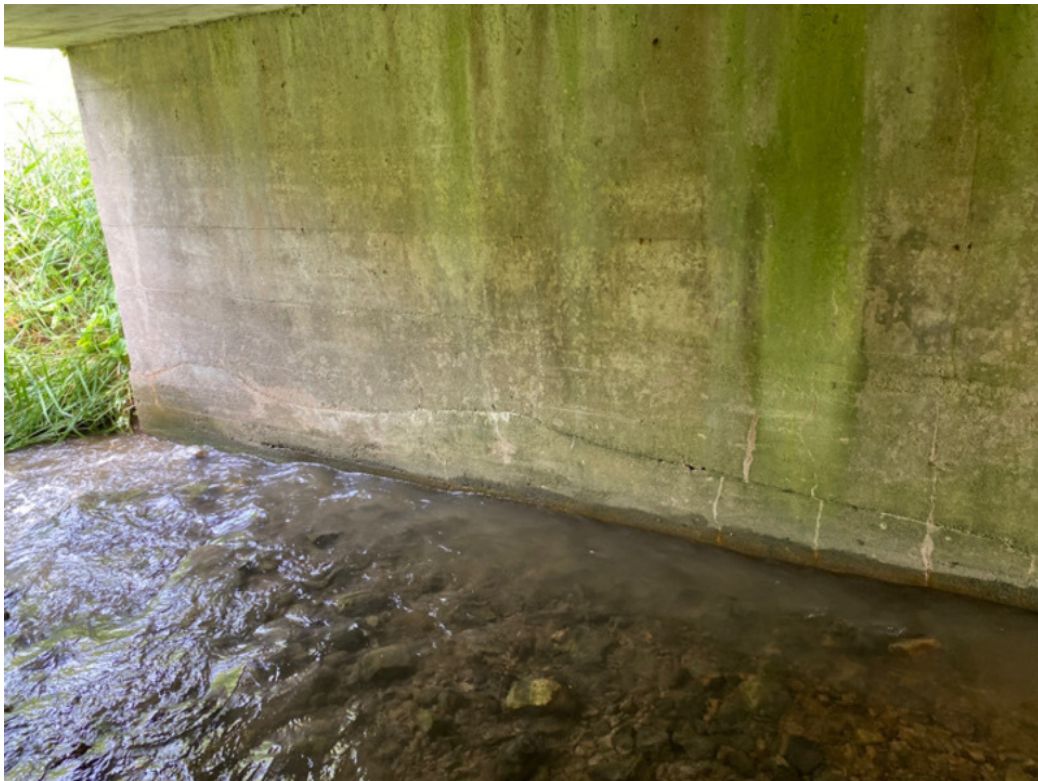
4. 4: Abutment Walls (North)

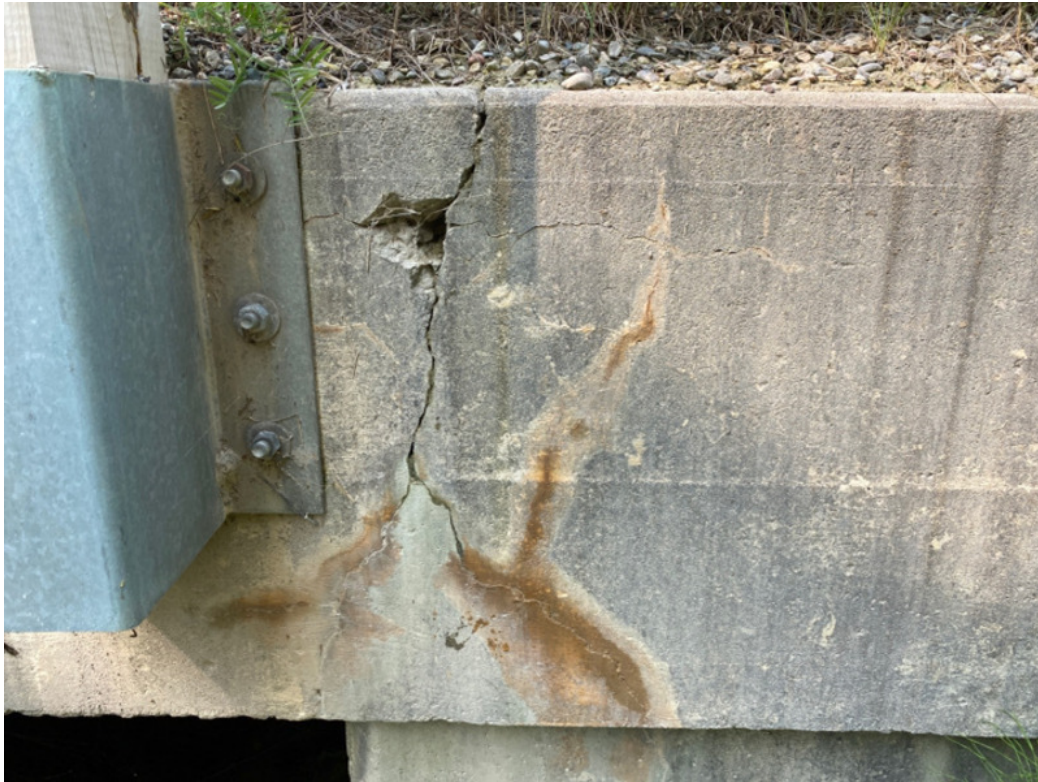
5. 4: Wingwalls (North East)

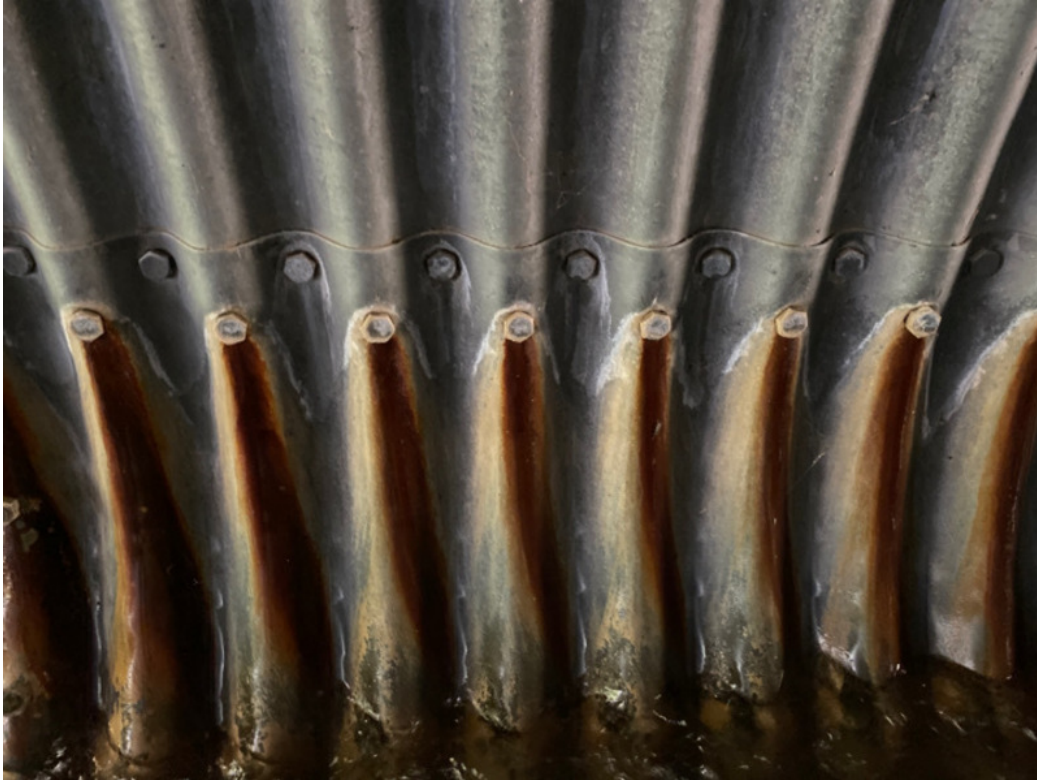
1. 5: Barrels (North)

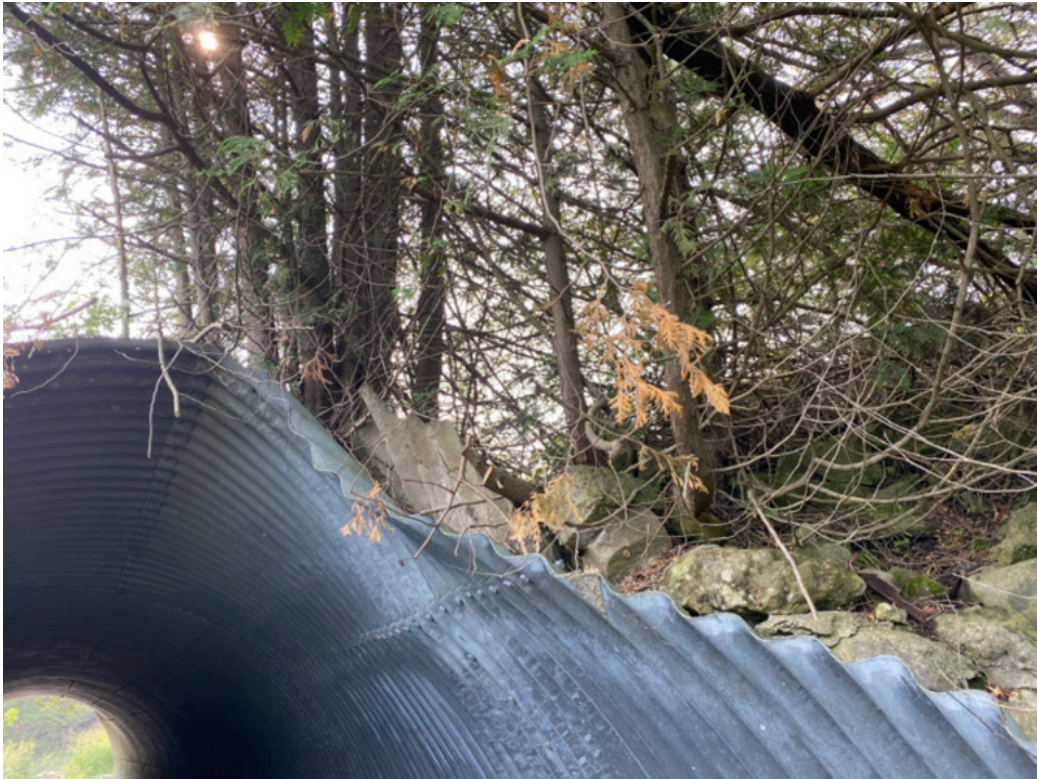
2. 5: Barrels (South West)

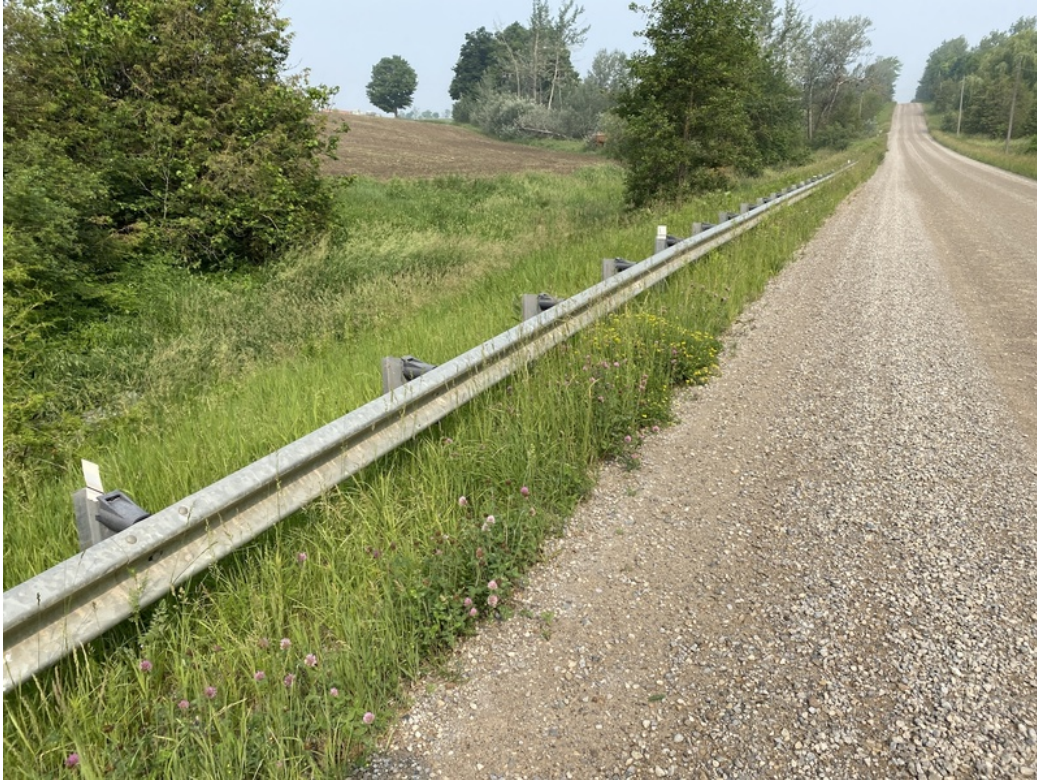
3. 5: Railing System (East)

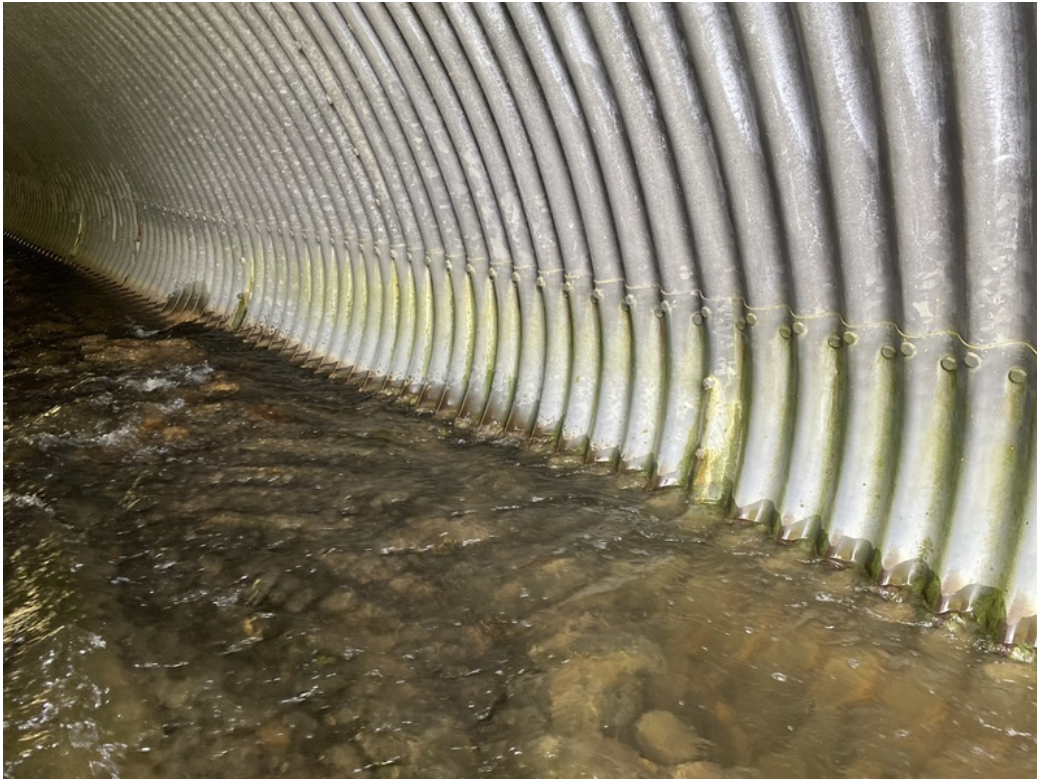
6. 5: Barrels (South)

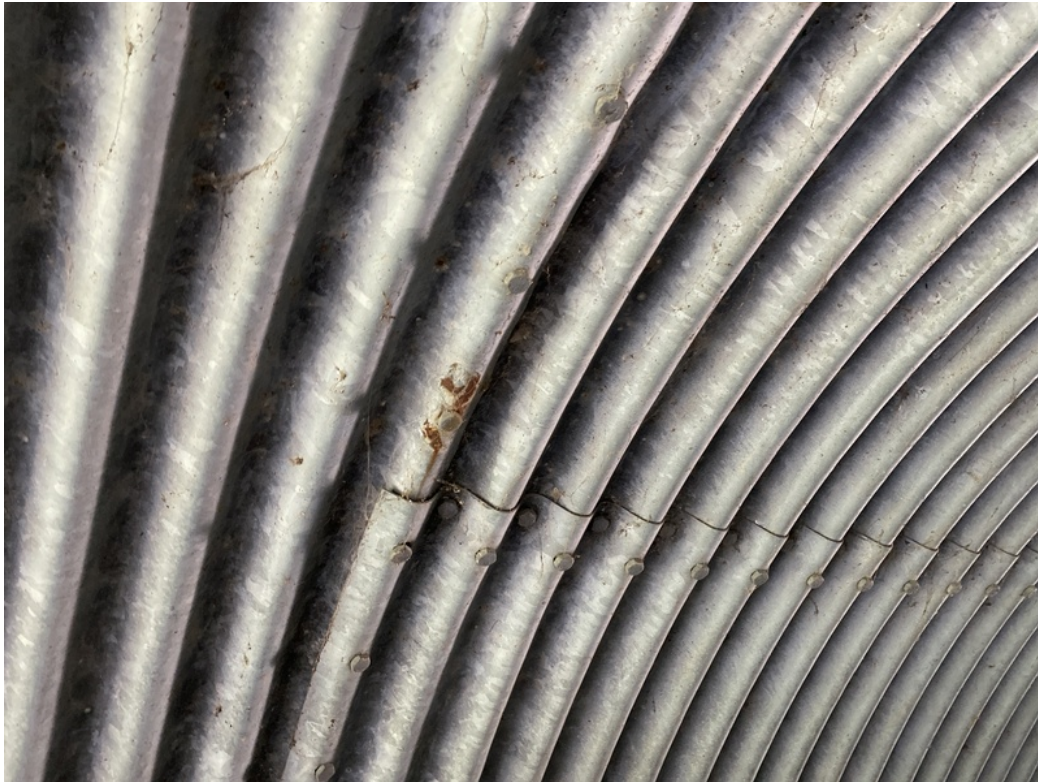
6. 5: Barrels (North)
