BURNSIDE

2023 OSIM Bridge Inspections Report

**Township of East Garafraxa
065371 Dufferin County Road 3, Unit 2
East Garafraxa, ON L9W 7J8**

**January 2024
300053343.2023**

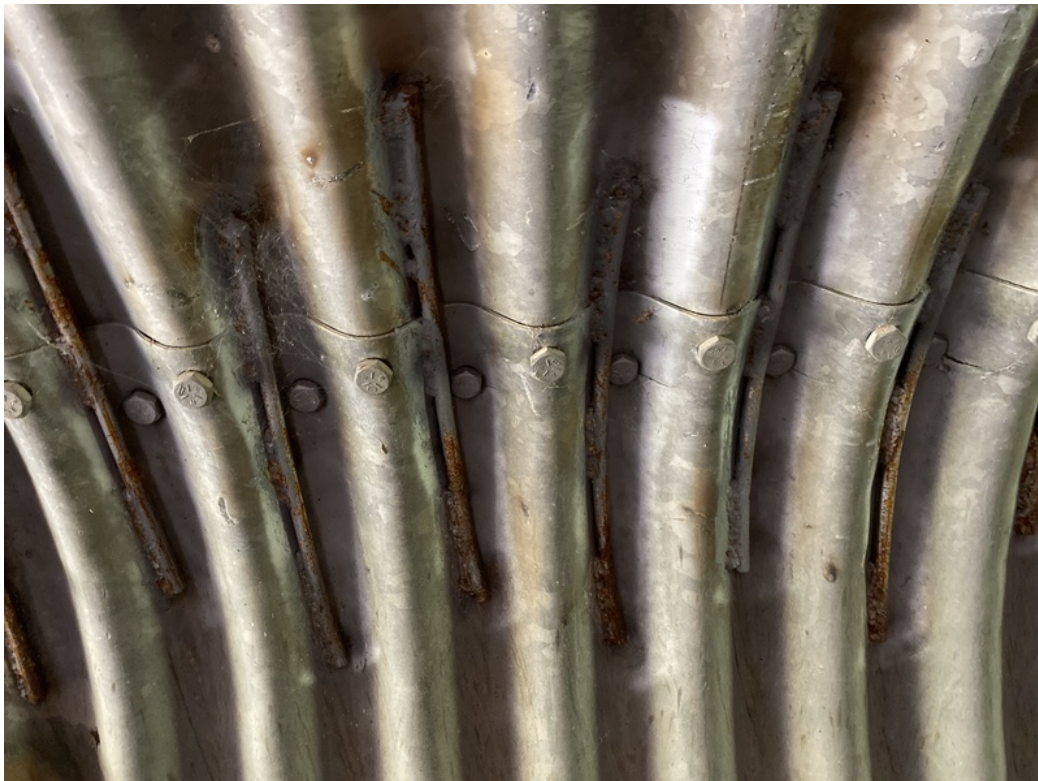
6. 5: Barrels (South)

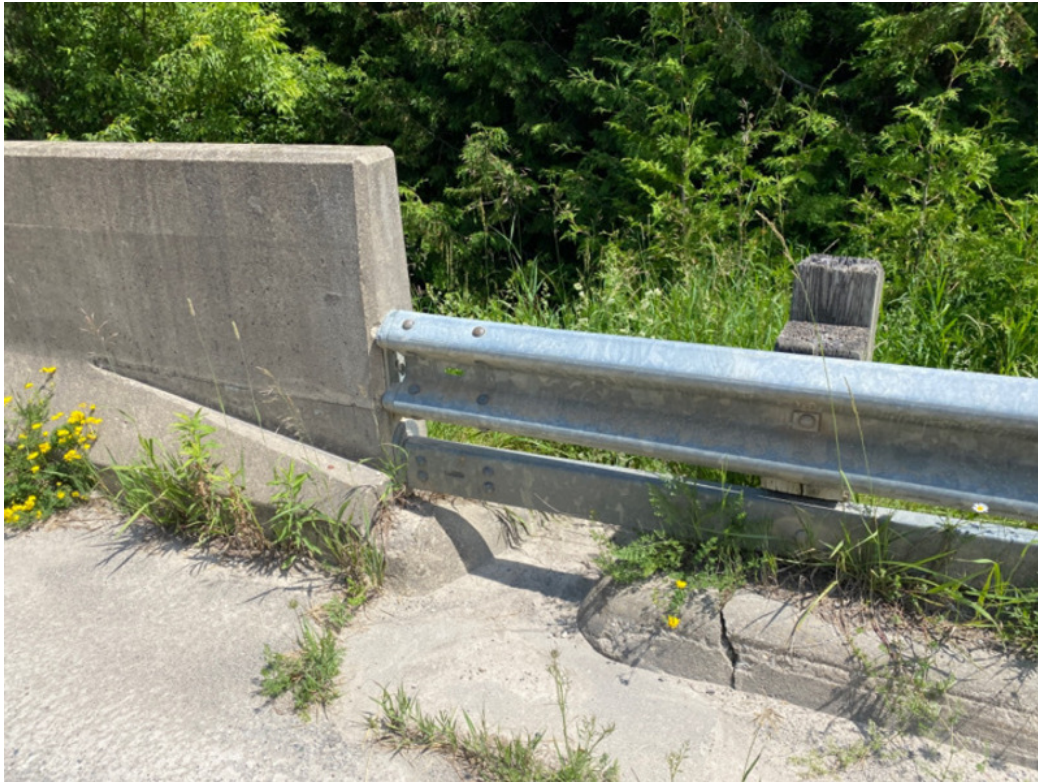
1. 6: Approach Guide Rail (All Quadrants)

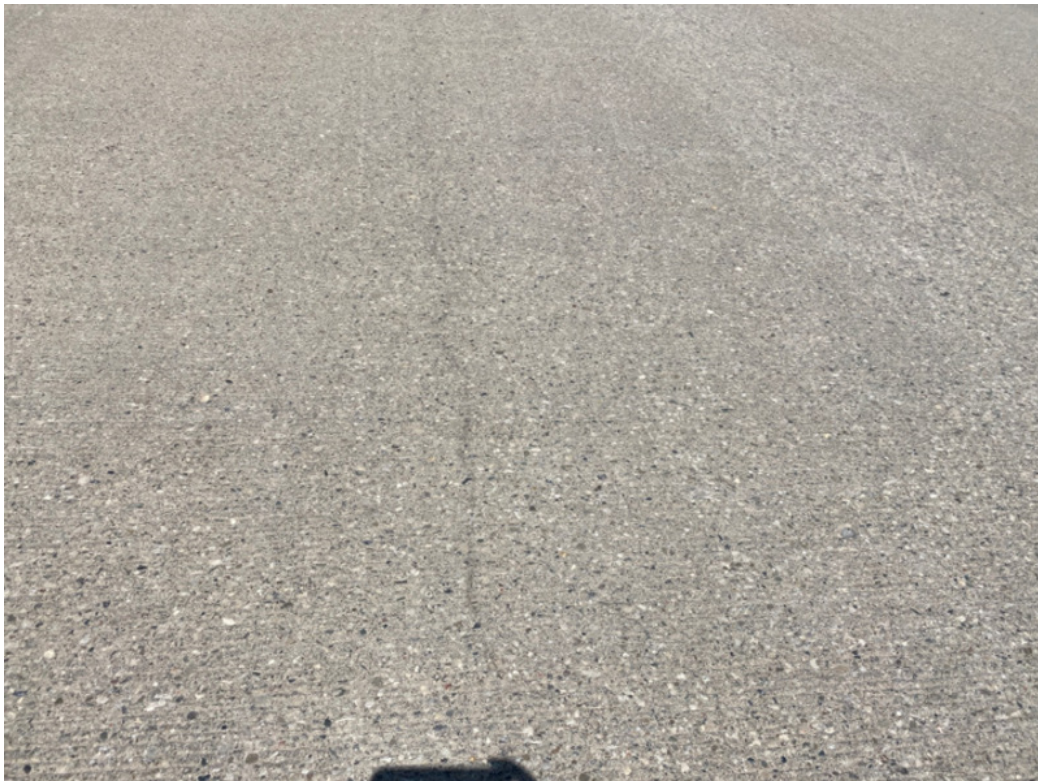
2. 6: Deck Top (North)

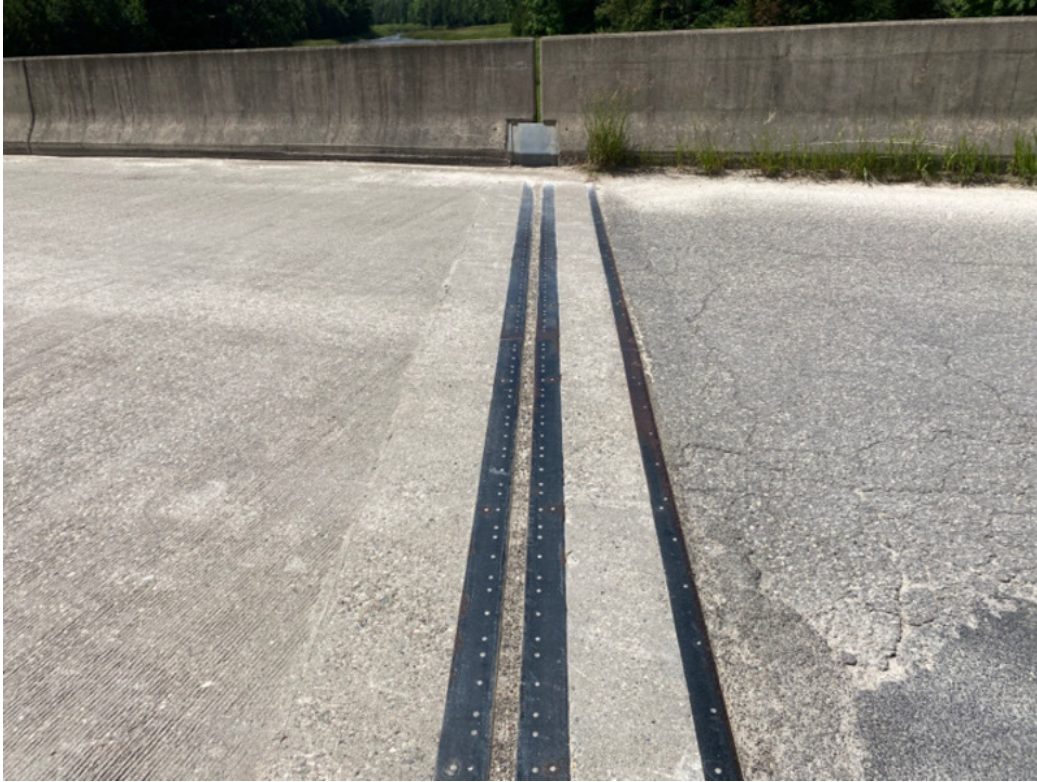
3. 6: Seals / Sealants (North)

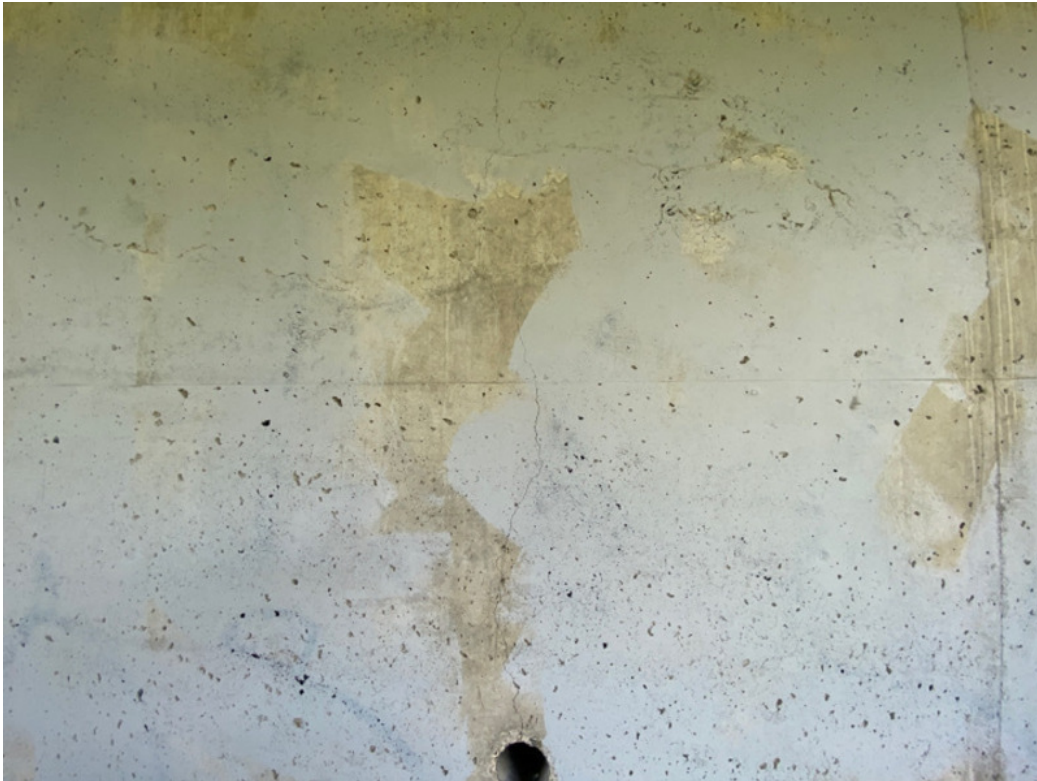
4. 6: Abutment Walls (South)

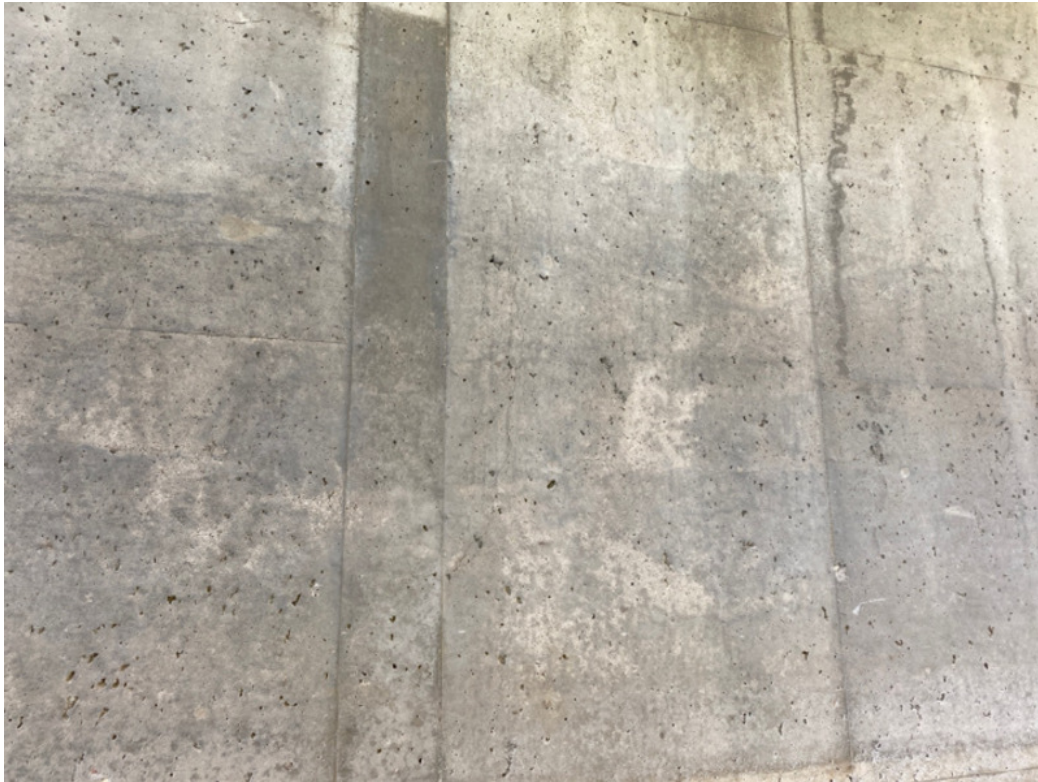
5. 6: Shaft / Bents (North)

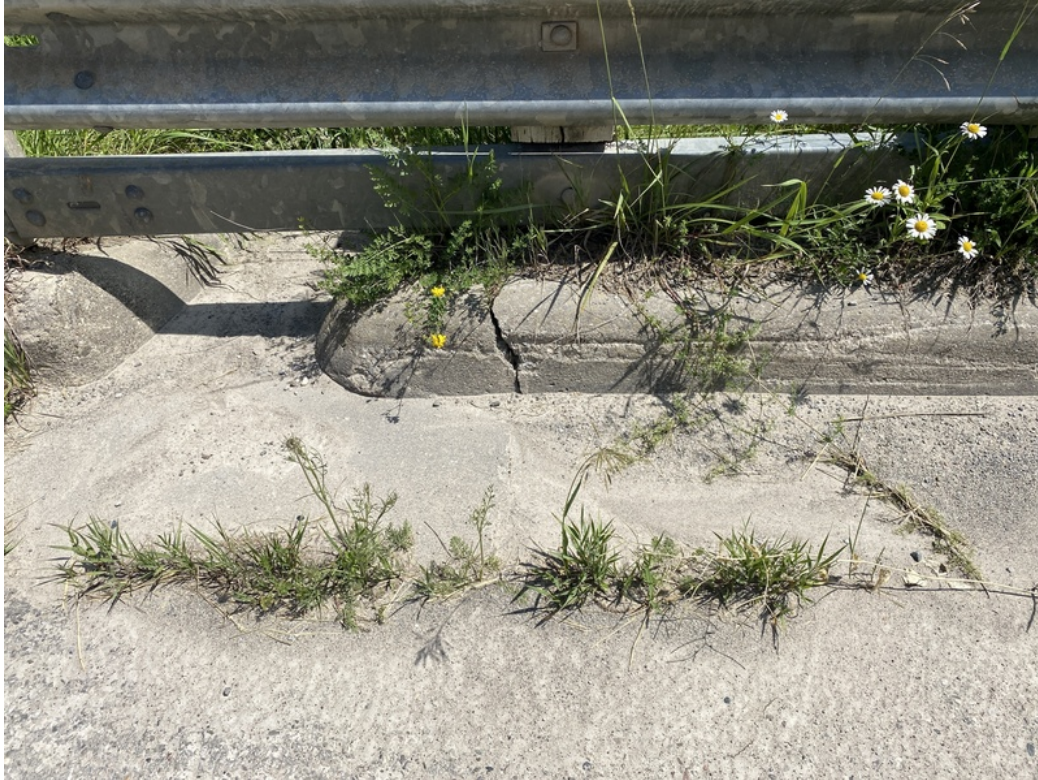
7. 6: Approach Curb/Gutters (South West)

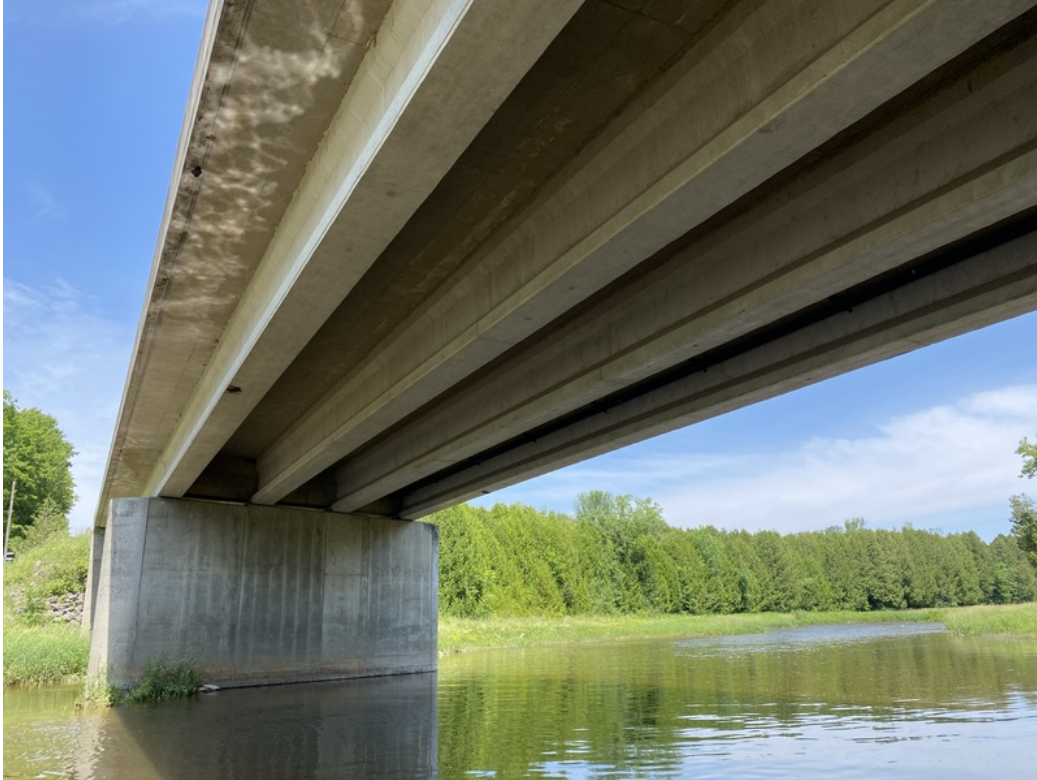
11. 6: Girders - Middle (South)

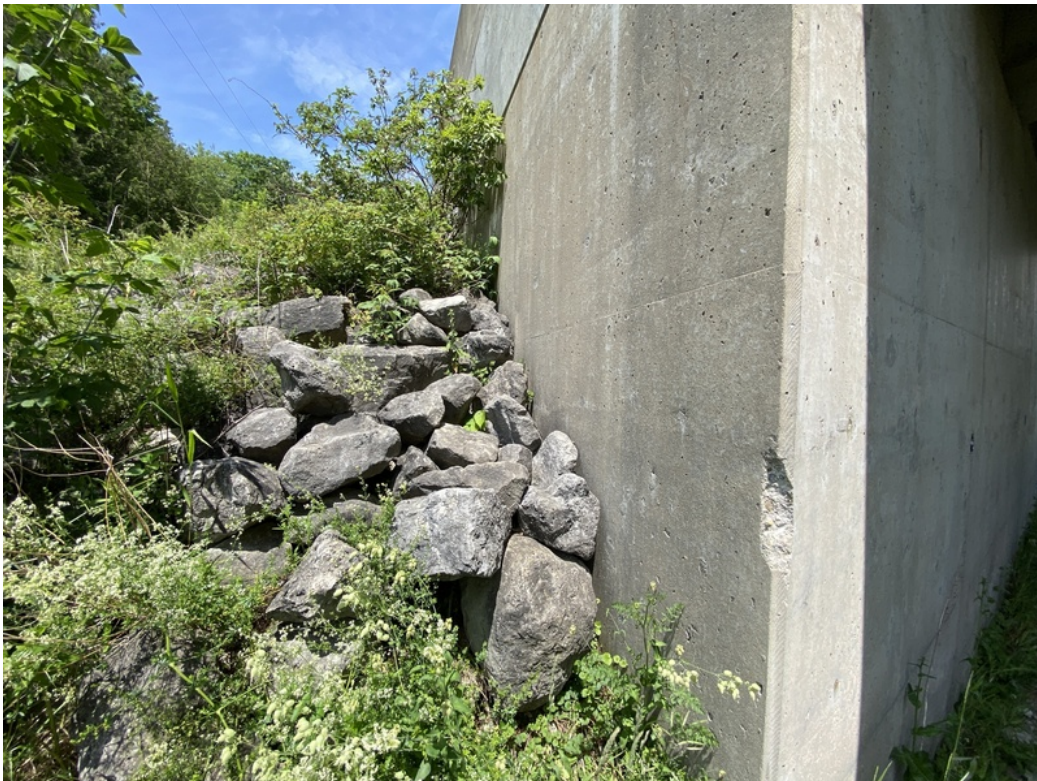
12. 6: Wingwalls (North West)

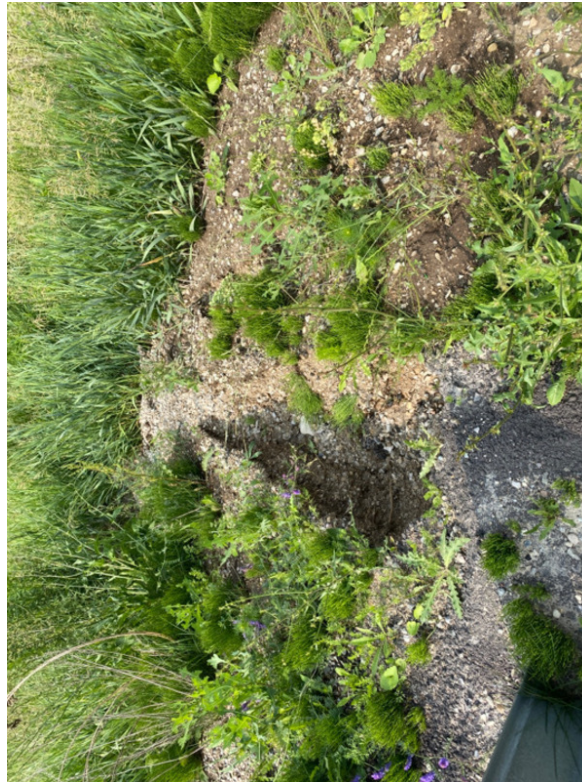
1. 7: Approach Guide Rail (North West)

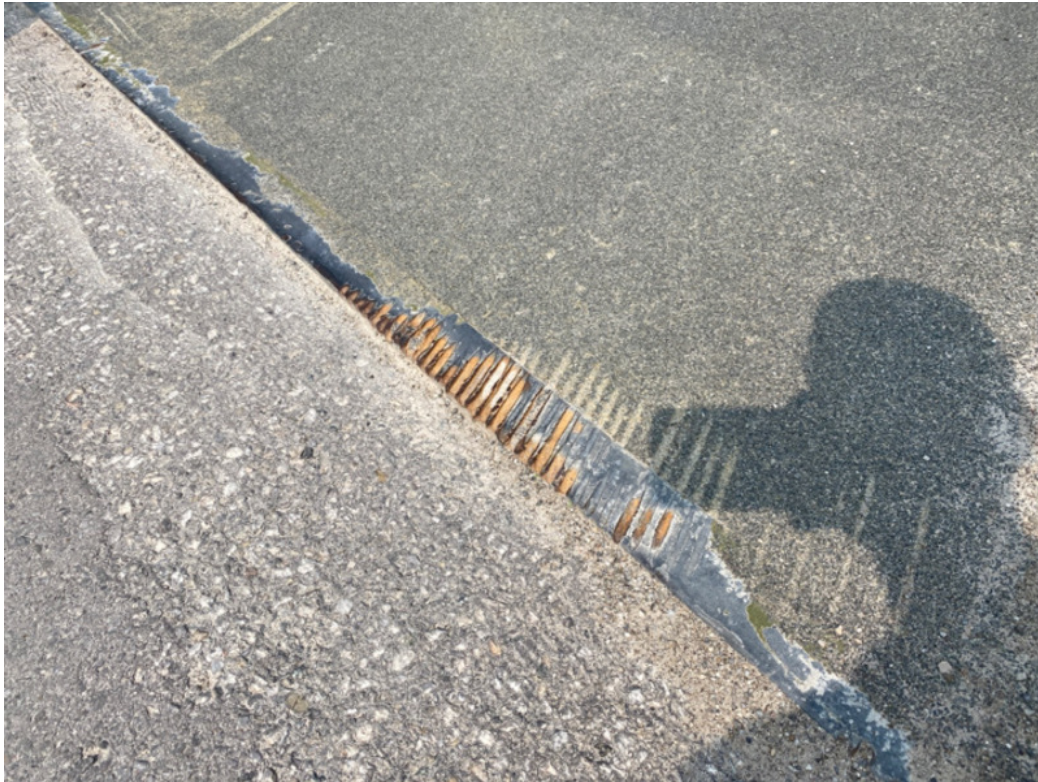
3. 7: Armouring/Retaining Device (South)

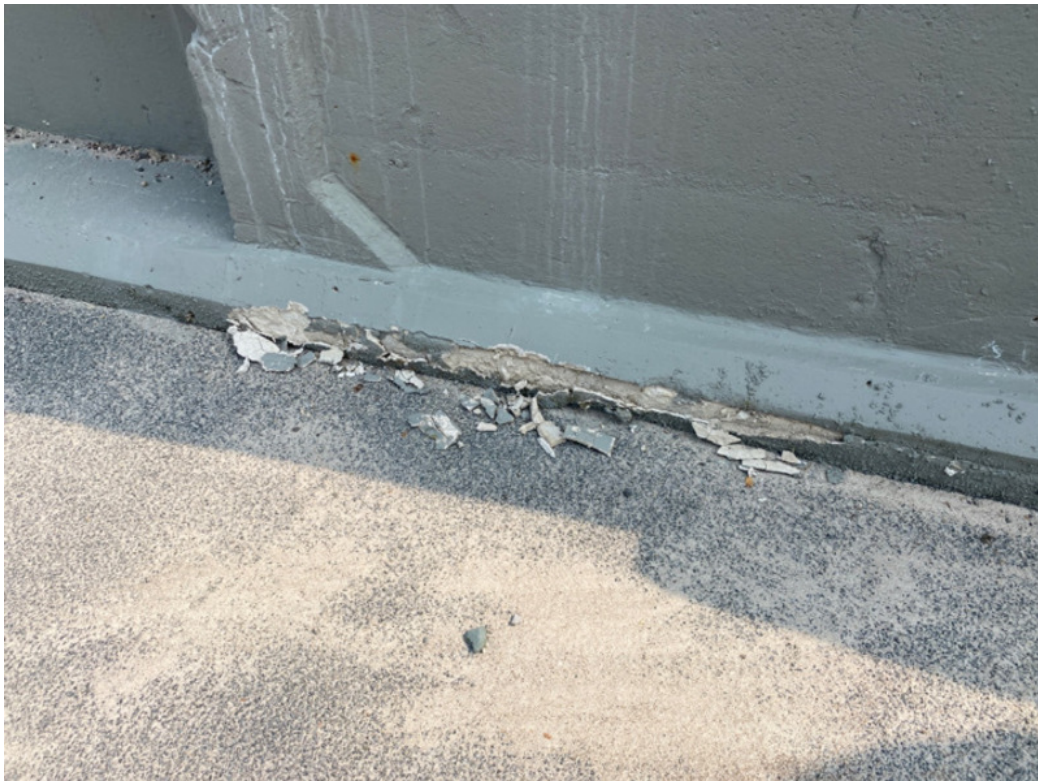
4. 7: Curbs (East)

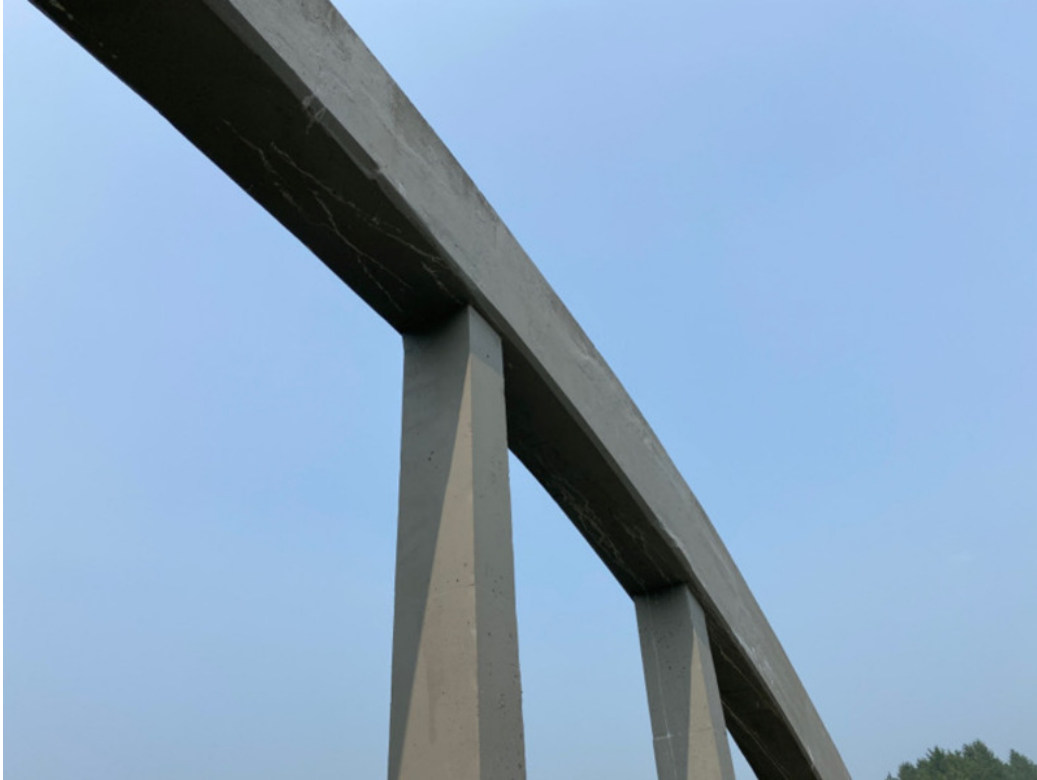
5. 7: Top Chords (South West)

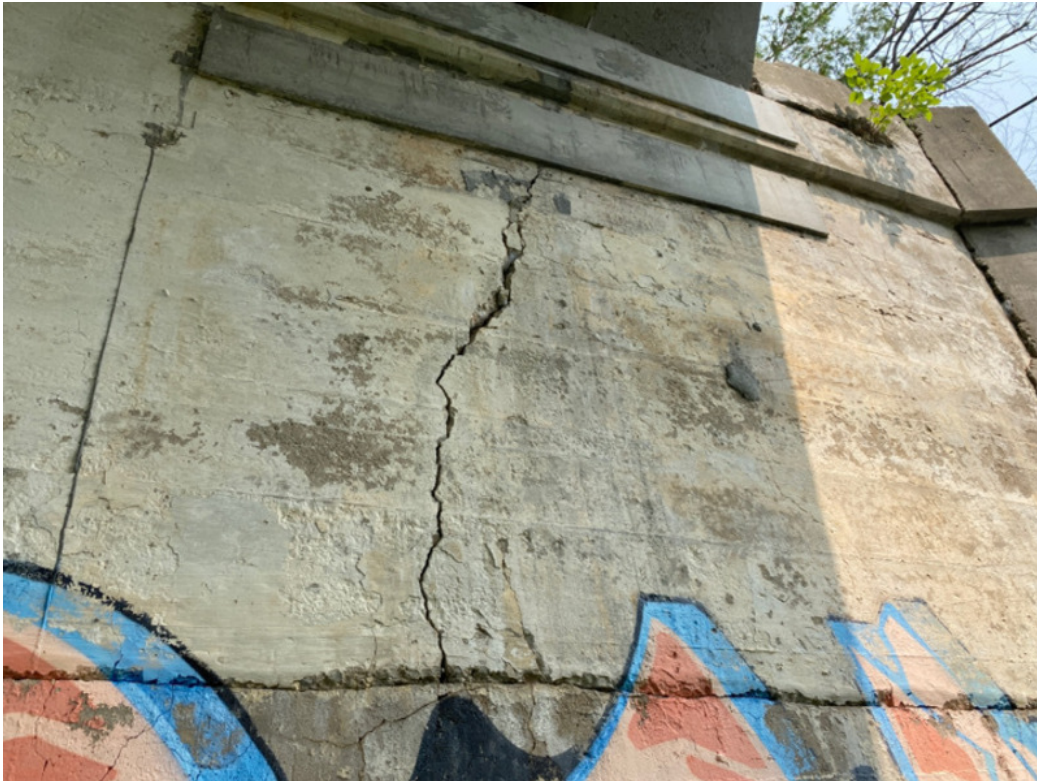
6. 7: Abutment Walls (North)

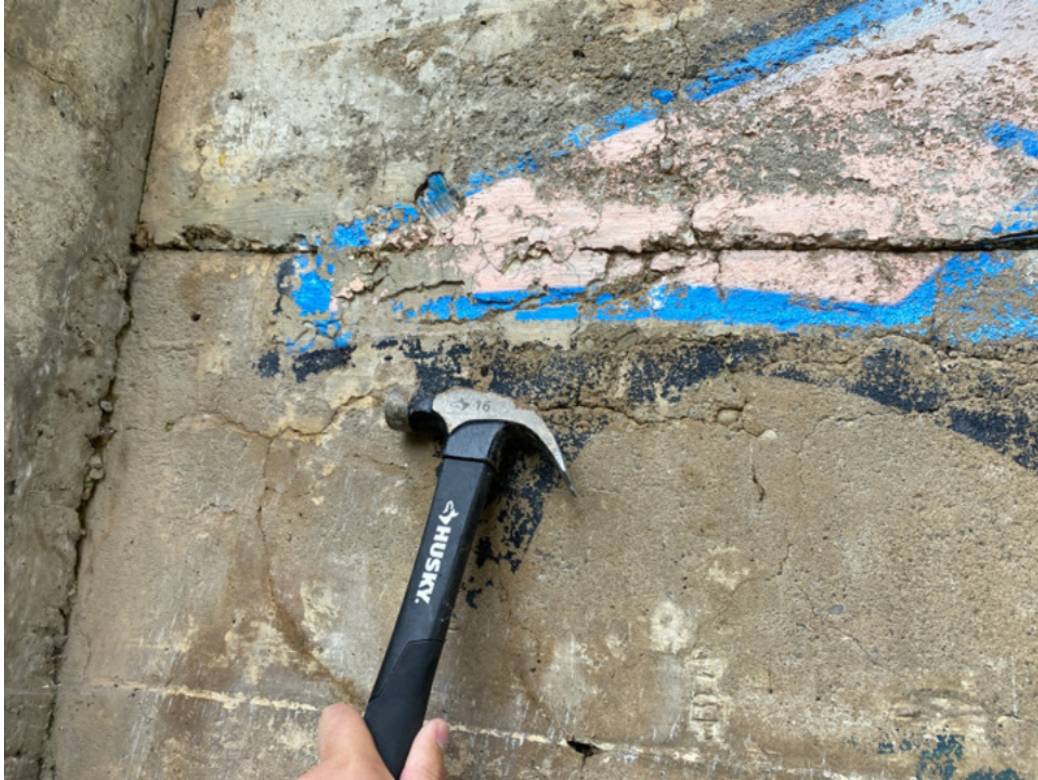
7. 7: Abutment Walls (North)

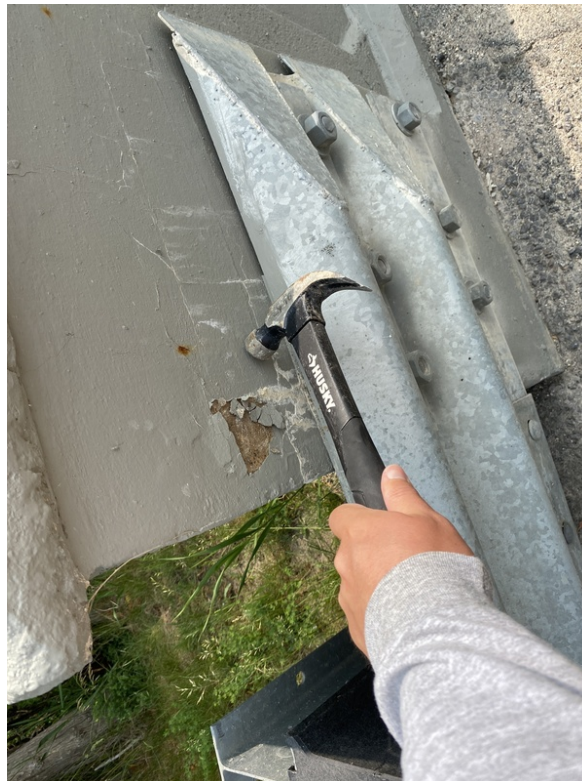
10. 7: End Post (North West)

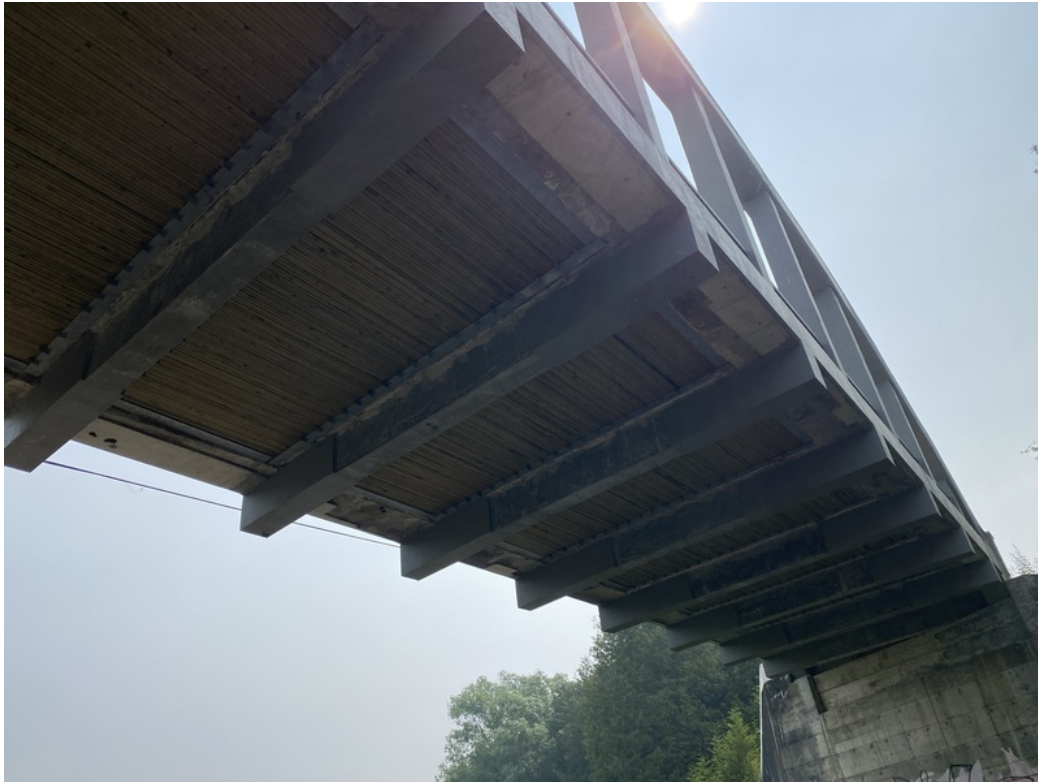
11. 7: Floor Beams (South)

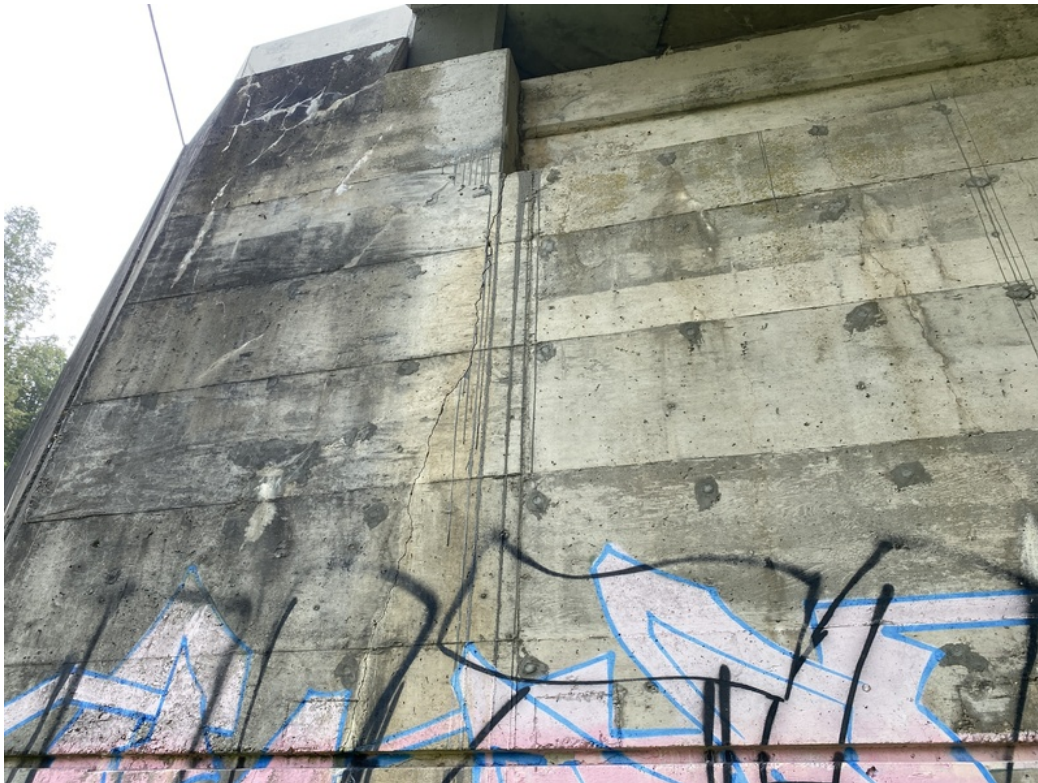
12. 7: Abutment Walls (South)

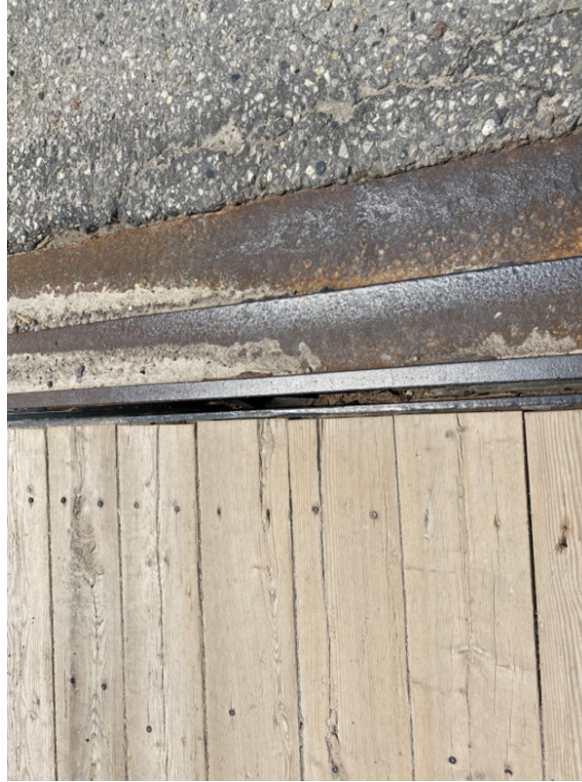
1. 8: Seals / Sealants (West)

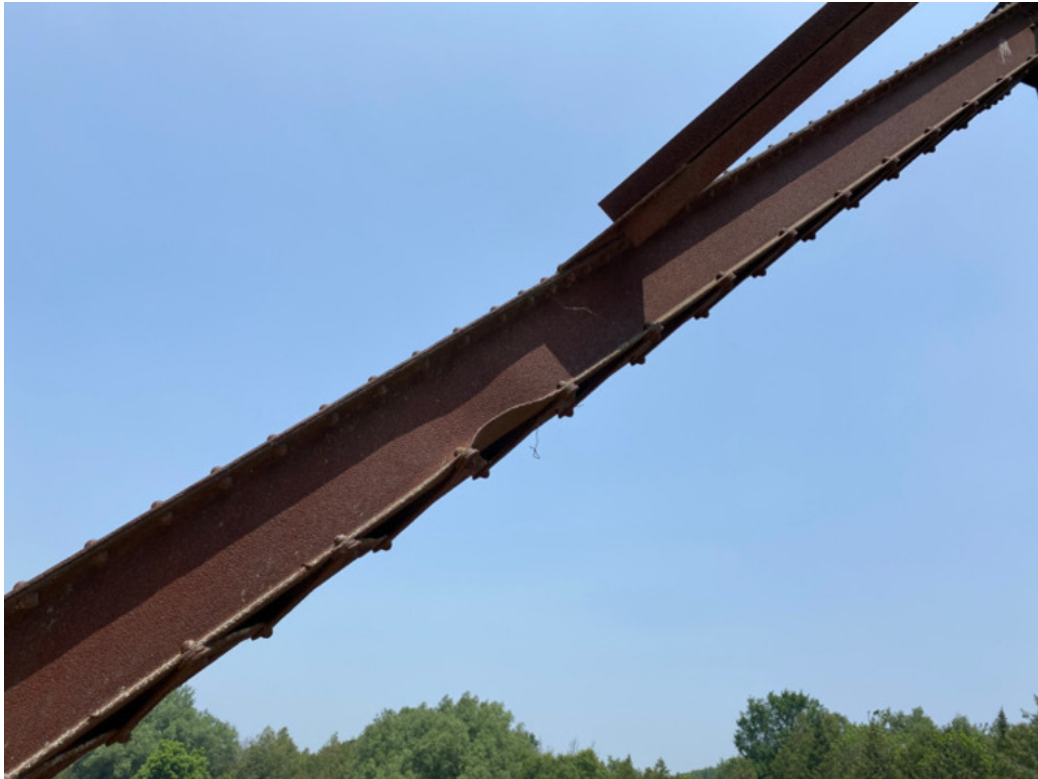
2. 8: Top Chords (North West)

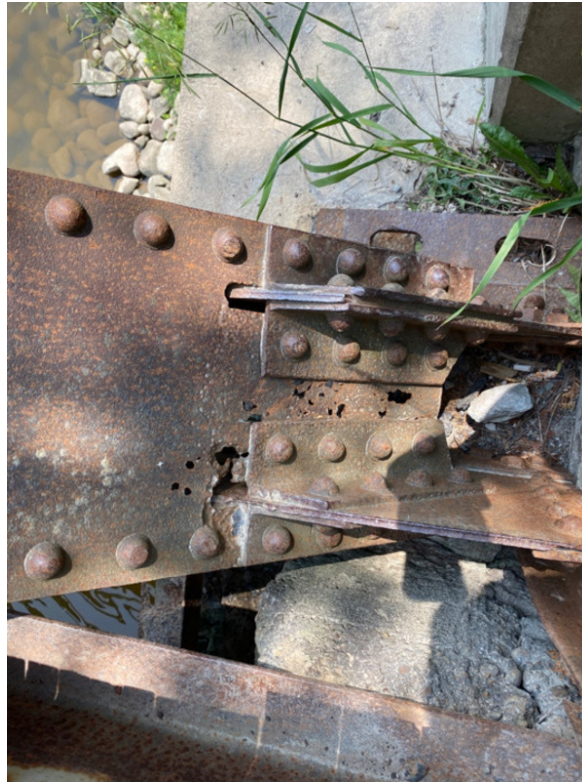
3. 8: Top Chords (South West)

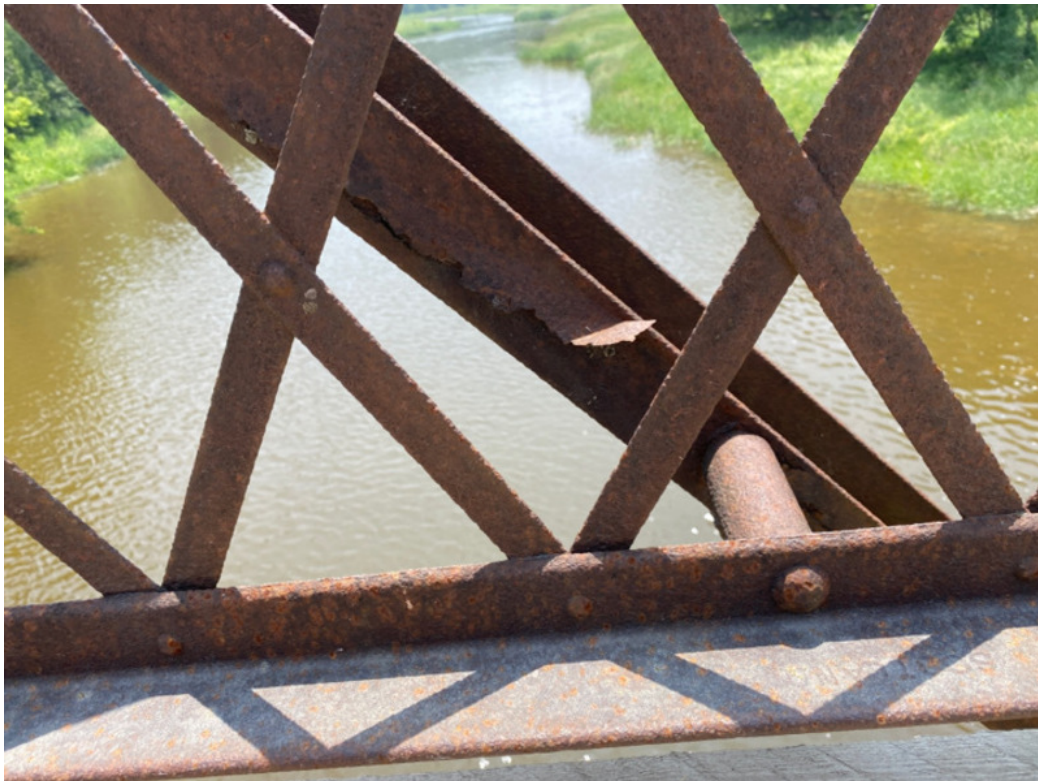
4. 8: Verticals / Diagonals (South)

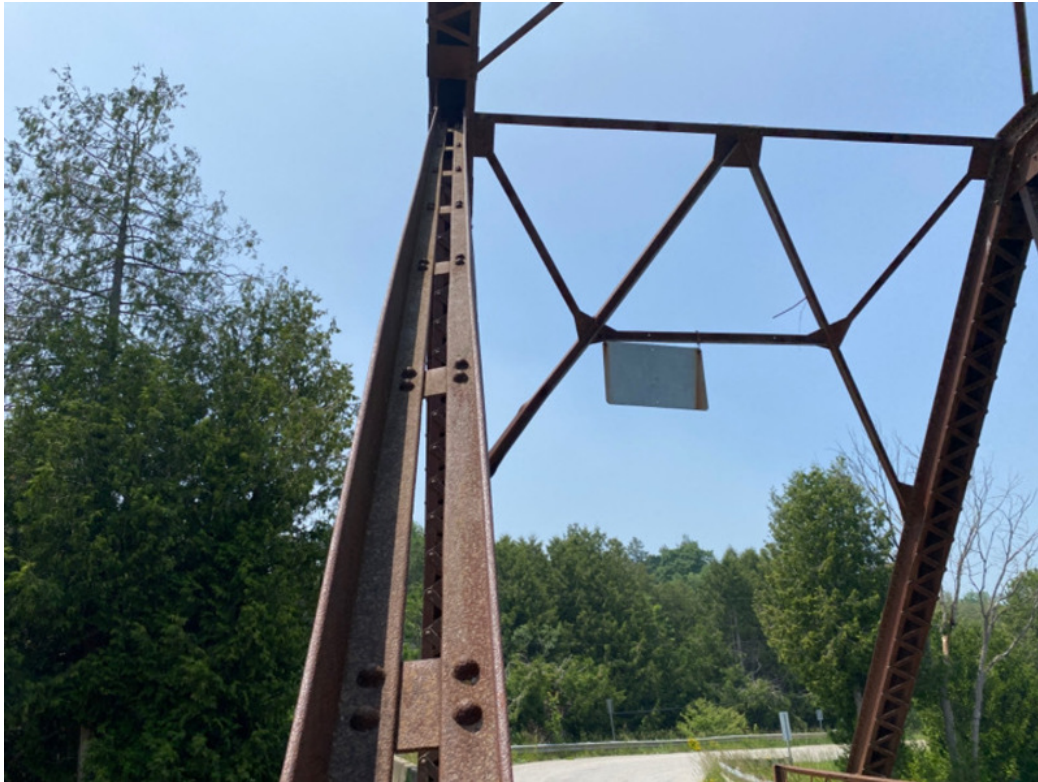
5. 8: Verticals / Diagonals (South West)

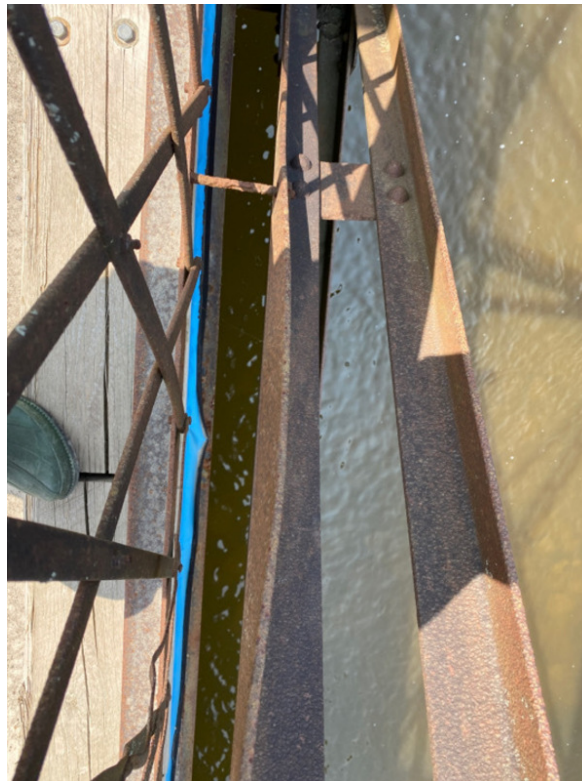
6. 8: Verticals / Diagonals (North)

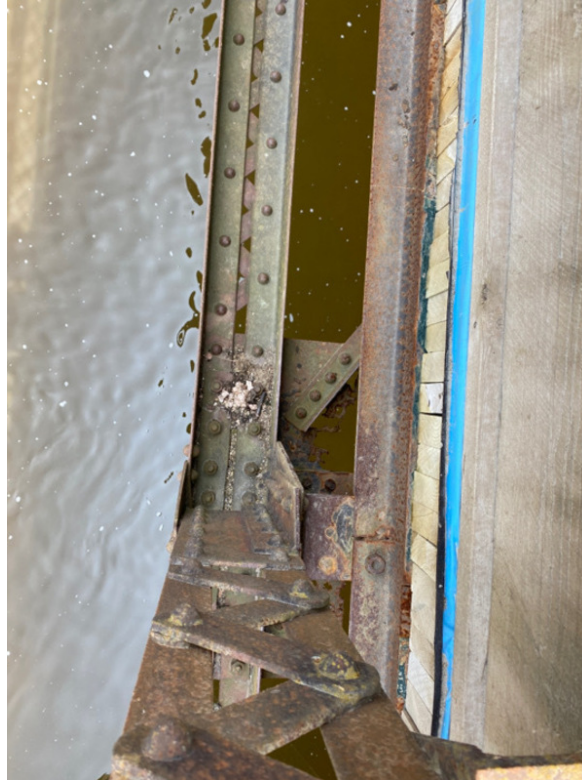
7. 8: Connections (North)

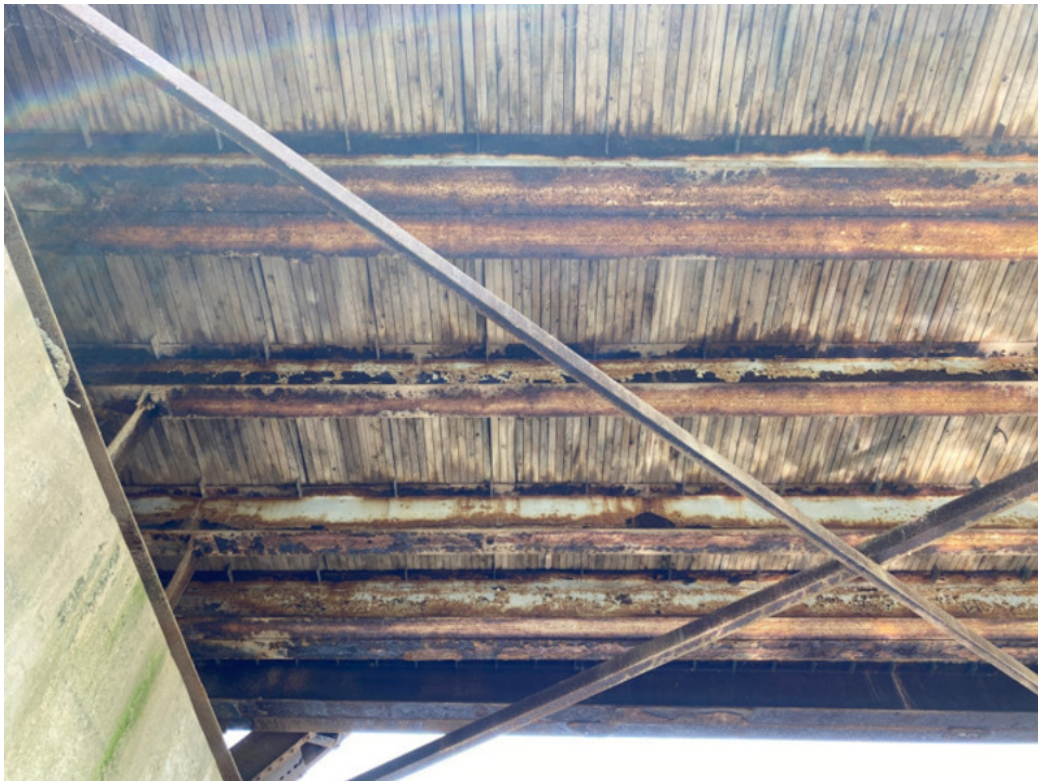
8. 8: Girders - Ends (West)

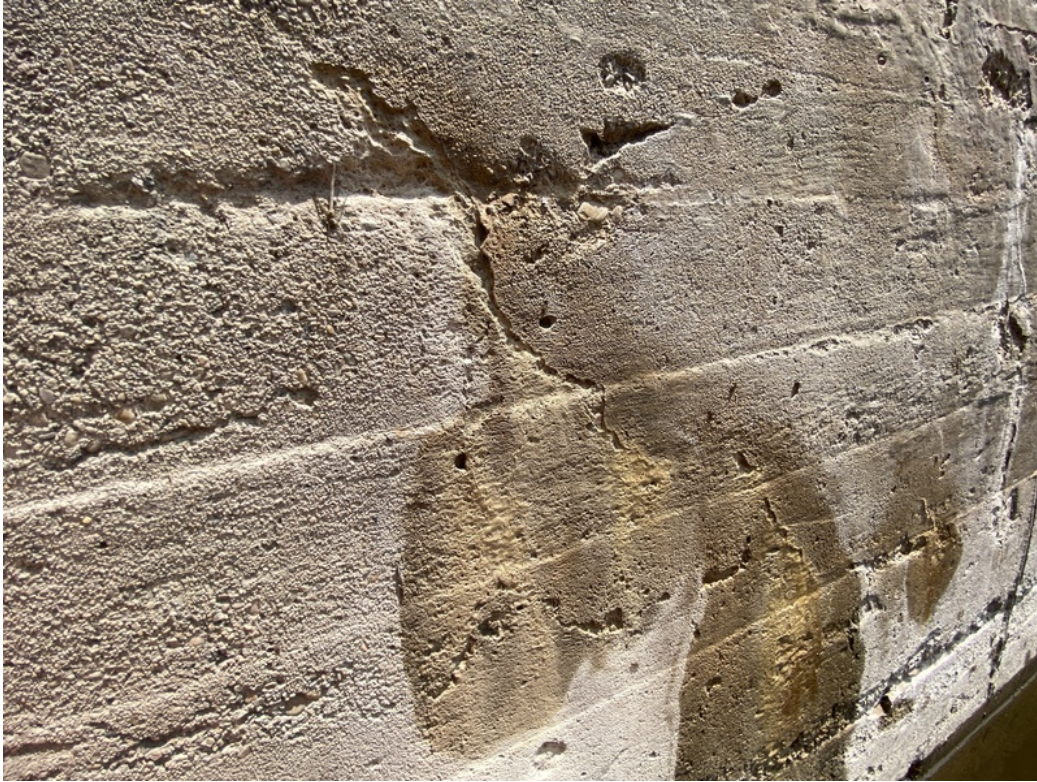
9. 8: Abutment Walls (South East)

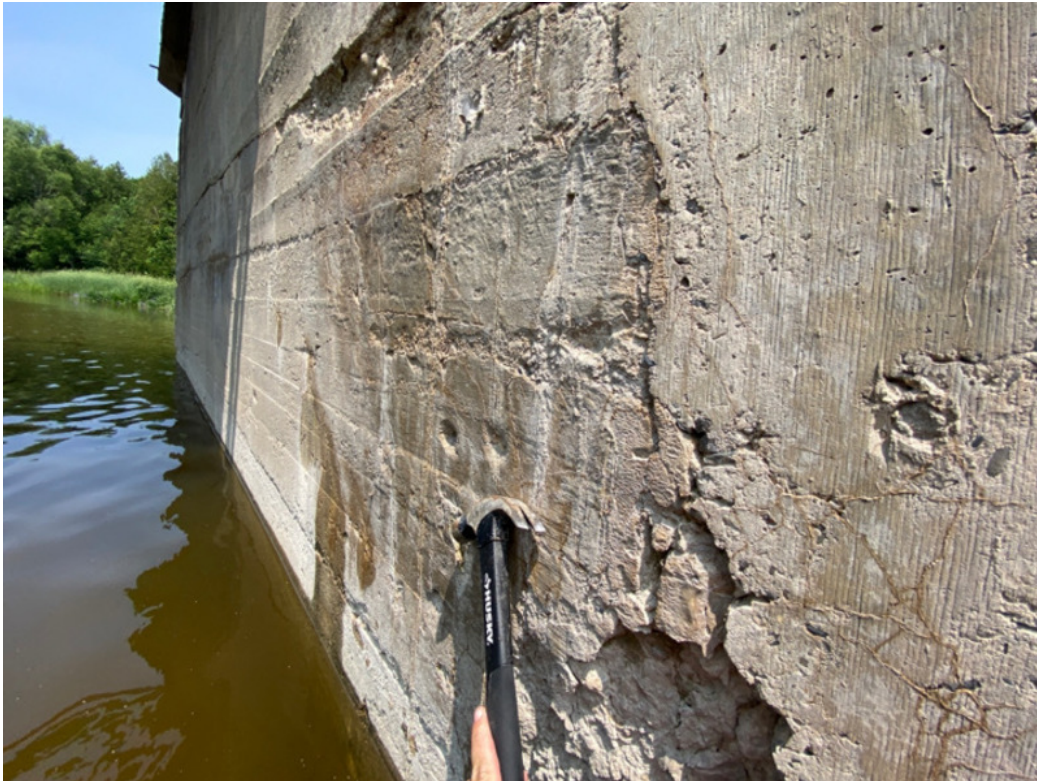
10. 8: Abutment Walls (East)

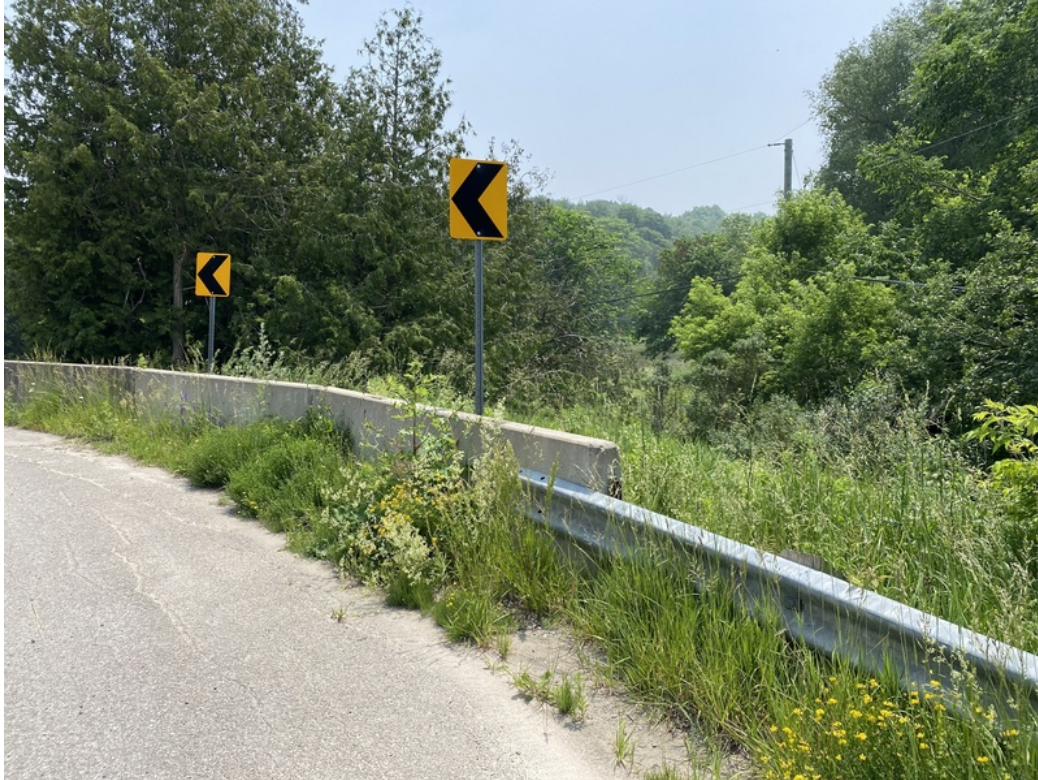
2. 8: Approach Guide Rail (South West)

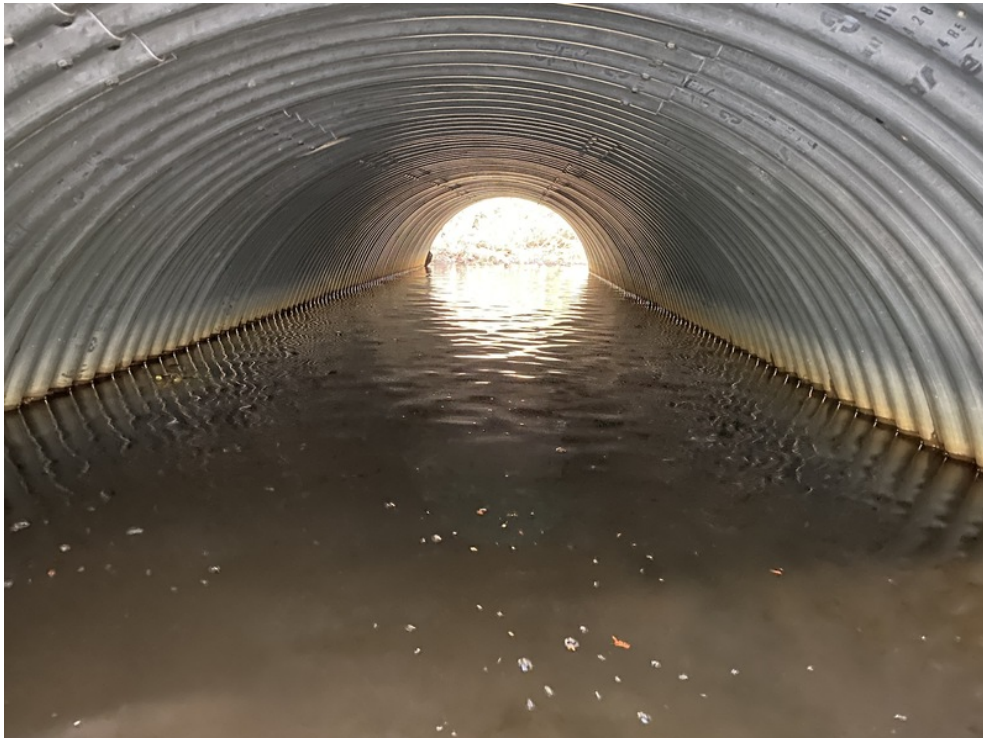
Barrels (Through Structure)

| Surface corrosion at waterline

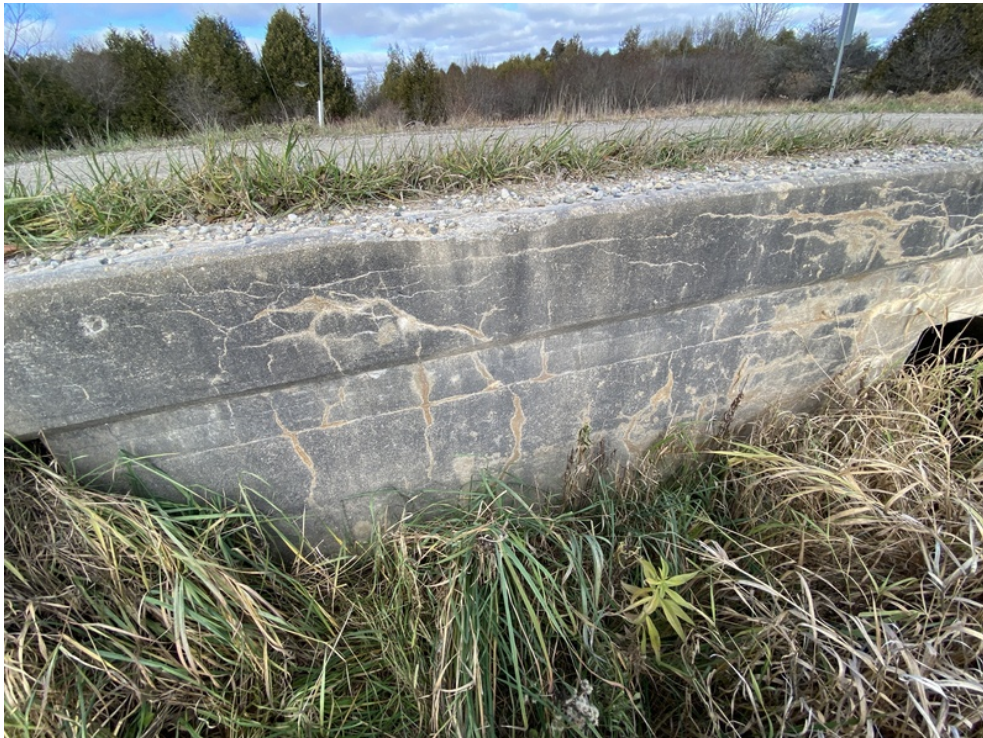
Outlet (South East)

| Hairline to narrow stained cracks
