BURNSIDE

2023 OSIM Bridge Inspections Report

**Township of East Garafraxa
065371 Dufferin County Road 3, Unit 2
East Garafraxa, ON L9W 7J8**

**January 2024
300053343.2023**

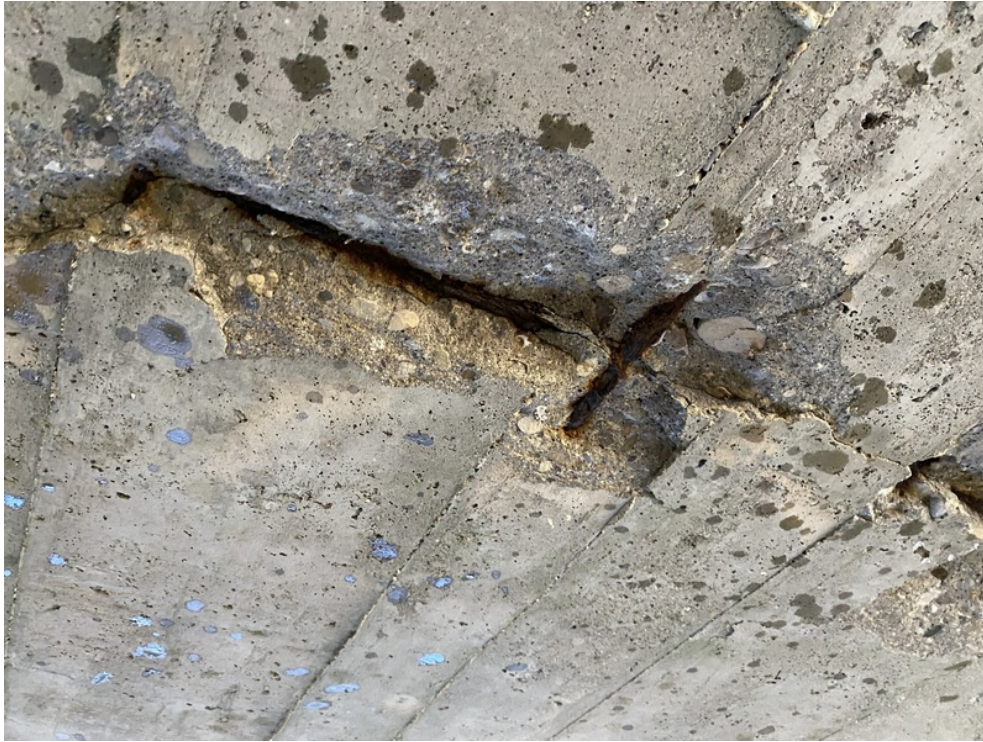
Barrels (Through Structure)

| Spall with exposed corroded rebar

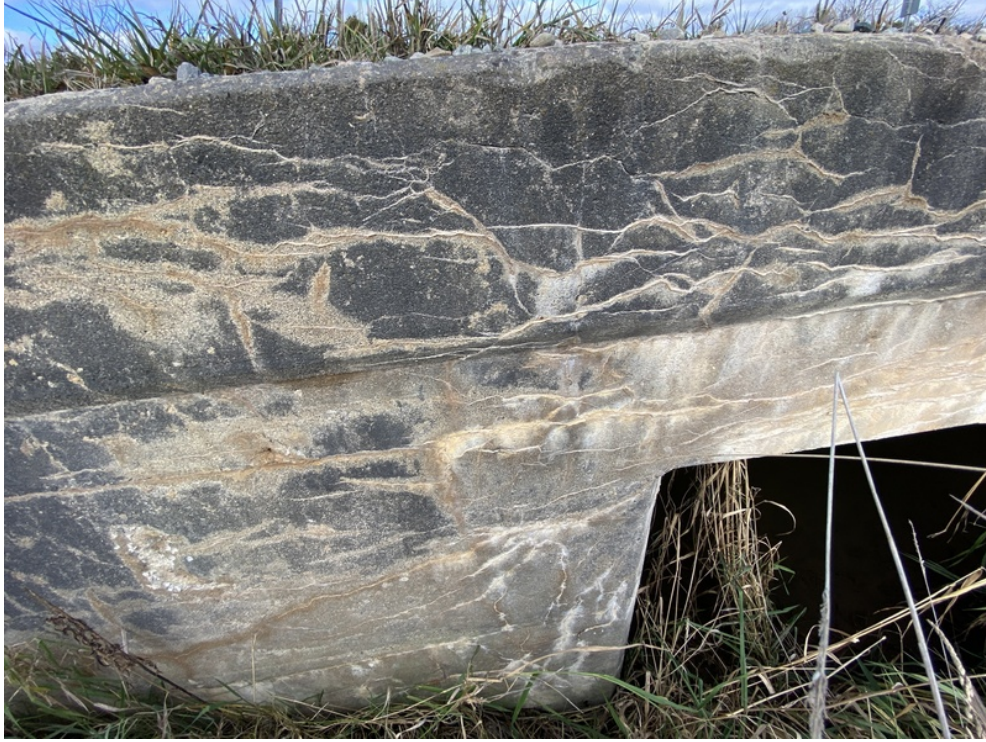
Inlet (North West)

| Hairline to narrow stained cracks

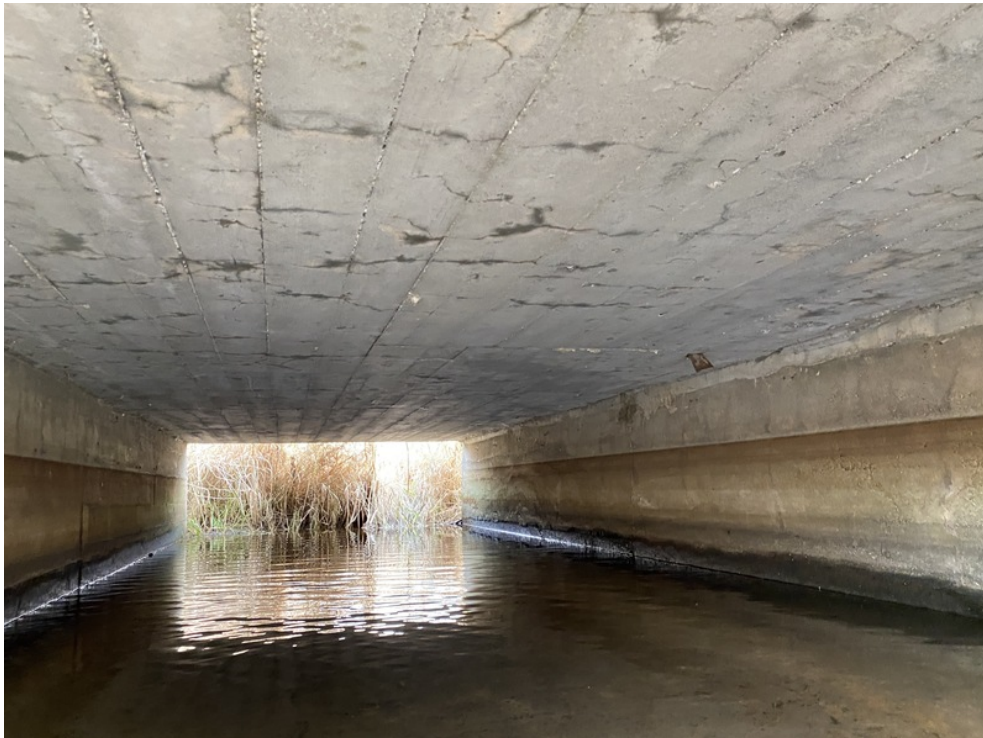
Barrels (Through Structure)

| Moisture penetration in soffit

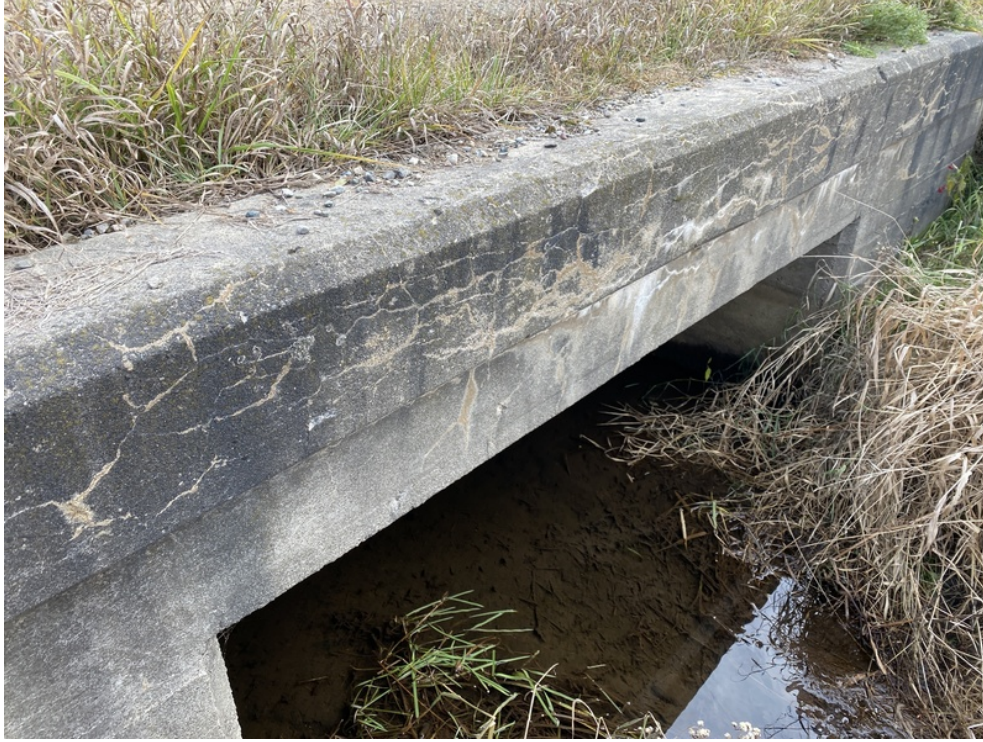
Outlet (North East)

| Hairline stained cracks

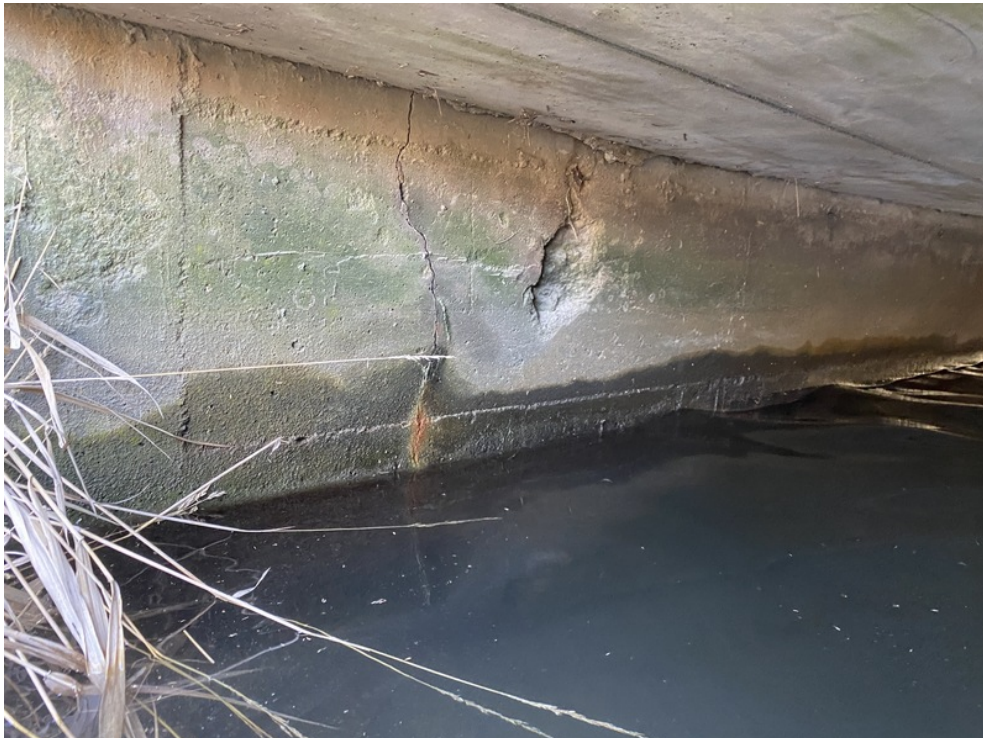
Barrels (Through Structure)

| Spall

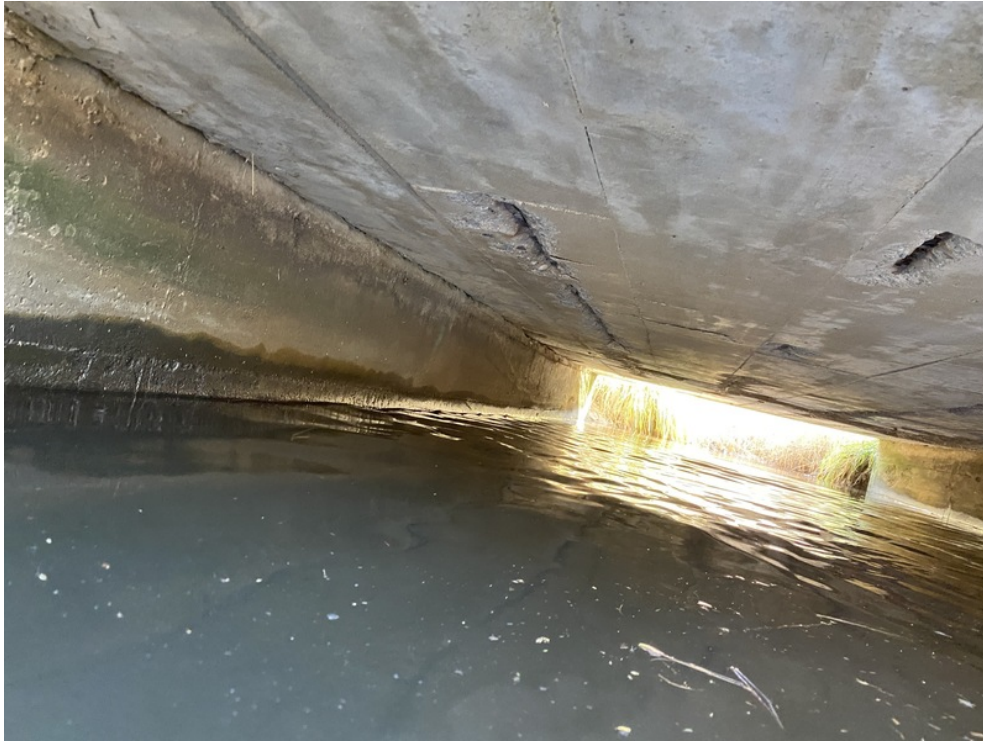
Barrels (Through Structure)

| Spall with exposed corroded rebar in soffit

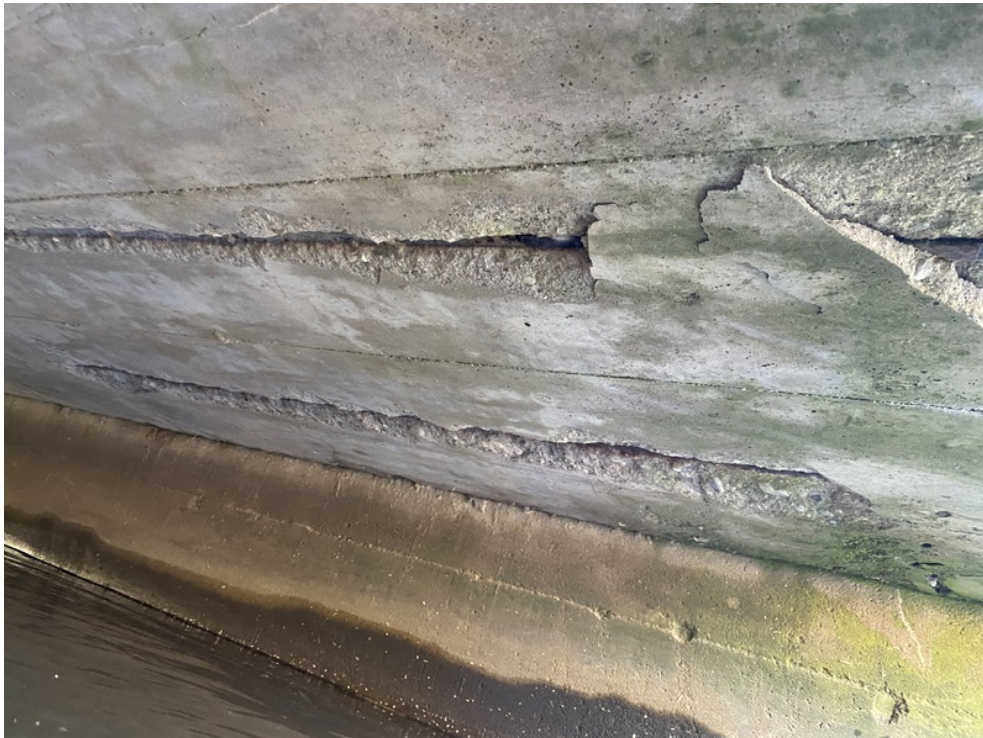
Barrels (Through Structure)

| Spall with exposed corroded rebar in soffit

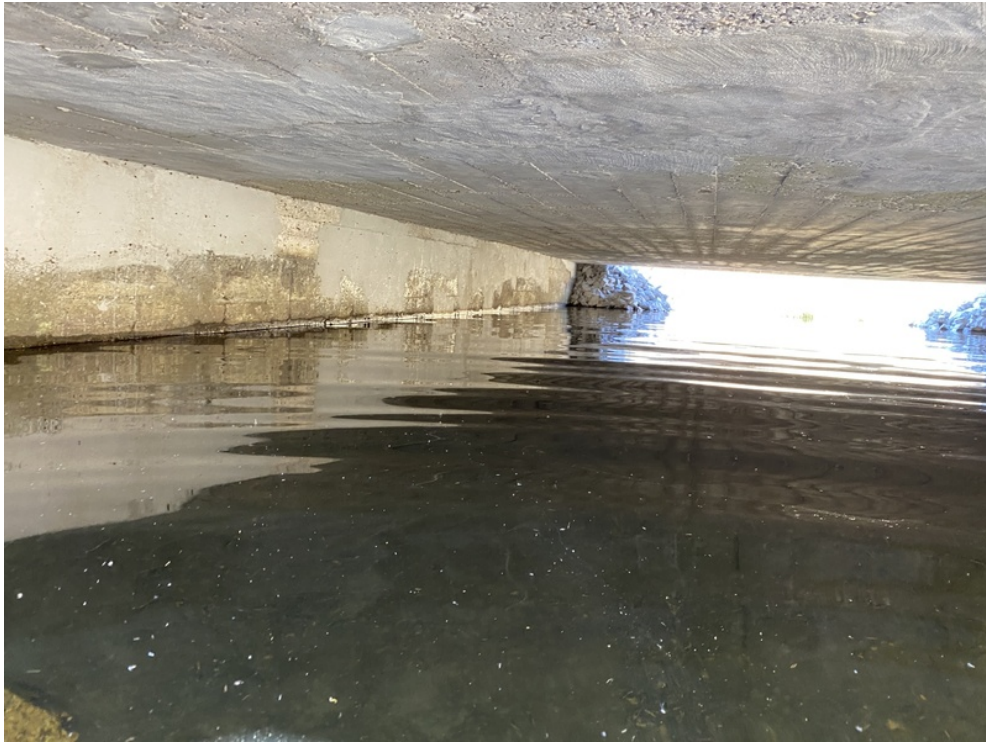
Barrels (Through Structure)

| Concrete patch repairs in soffit
